TEST REPORT 12206/D/23

138 kV Composite line insulator

138 kV / 111 kN

CSA C411.4-16, IEC 60060-1 Ed.3:2010

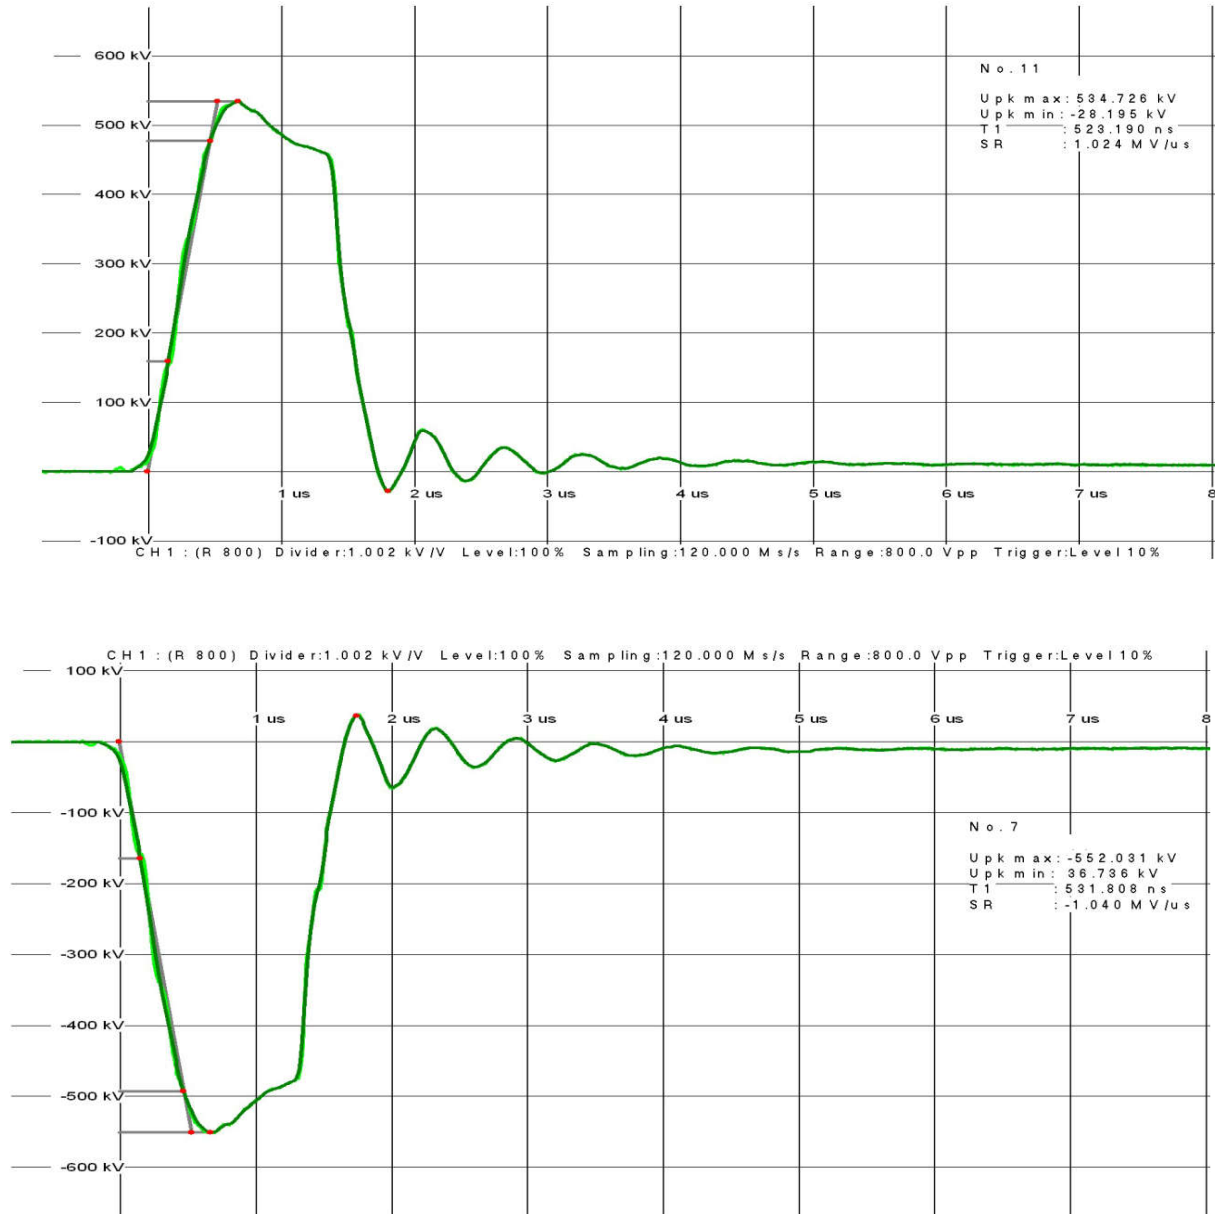
Figure 2 Representative wave shape of the steep-front impulse test

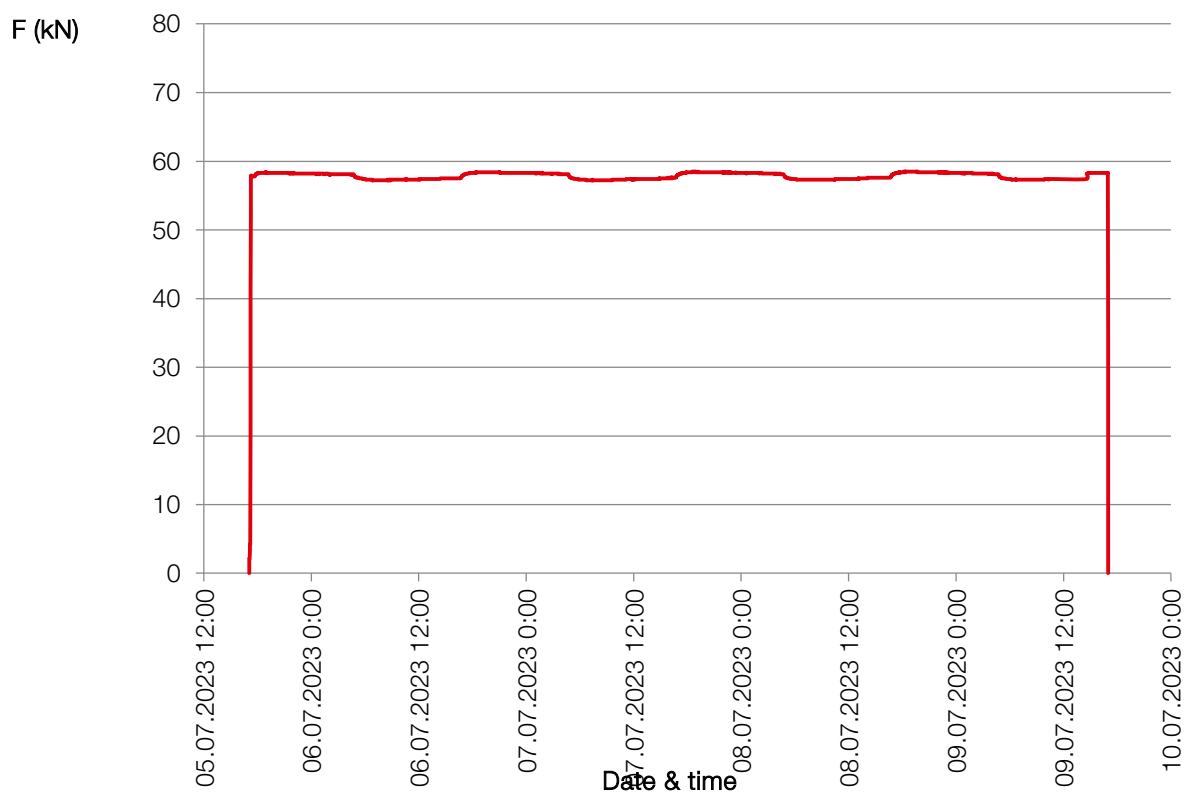
Figure 3 Record of tensile load during thermal-mechanical cycles, test samples No. 23

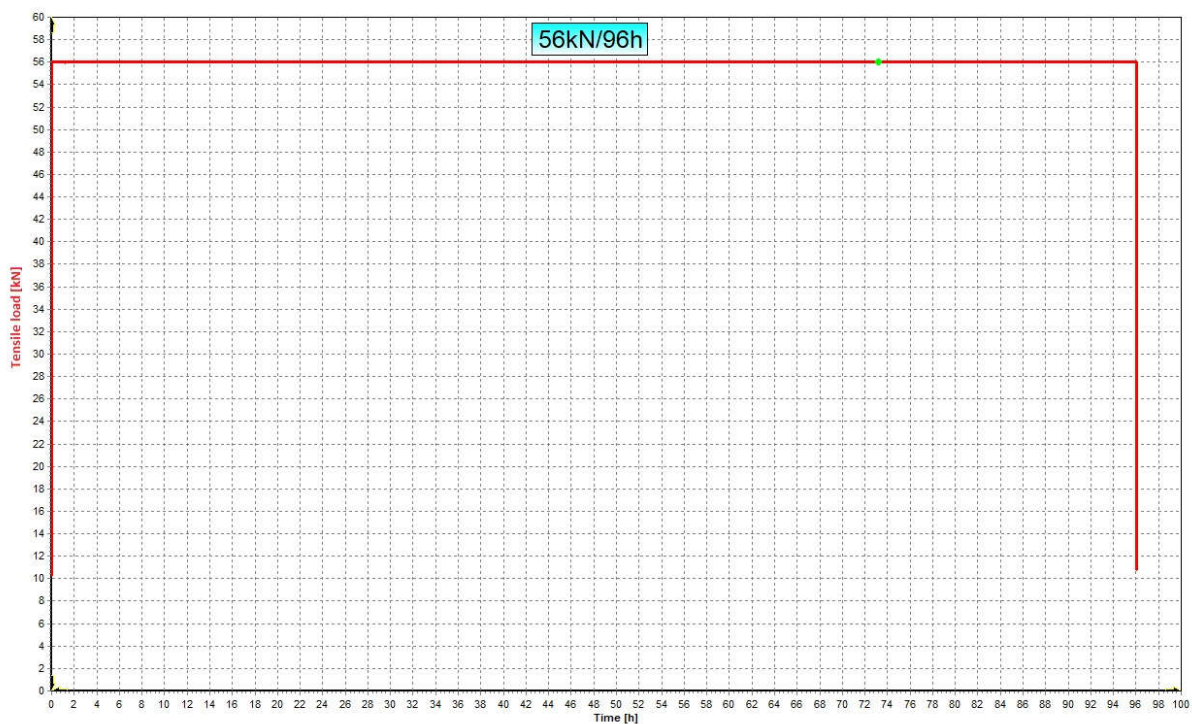
Figure 4 Record of tensile load during thermal-mechanical cycles, test samples No. 24 and 25

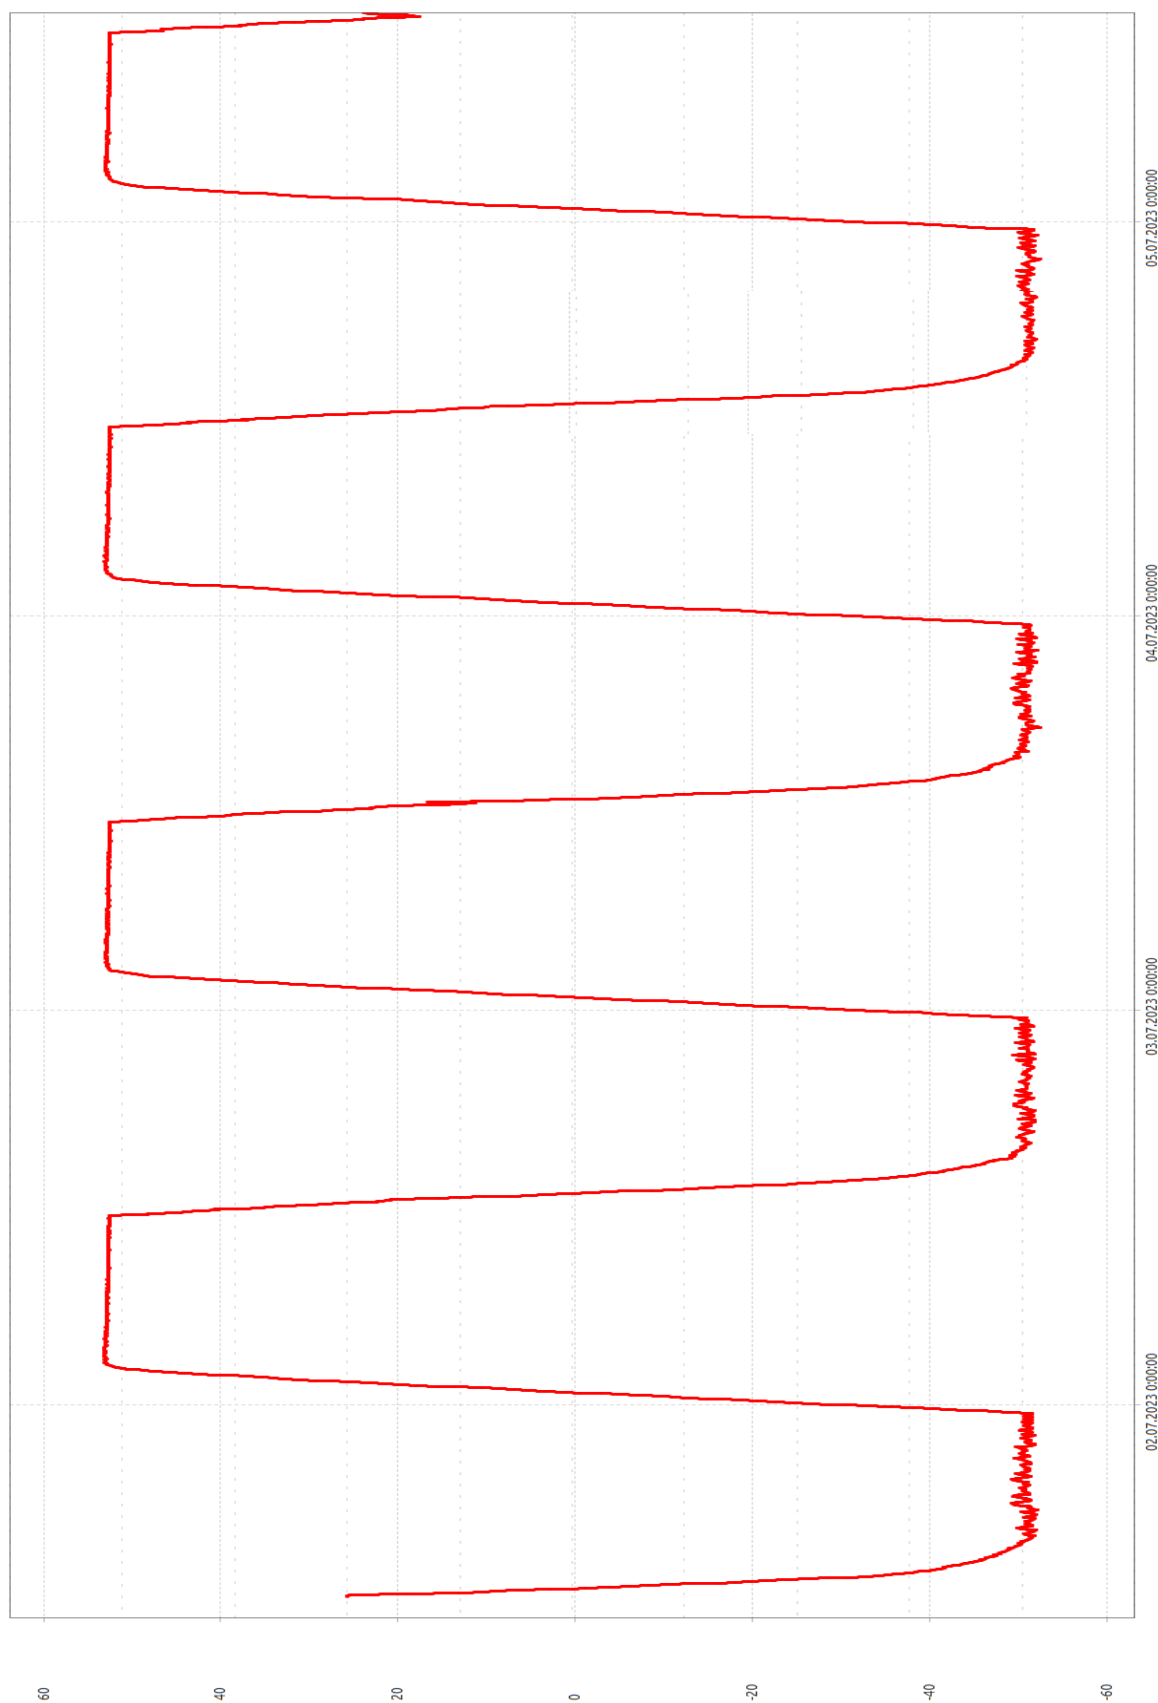
Figure 5 Record of temperature during thermal-mechanical cycles, test sample No. 24 and 25

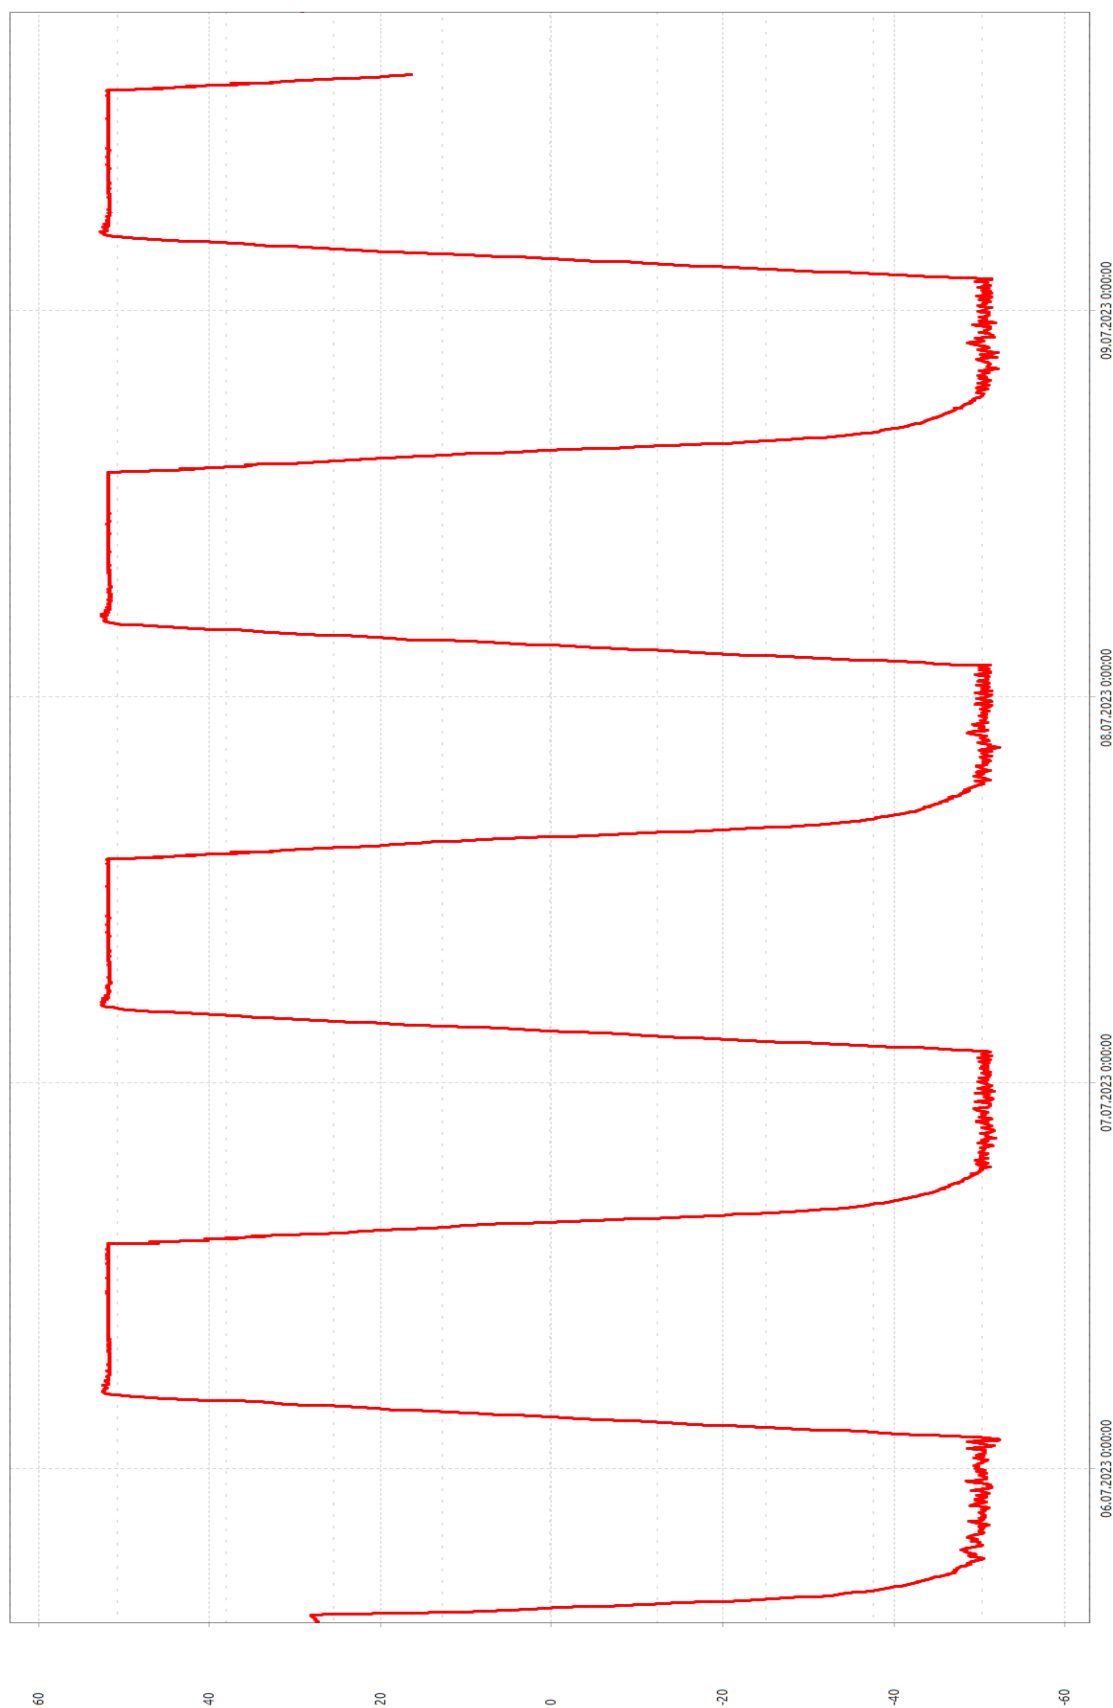
Figure 6 Record of temperature during thermal-mechanical cycles, test samples No. 23

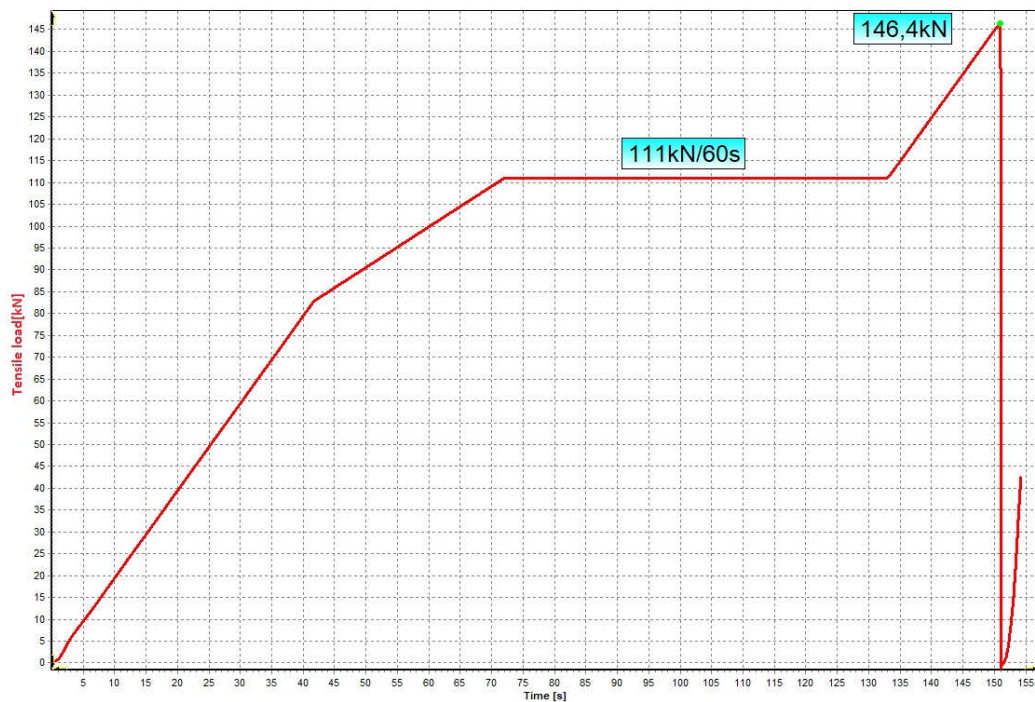
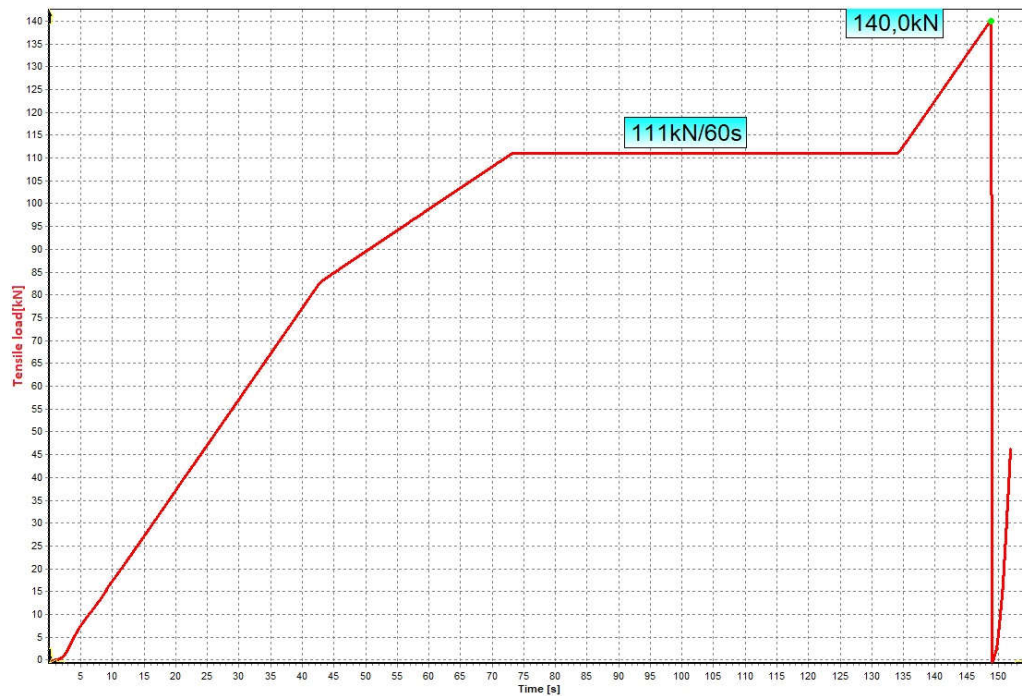
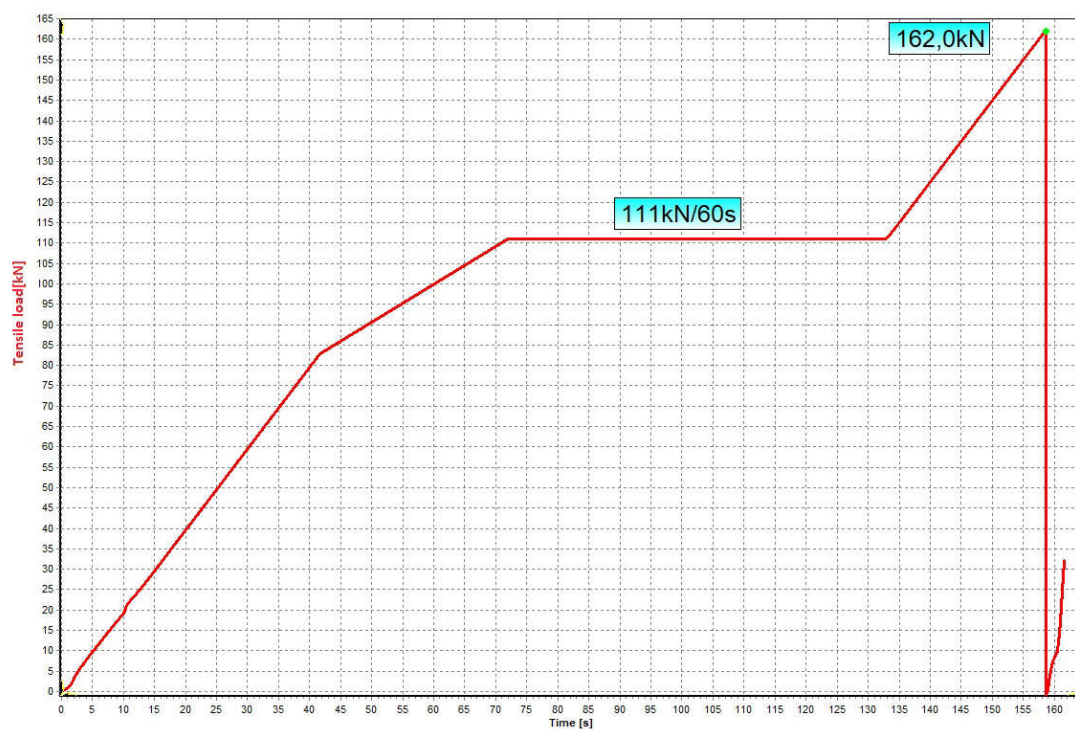
Figure 7 Record of tensile load test, test sample No. 3

Figure 8 Record of tensile load test, test sample No. 4

Figure 9 Record of tensile load test, test sample No. 5

Records of measured mechanical loading during the mechanical failing tests are given in Figure 7, Figure 8 and Figure 9.

Test date: 2023-05-26			
Sample No.	100 % SML	Failing load	Type of failure
3	111 kN / 60 s - OK	146,4 kN	Pull out of the core from the end fitting
4	111 kN / 60 s - OK	140,0 kN	Pull out of the core from the end fitting
5	111 kN / 60 s - OK	162,0 kN	Pull out of the core from the end fitting

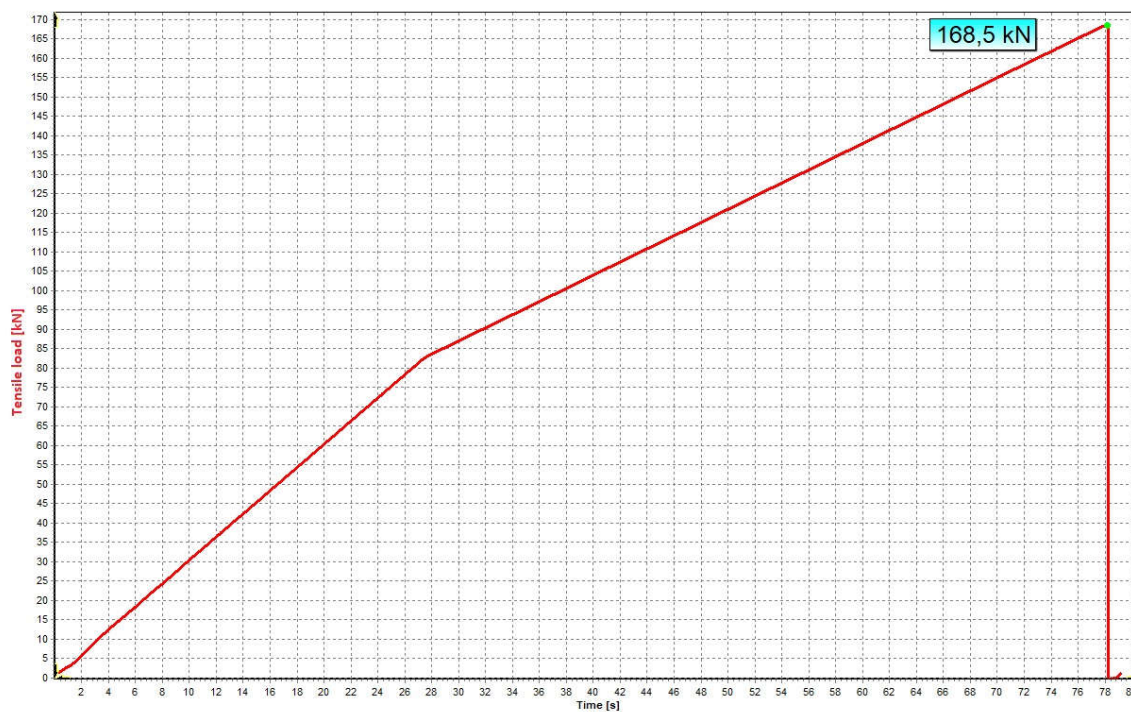
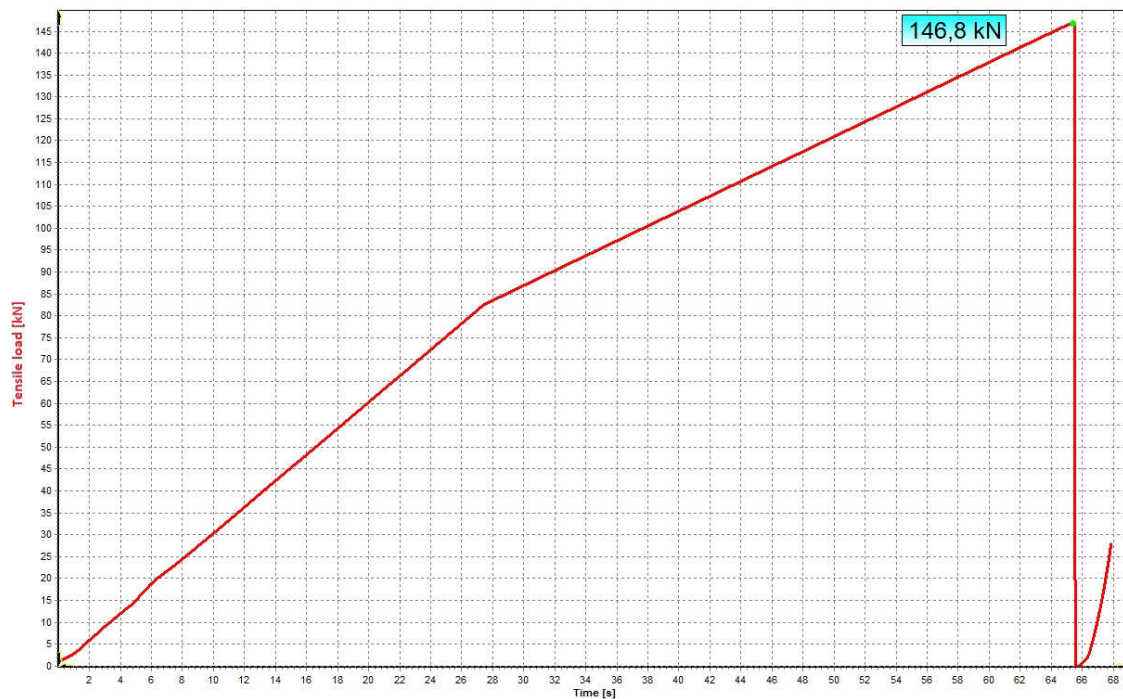
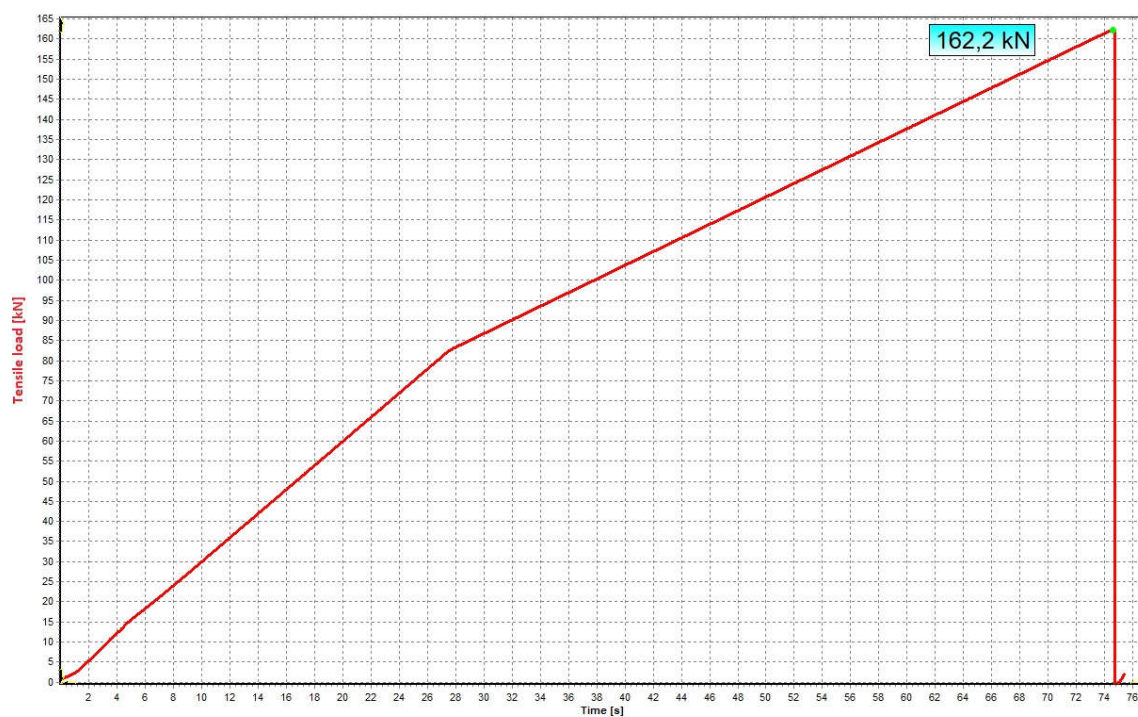
Figure 10 Record of mechanical failing test, test sample No. 6 (assembled core load-time test)

Figure 11 Record of mechanical failing test, test sample No. 7 (assembled core load-time test)

Figure 12 Record of mechanical failing test, test sample No. 8 (assembled core load-time test)

Records of measured mechanical loading during the mechanical failing tests are given in Figure 10, Figure 11 and Figure 12.

Test date: 2023-06-12		
Sample No.	Type of failure	Failing load
6	Pull out of the core from the end fitting	168,5 kN
7	Pull out of the core from the end fitting	146,8 kN
8	Pull out of the core from the end fitting	162,2 kN
Average of the failing load M_{AV}		159,2 kN
60 % of M_{AV}		95,5 kN

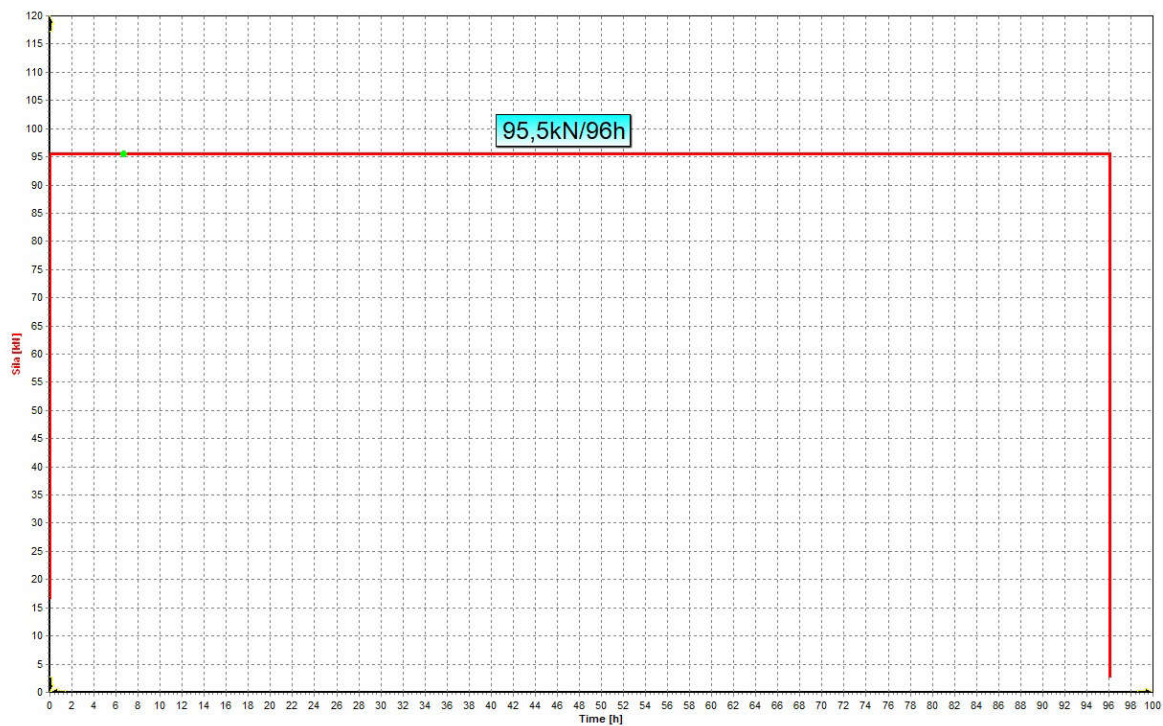
Figure 13 Record of mechanical withstand load test, test samples No. 9, 10 and 11
(assembled core load-time test)

Test date: from 2023-06-12 to 2023-06-16		
Sample No.	Tensile load	Test result
9	95,5 kN / 96 hours	No failure occurred during the 96 hours withstand load test
10	95,5 kN / 96 hours	No failure occurred during the 96 hours withstand load test
11	95,5 kN / 96 hours	No failure occurred during the 96 hours withstand load test

No failure (breakage or complete pull-out of the core or fracture of the metal fittings) occurred during the 96 hours withstand load test.

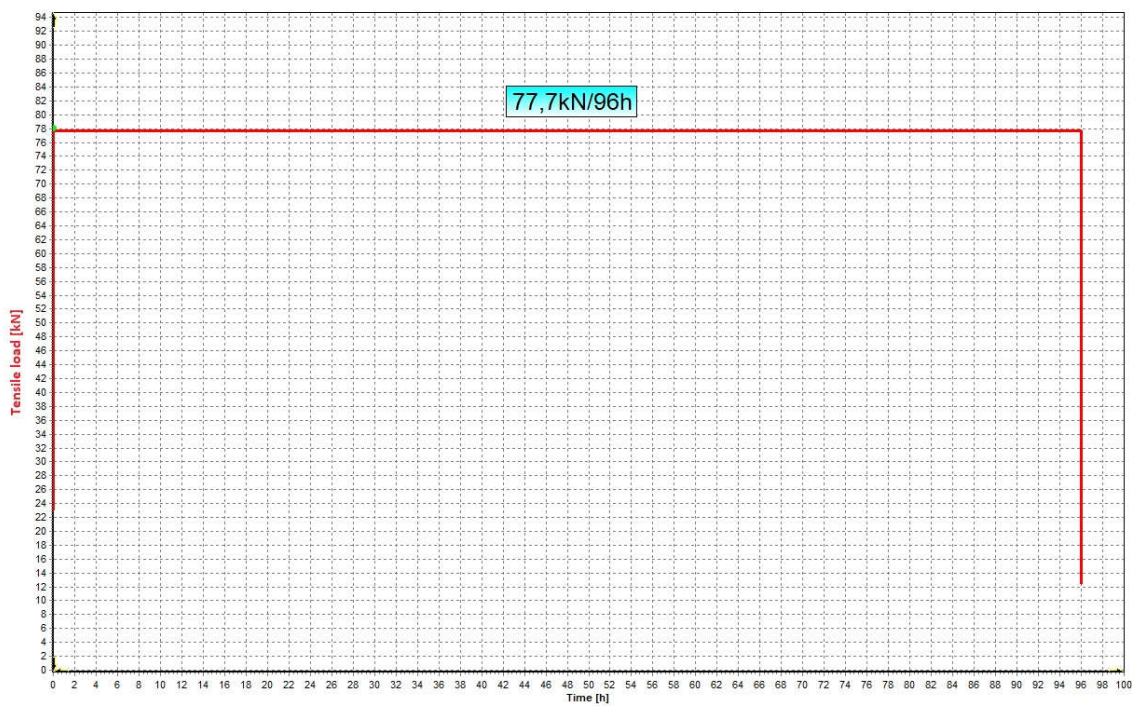
Figure 14 Record of mechanical withstand load test, test samples No. 26, 27, 28 and 29
(mechanical load-time test)

No failure (breakage or complete pull-out of the core or fracture of the metal fittings) occurred during 96 h test at 70 % of the SML on insulators No. 26, 27, 28 and 29.

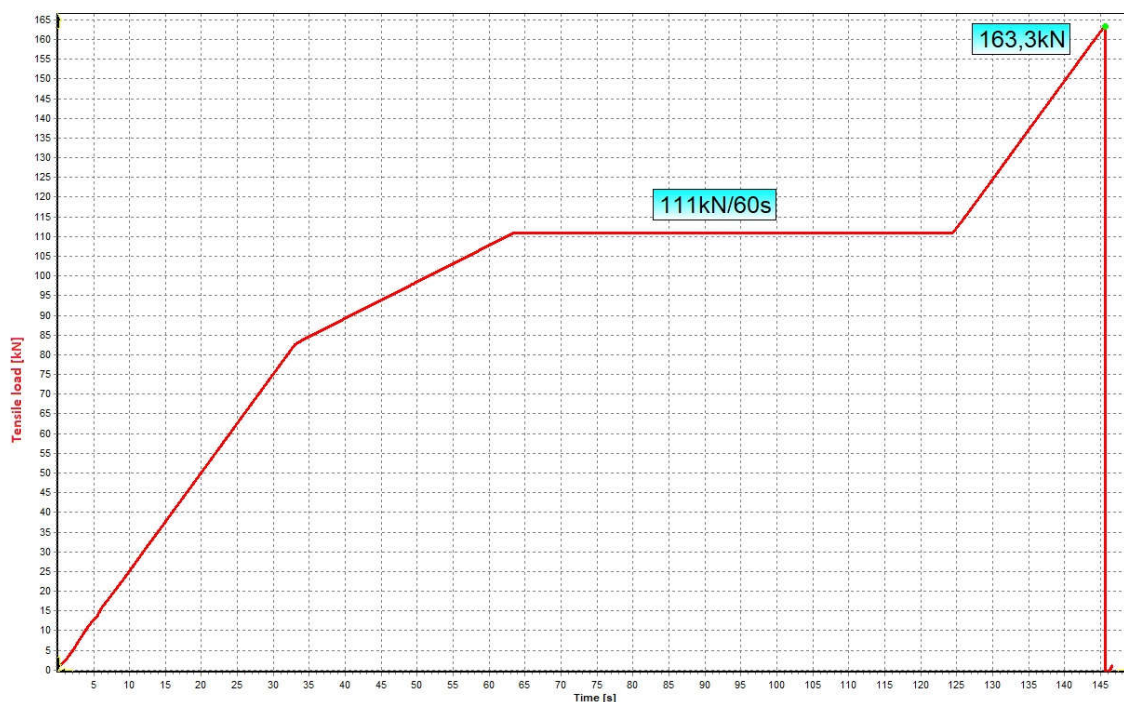
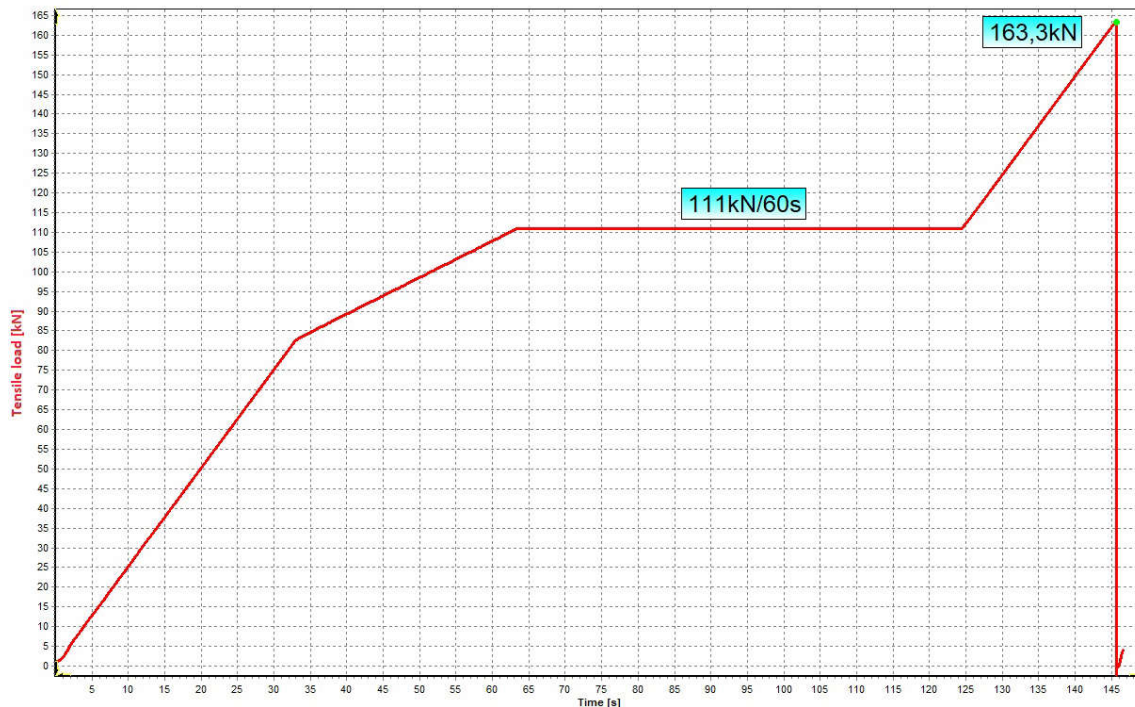
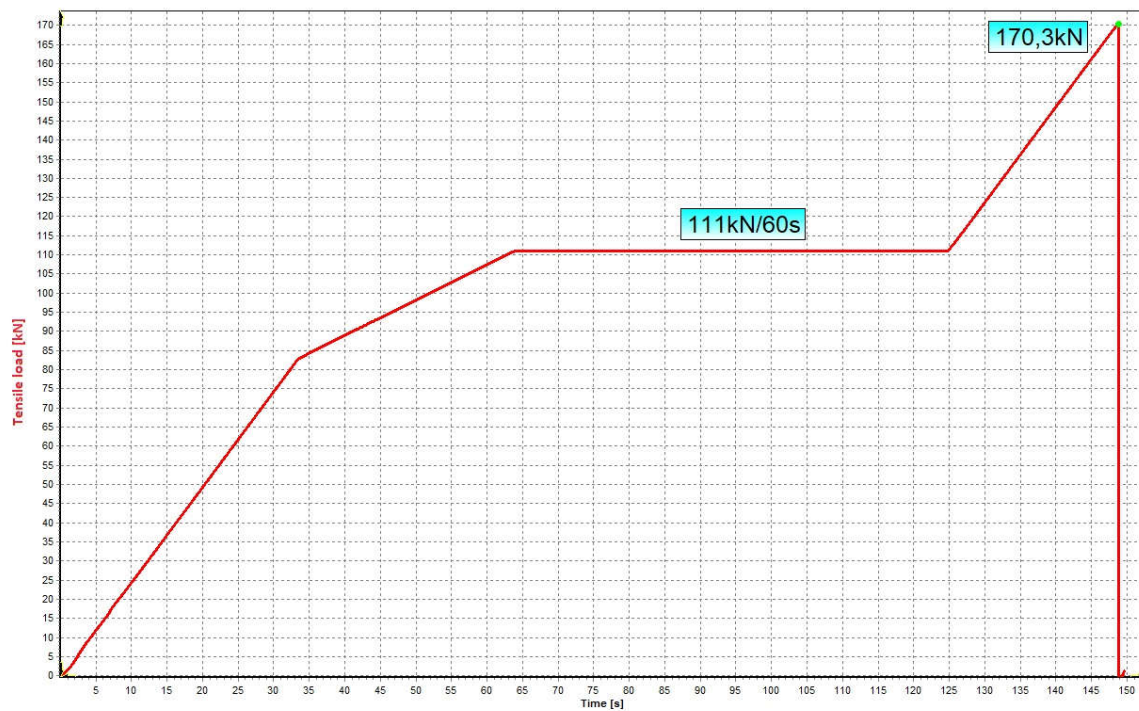
Figure 15 Record of mechanical failing test, test sample No. 26 (mechanical load-time test)

Figure 16 Record of mechanical failing test, test sample No. 27 (mechanical load-time test)

Figure 17 Record of mechanical failing test, test sample No. 28 (mechanical load-time test)

Test date: 2023-07-04			
Sample No.	100 % SML	Failing load	Type of failure
26	111 kN / 60 s - OK	163,3 kN	Pull out of the core from the end fitting
27	111 kN / 60 s - OK	163,3 kN	Pull out of the core from the end fitting
28	111 kN / 60 s - OK	170,3 kN	Pull out of the core from the end fitting

No failure (breakage or complete pull-out of the core or fracture of the metal fittings) occurred during 1 minute withstand test at 100 % of the SML on insulators No. 26, 27 and 28.

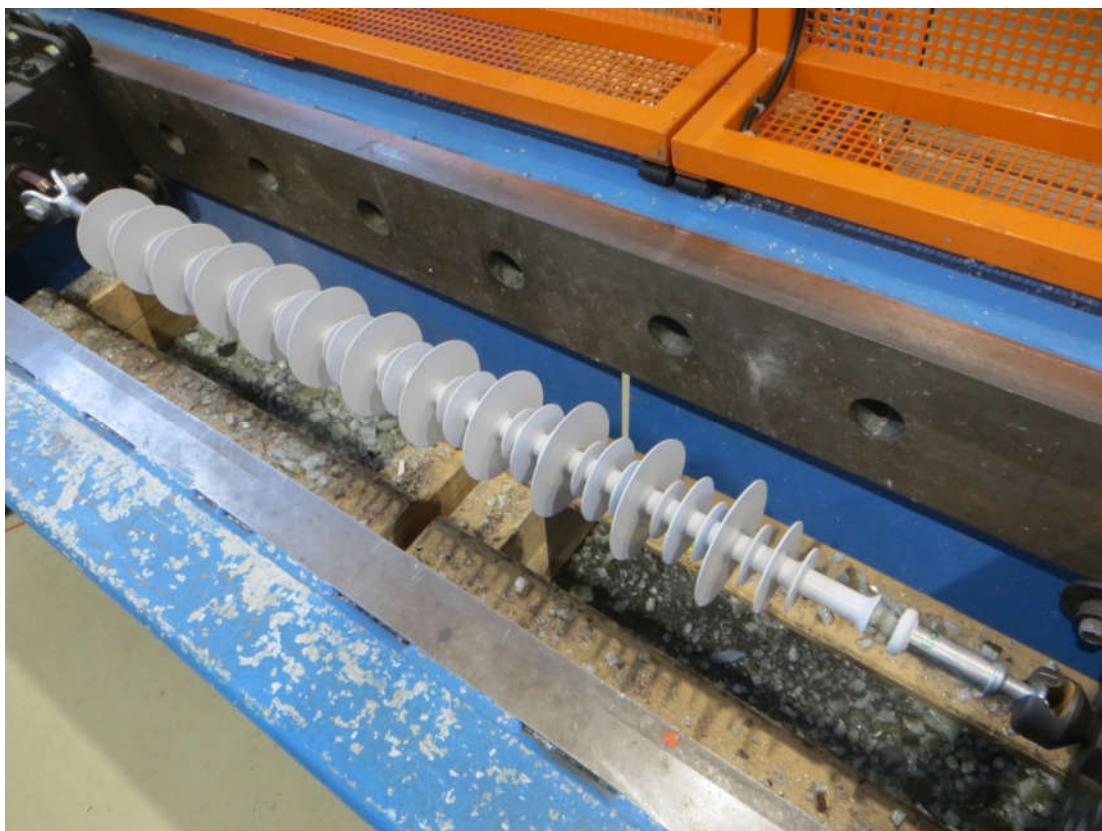
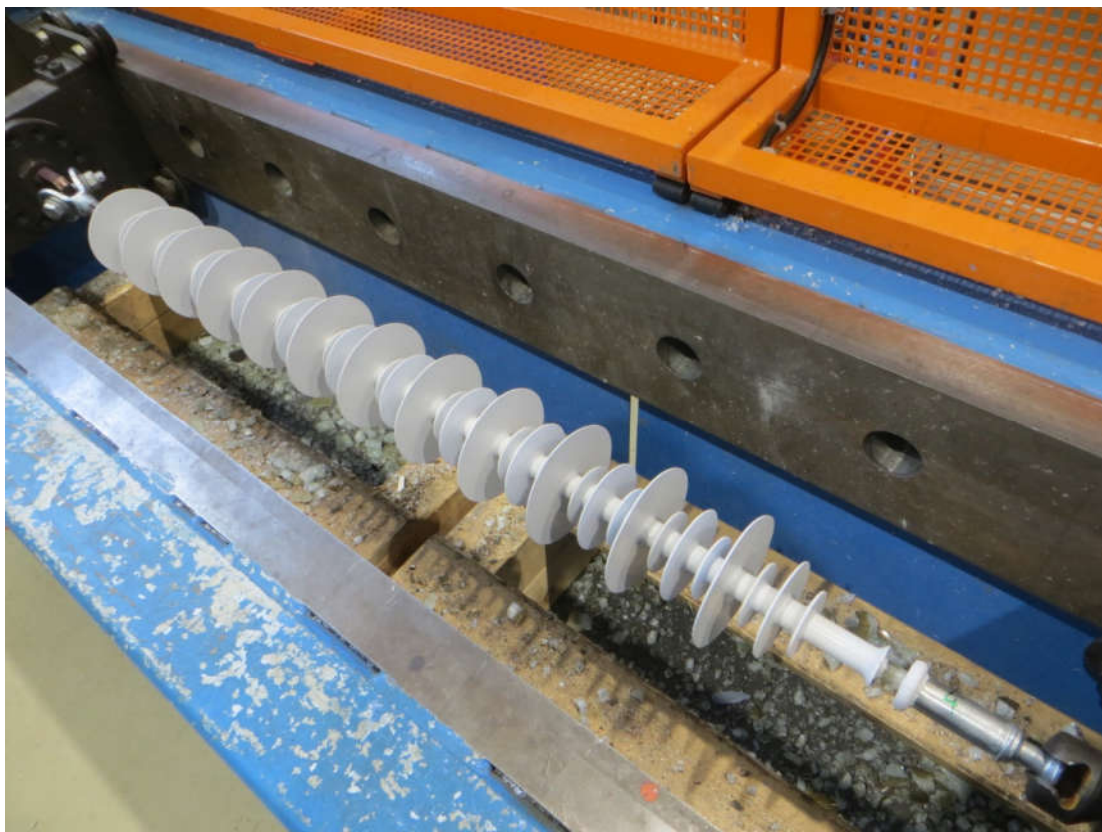
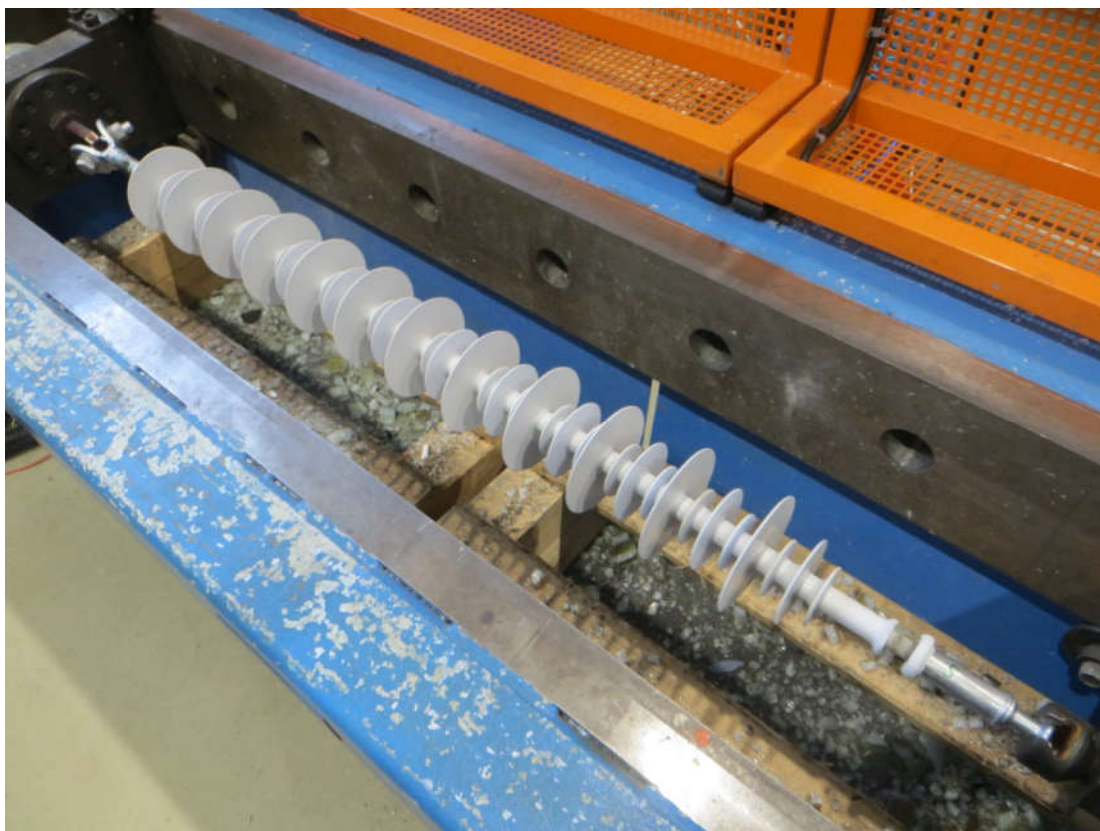
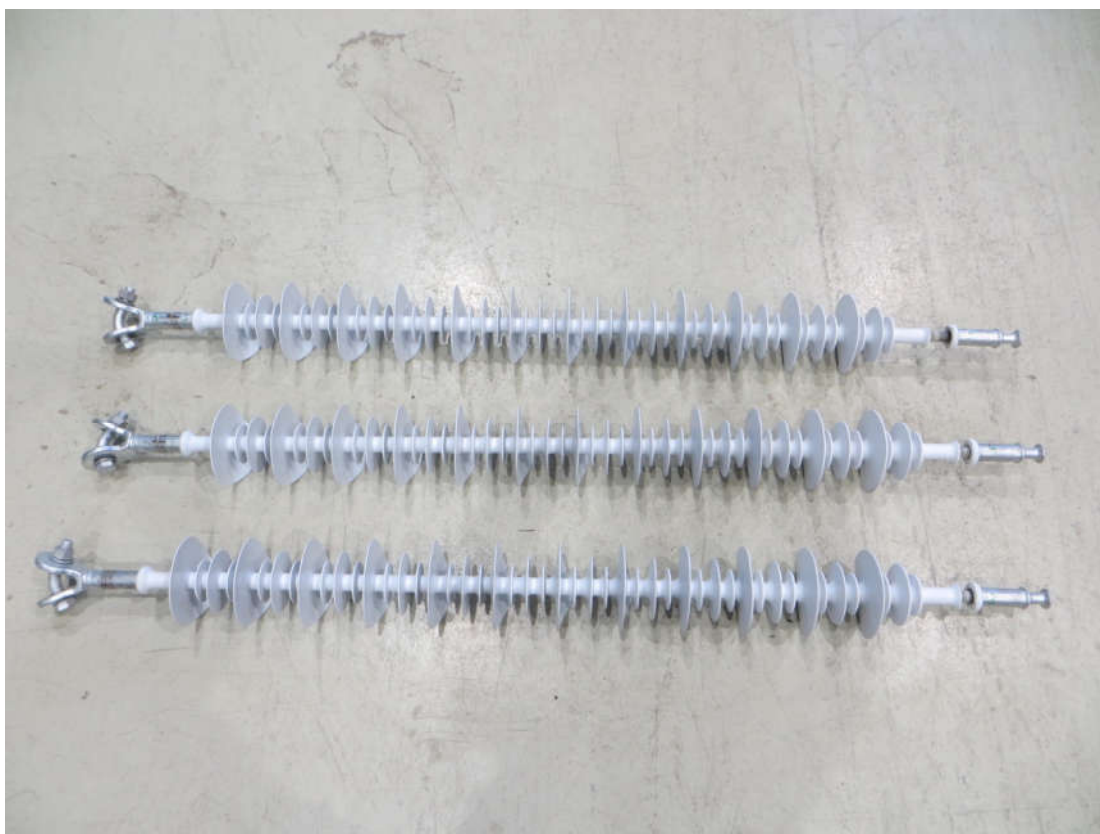
Figure 24 Tensile load test, test sample No. 3

Figure 25 Tensile load test, test sample No. 4

Figure 26 Tensile load test, test sample No. 5

Figure 27 Test samples No. 3, 4 and 5, after tensile load test

Test was carried out according to CSA C411.4-16, clause 5.6.2. Three insulators No. 3, 4 and 5 were subjected to tensile load applied between couplings. The tensile load was increased rapidly but smoothly from zero to approximately 75 % of expected mechanical failing load and then gradually increased in a time between 30 s to 90 s until breakage of the core or complete pull-out occurs (see Figure 24, Figure 25, Figure 26 and Figure 27). The average of the three failing loads was calculated.

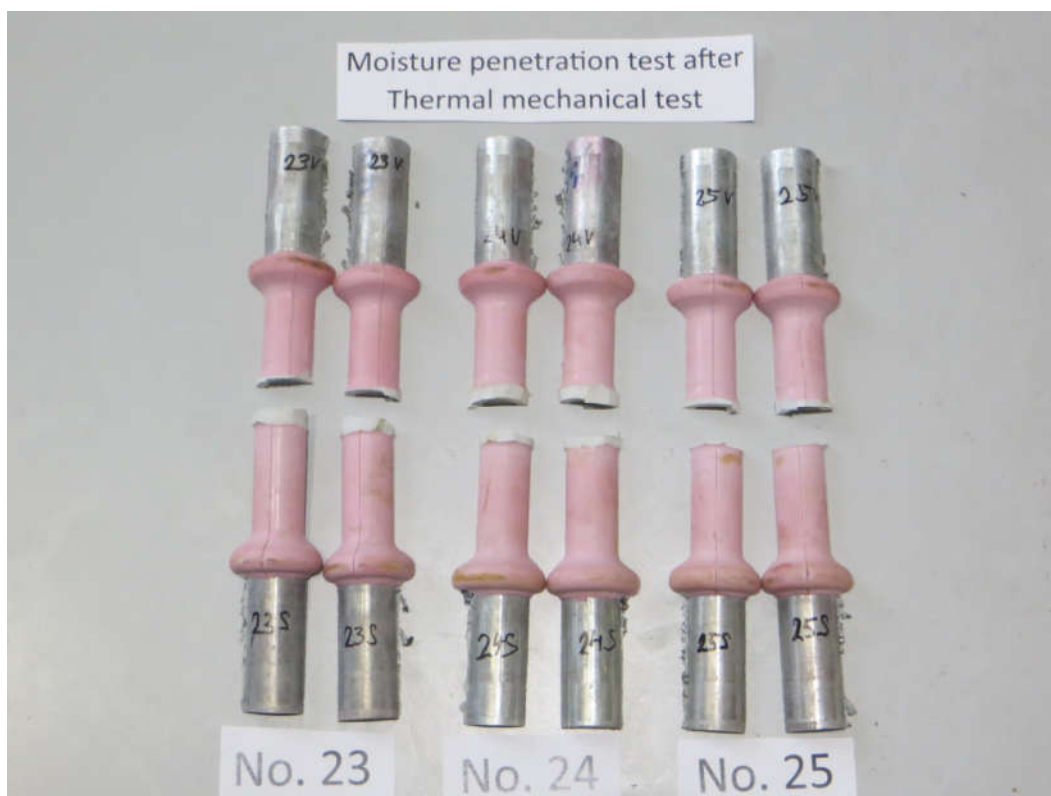
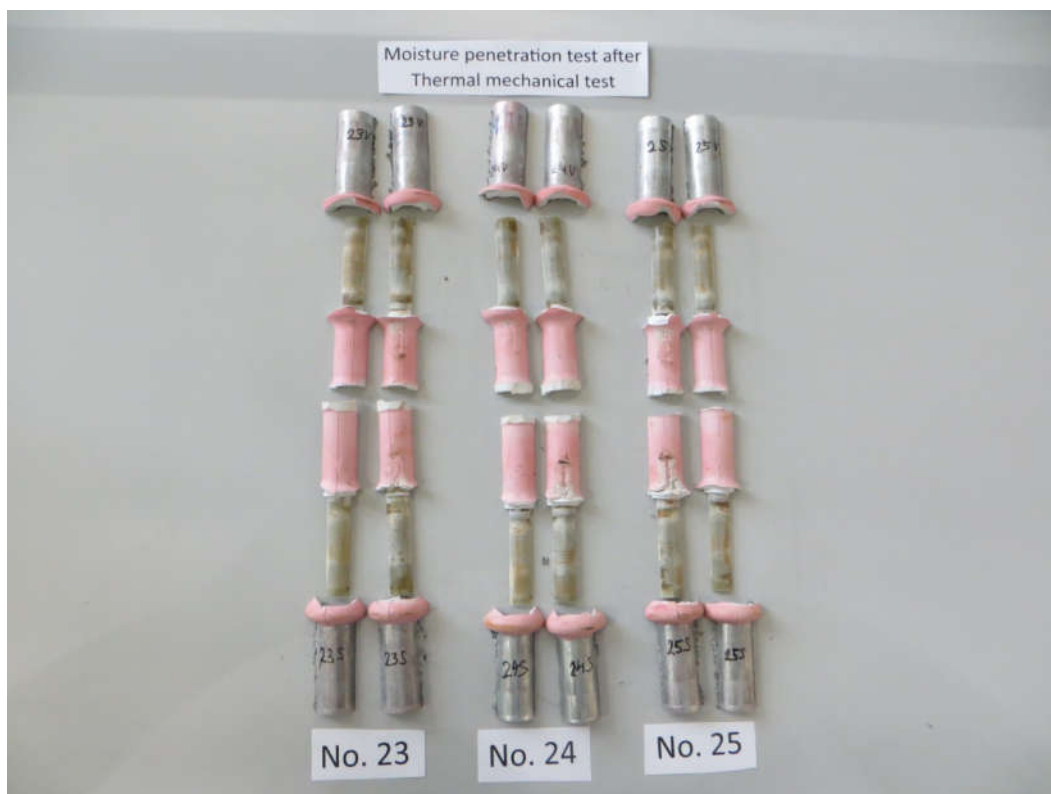
Figure 30 Test samples after cut of end metal fittings
(moisture penetration test after thermal mechanical test)

Figure 31 Test samples after removing the portion of metal fitting
(moisture penetration test after thermal mechanical test)

Moisture penetration test was carried out according to CSA C411.4-16, clause 5.7.3.2. Each end of tested insulator was submerged in a dye composed 1 % alcohol solution of astrazon dye for a minimum 15 min. After that the insulator were removed from the solution, wiped dry (see Figure 29). The ends were cut nominally 90° to the axis of the core and about 50 mm from each metal fitting (see Figure 30). Then the portion of metal fitting was removed (see Figure 31).

Each insulator passed the moisture penetration test, there was no evidence of dye on the area of the core where the portion of end metal fitting were removed.
