TEST REPORT 12206/D/23

138 kV Composite line insulator

138 kV / 111 kN

CSA C411.4-16, IEC 60060-1 Ed.3:2010

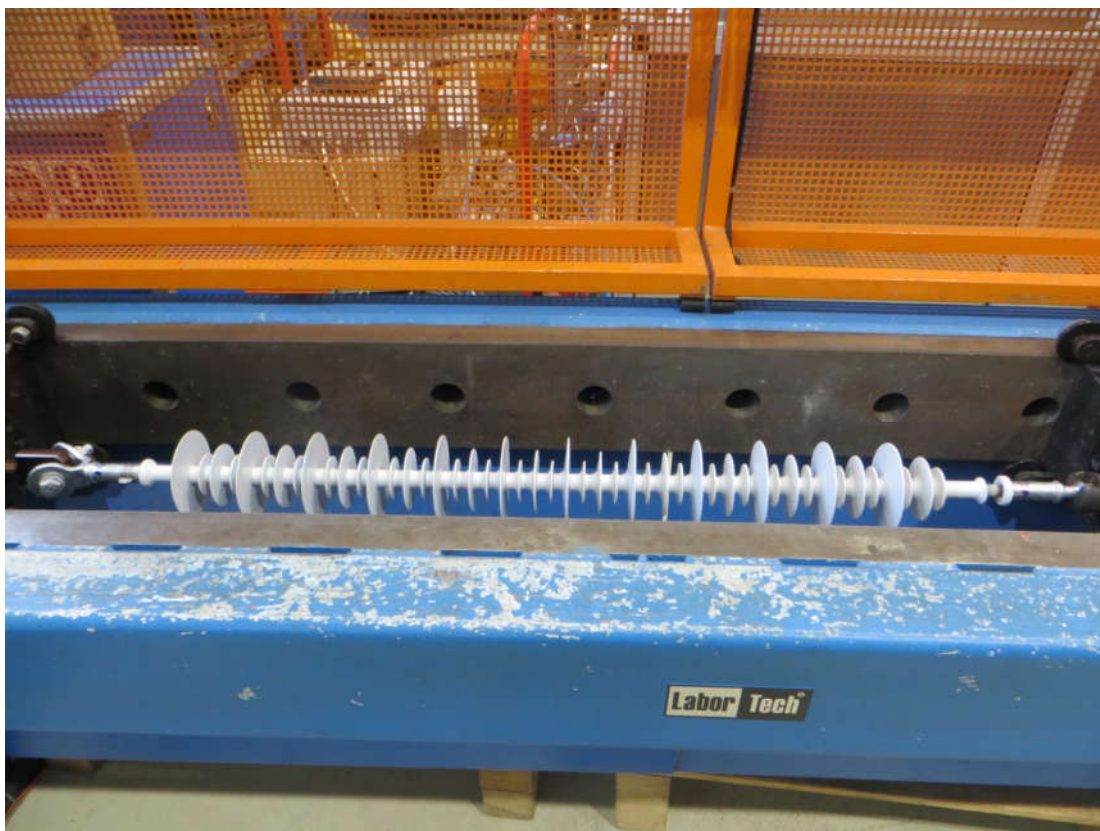
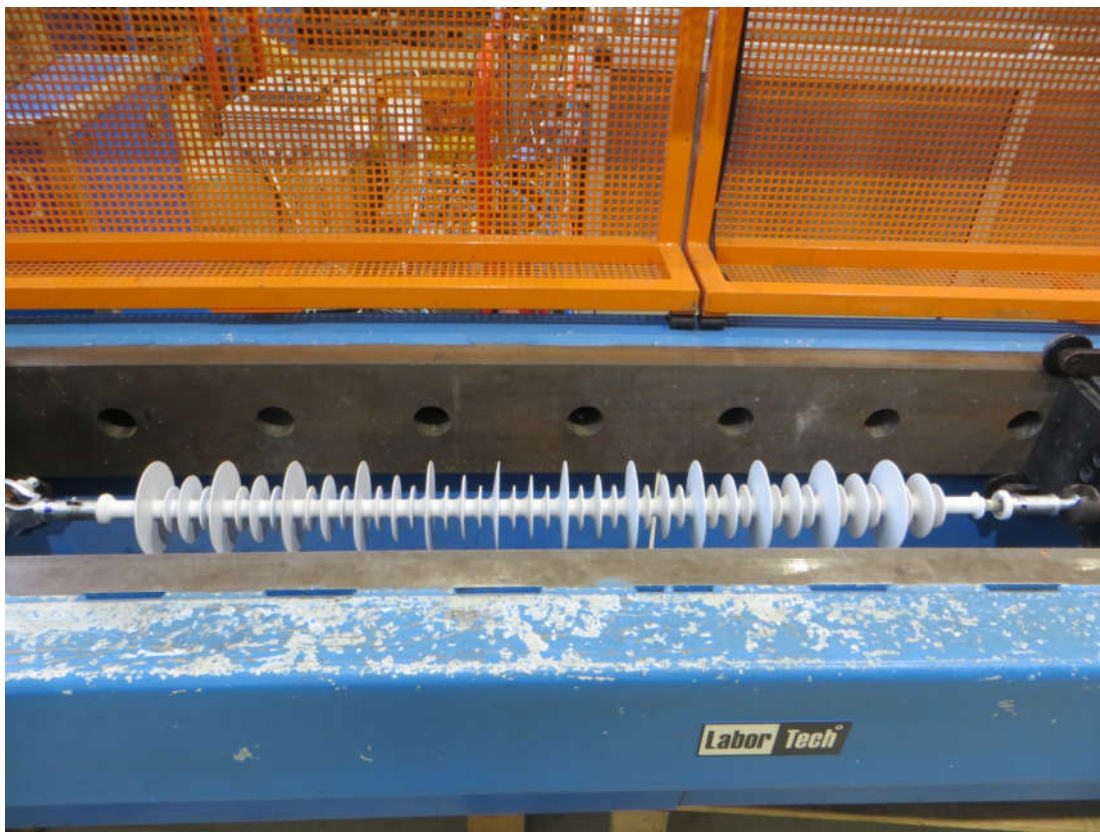
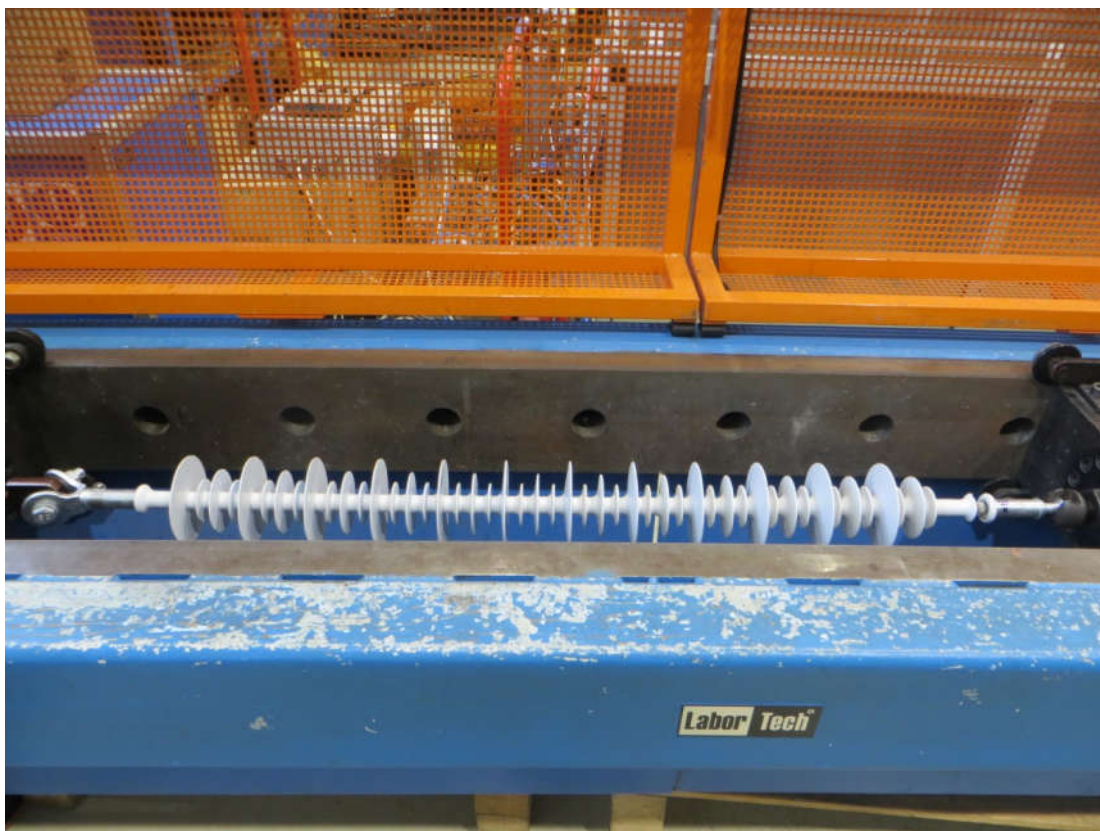
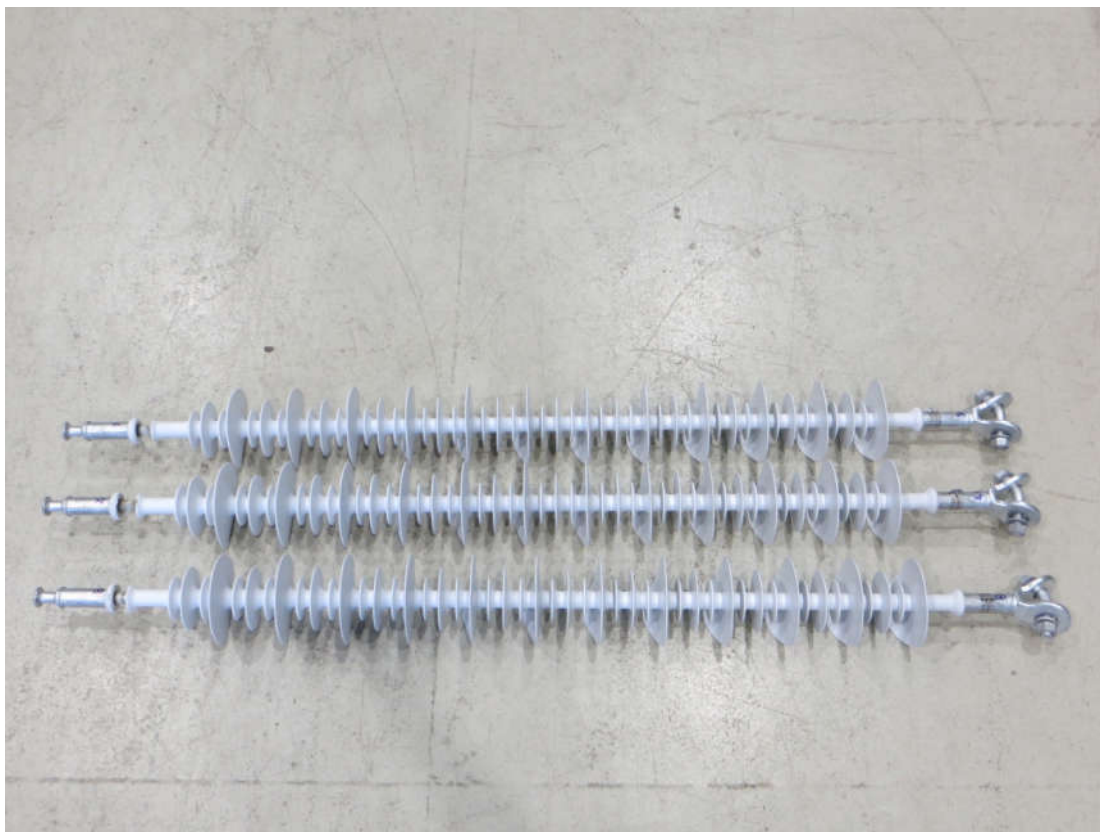
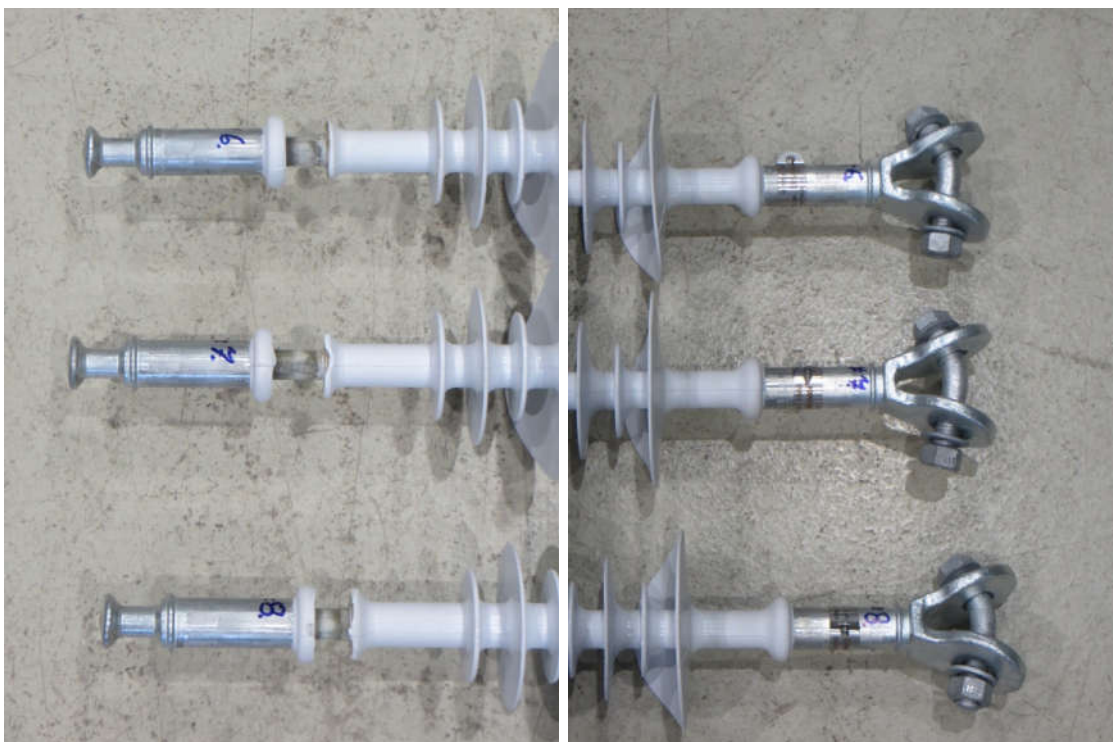
Figure 34 Assembled core load-time test, test sample No. 6

Figure 35 Assembled core load-time test, test sample No. 7

Figure 36 Assembled core load-time test, test sample No. 8

Figure 37 Test samples No. 6, 7 and 8 after Assembled core load-time test

Figure 38 Test samples No. 6, 7 and 8 after Assembled core load-time test

Test was carried out according to CSA C411.4-16, clause 5.8.2.2. Three insulators No. 6, 7 and 8 were subjected to tensile load applied between couplings. The tensile load was increased rapidly but smoothly from zero to approximately 75 % of expected mechanical failing load and then gradually increased in a time between 30 s to 90 s until breakage of the core or complete pull-out occurs (see Figure 34, Figure 35, Figure 36, Figure 37 and Figure 38). The average of the three failing loads was calculated.

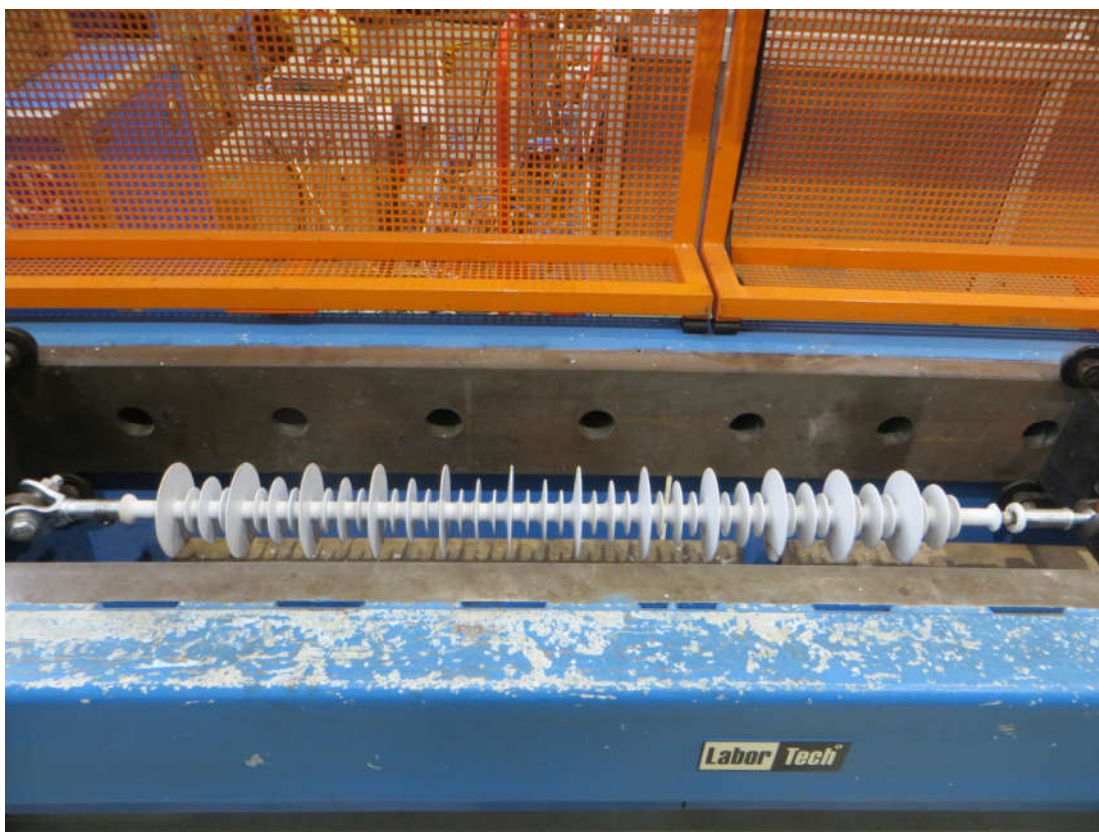
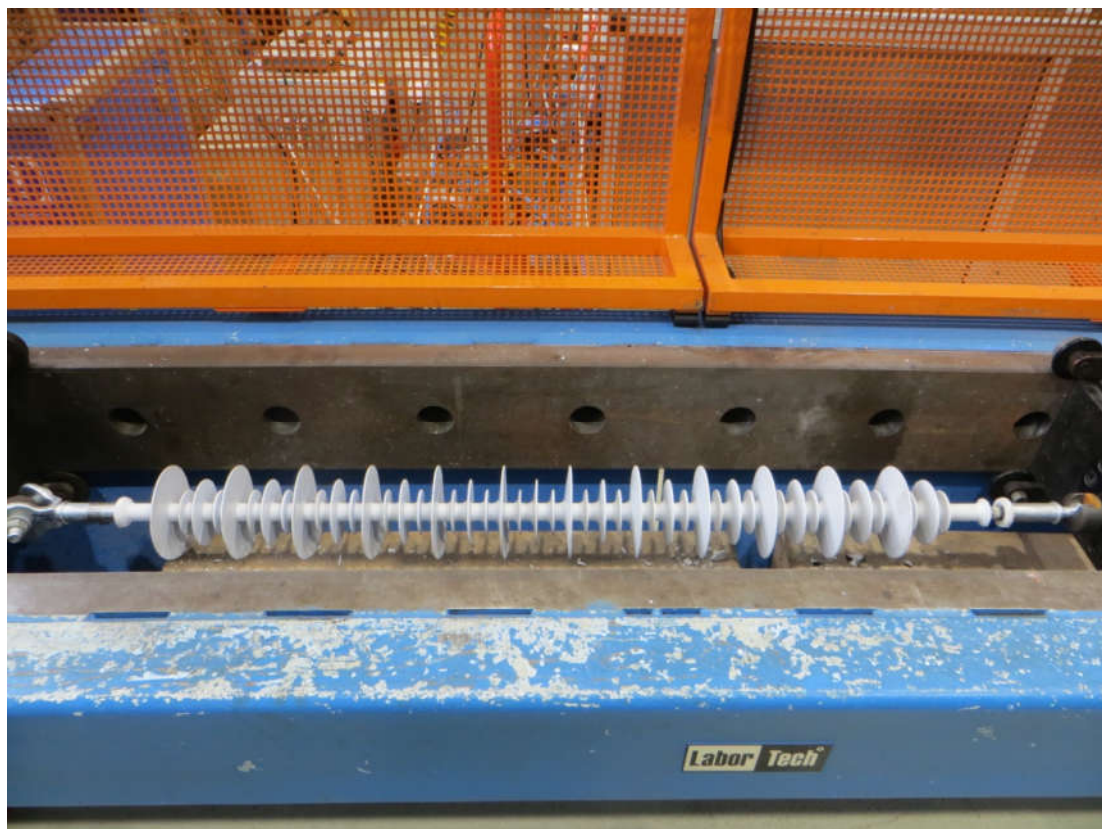
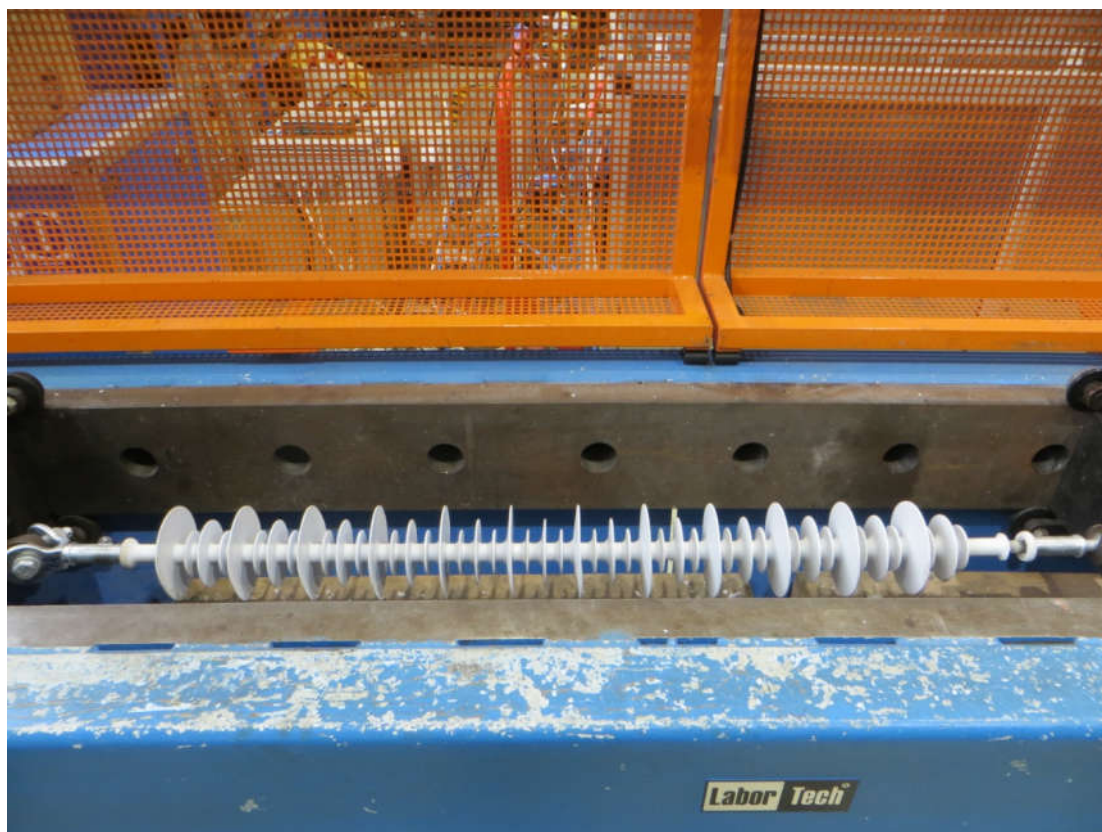
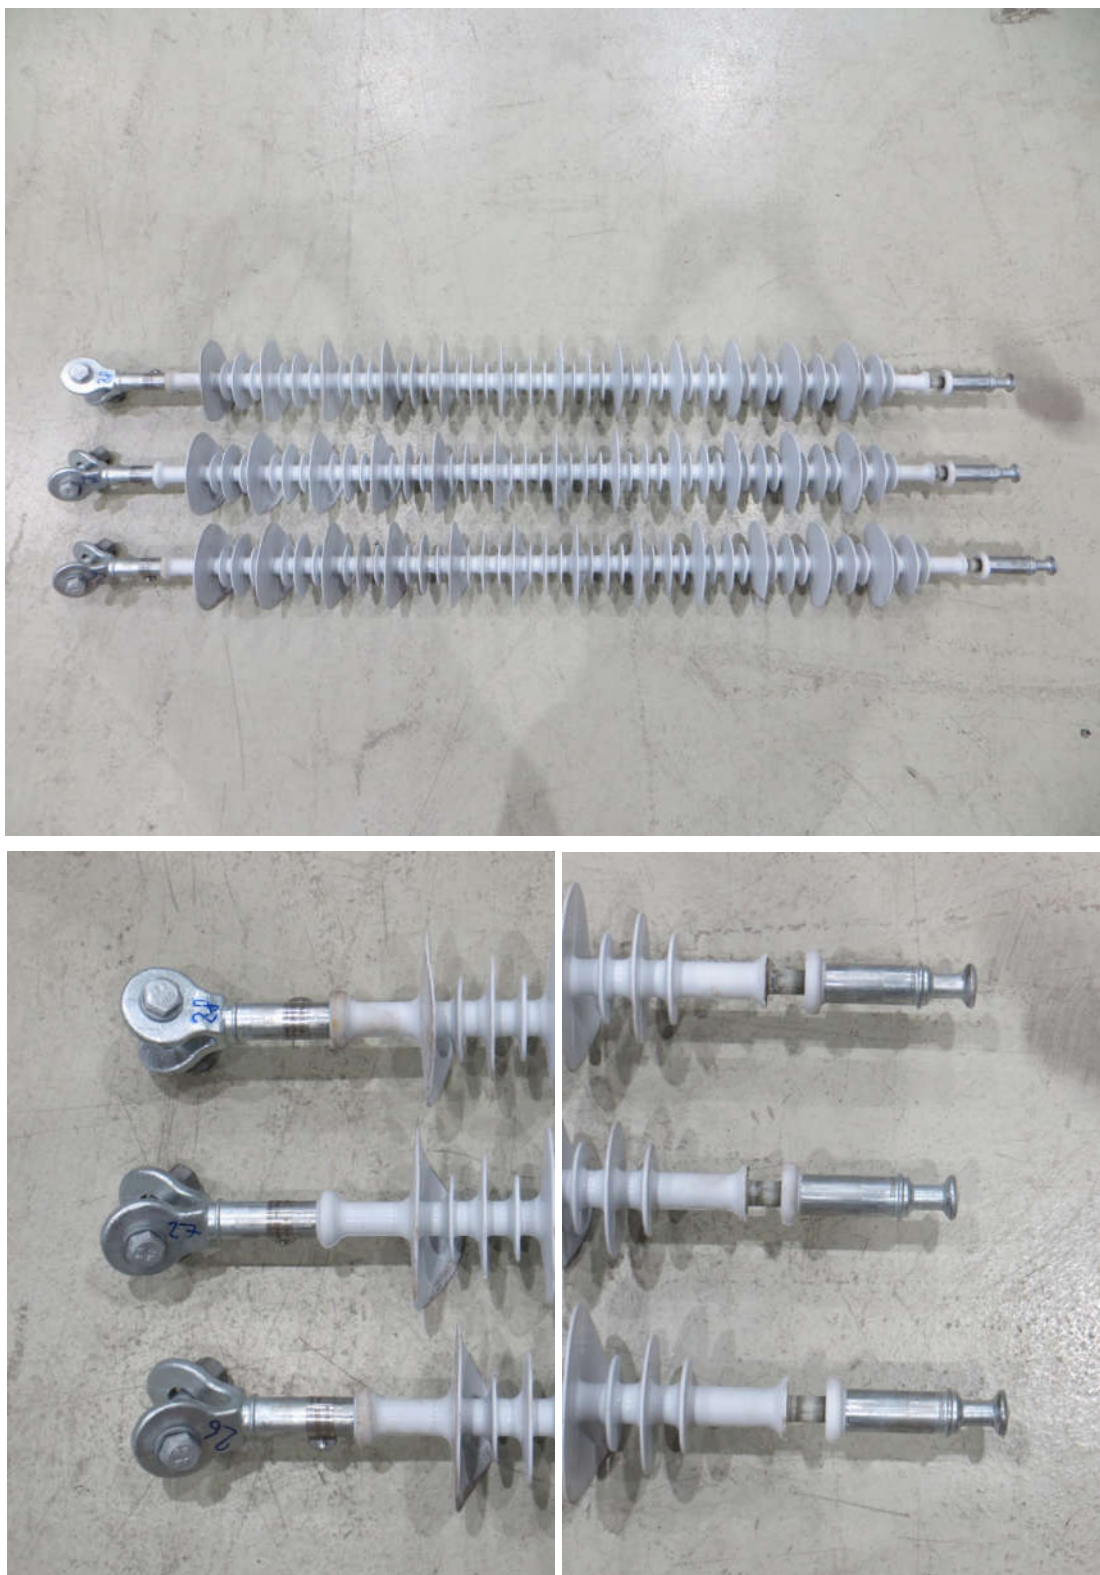
Figure 43 Mechanical load-time test, failing load test, test sample No. 26

Figure 44 Mechanical load-time test, failing load test, test sample No. 27

Figure 45 Mechanical load-time test, failing load test, test sample No. 28

Figure 46 Mechanical load-time test, test samples No. 26, 27 and 28 after mechanical failing load test

Test was carried out according to CSA C411.4-16, clause 5.9.2.3. Three insulators No. 26, 27 and 28 were then again subjected to tensile load applied between couplings. The tensile load was increased rapidly but smoothly from zero to approximately 75% of SML and then gradually increased in a time between 30 s to 90 s to 100% of SML. Load was sustained for the remainder of the 60 s. After finishing the test according to paragraph c) the tensile load on composite silicone insulator samples No. 26, 27 and 28 were increased up to failing load. Records of mechanical test are in Figure 15, Figure 16 and Figure 17. Test samples after the mechanical test are shown in Figure 43, Figure 44, Figure 45 and Figure 46.

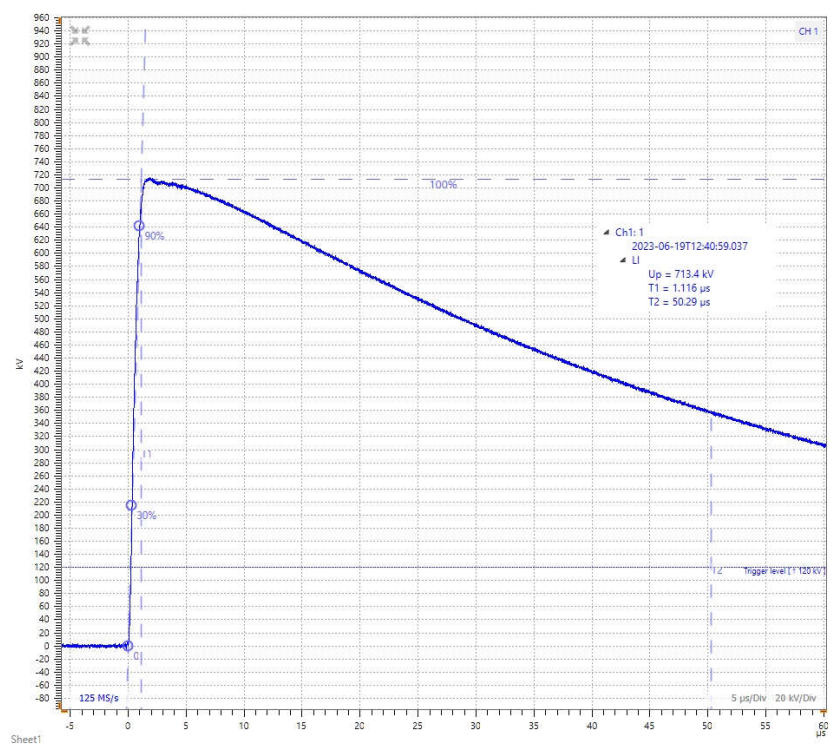
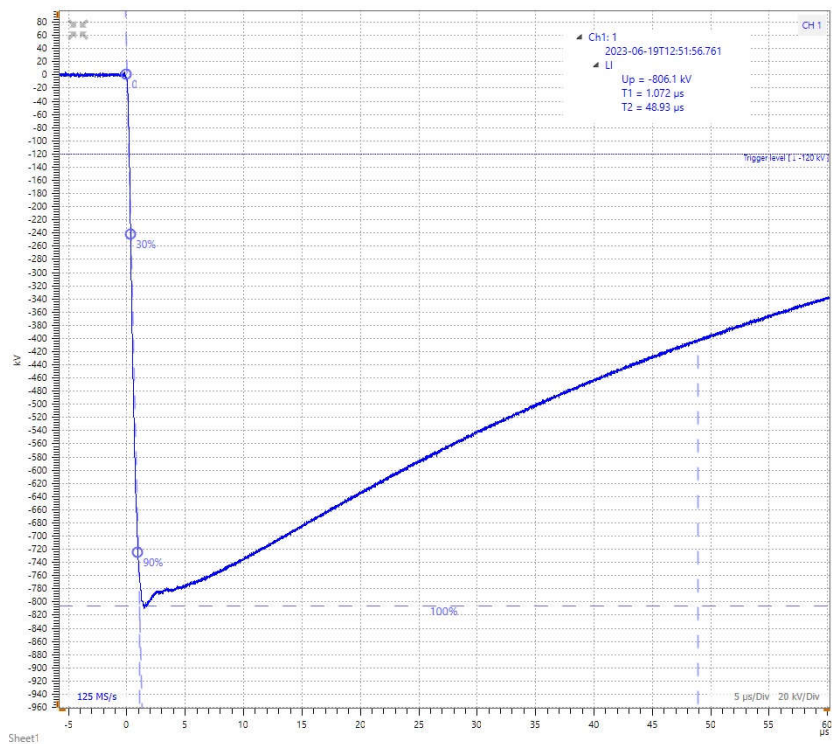
Figure 2 Record of the lightning impulse voltage 1,2/50 μs

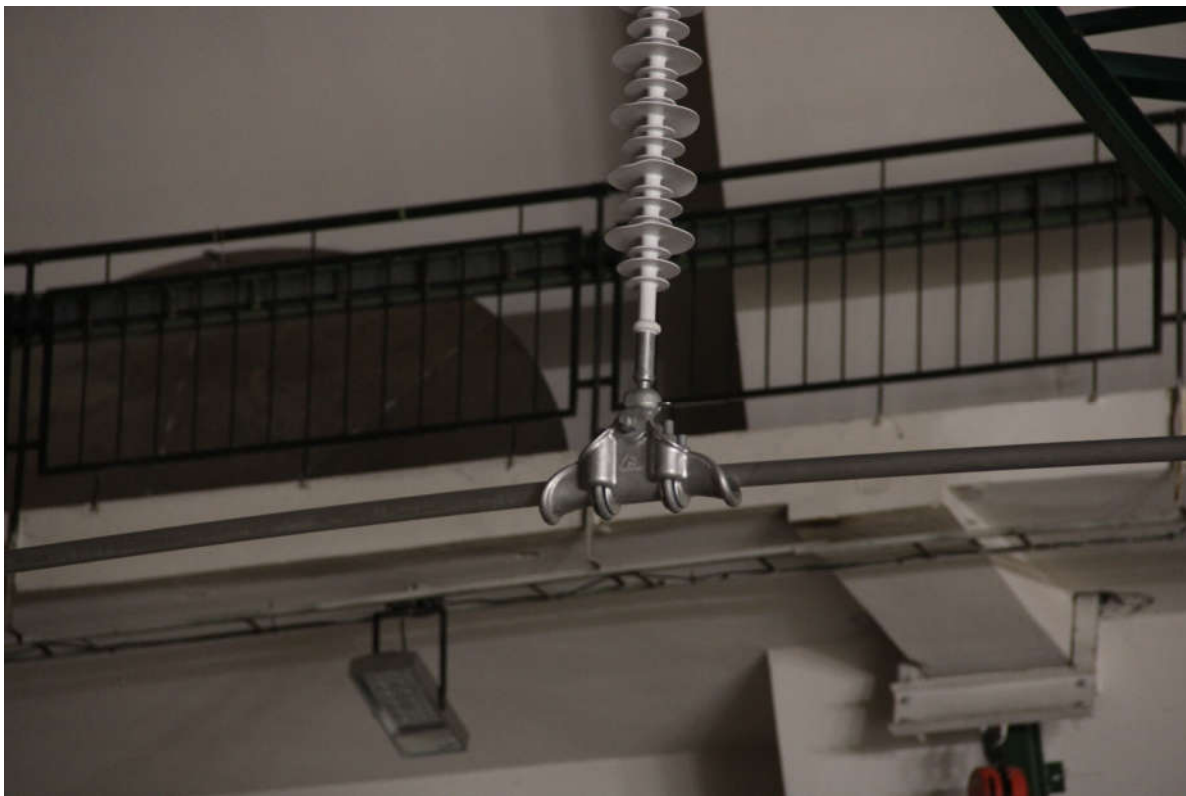
Figure 5 Test arrangement under corona test at 100 kV (no visible corona)

Date of the test: 2023-07-31	
Atm. conditions	
pressure (kPa)	98,4
temperature (°C)	23,2
rel. humidity (%)	49,7
Measurement No.	Corona extinction voltage (kV)
1	142
2	144
3	143
Average value	143
Location of corona	Insulator
Criteria $U_e > 100$ kV)

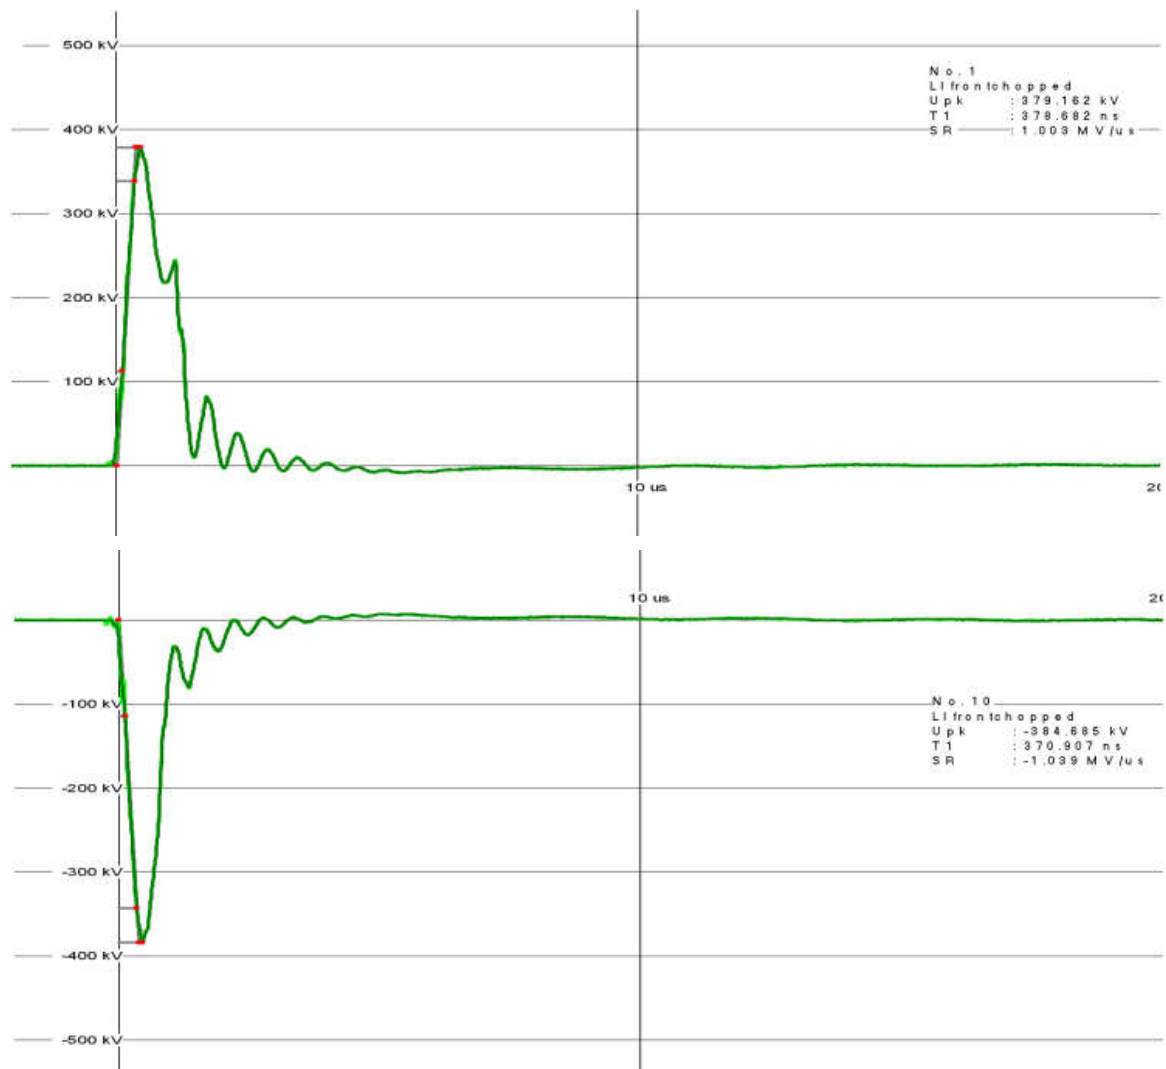
Figure 2 Representative wave shape of the steep-front impulse

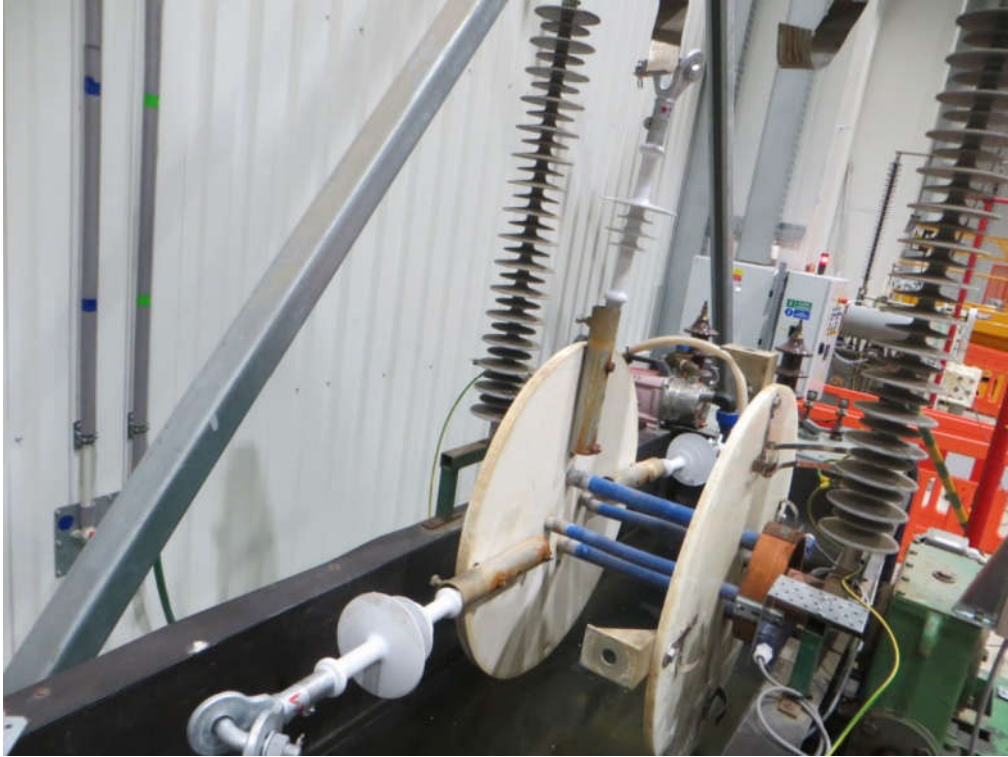
Figure 3 Tracking and erosion test (method 2 –Dip tank tracking wheel), test setup

The voltage stress was 35 V/mm of insulator leakage distance. Each insulator was exposed to 30 000 cycles in accordance with CSA C411.4, annex B.

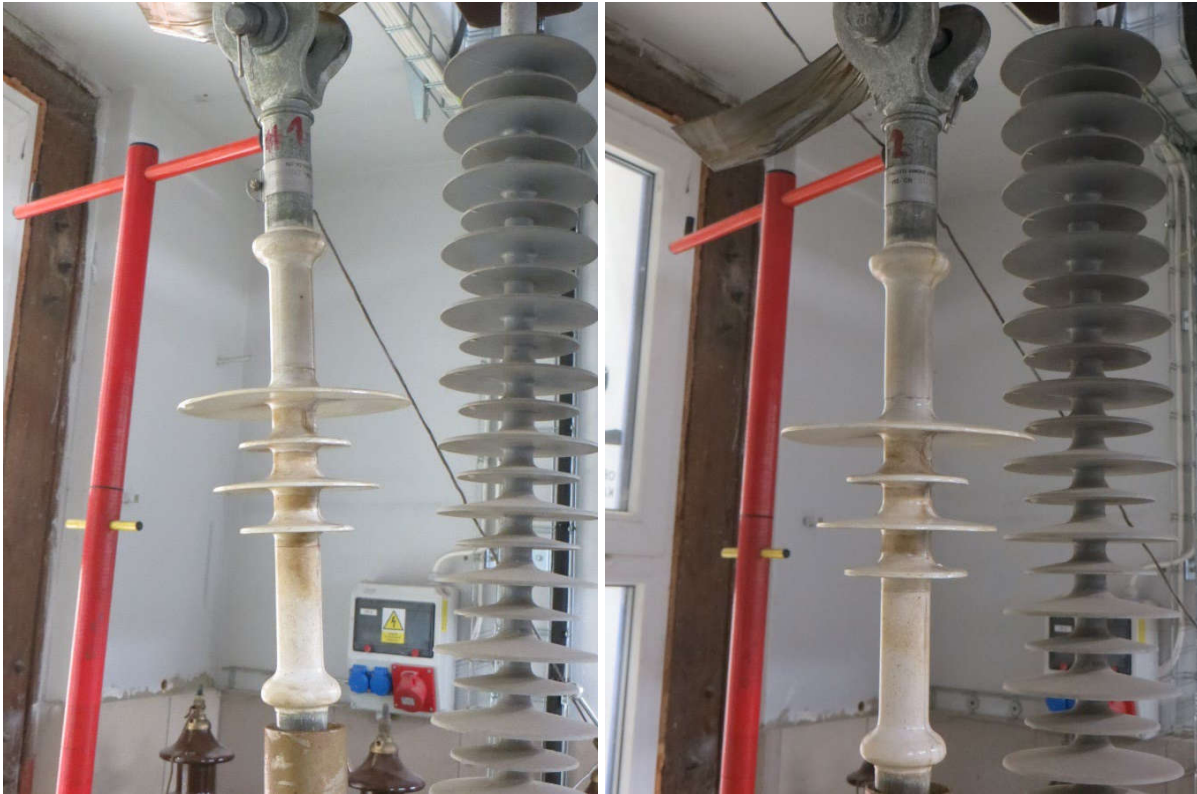
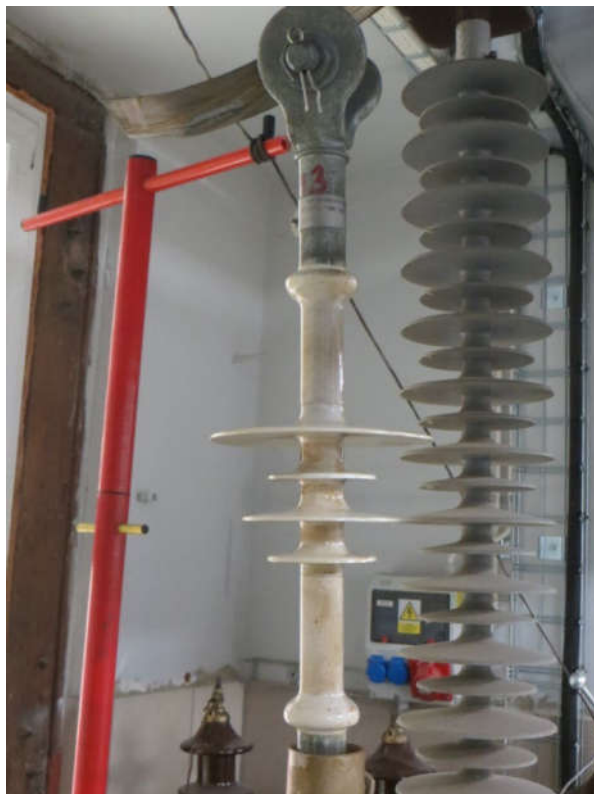
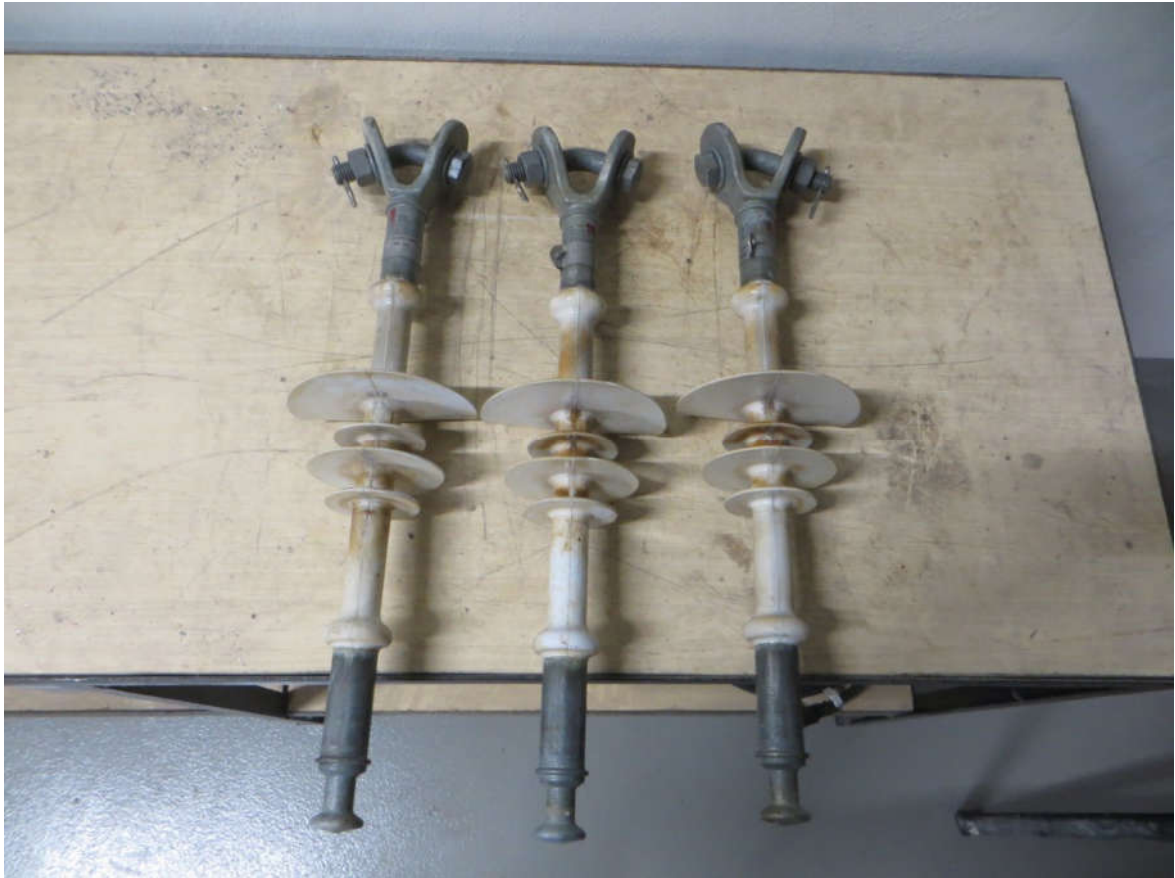
Figure 5 Composite line insulators, test sample No. 1 and 2, after tracking and erosion test

Figure 6 Composite line insulator, test sample No.3, after tracking and erosion test

Figure 7 Composite line insulators, test samples No. 1, 2 and 3, after tracking and erosion test

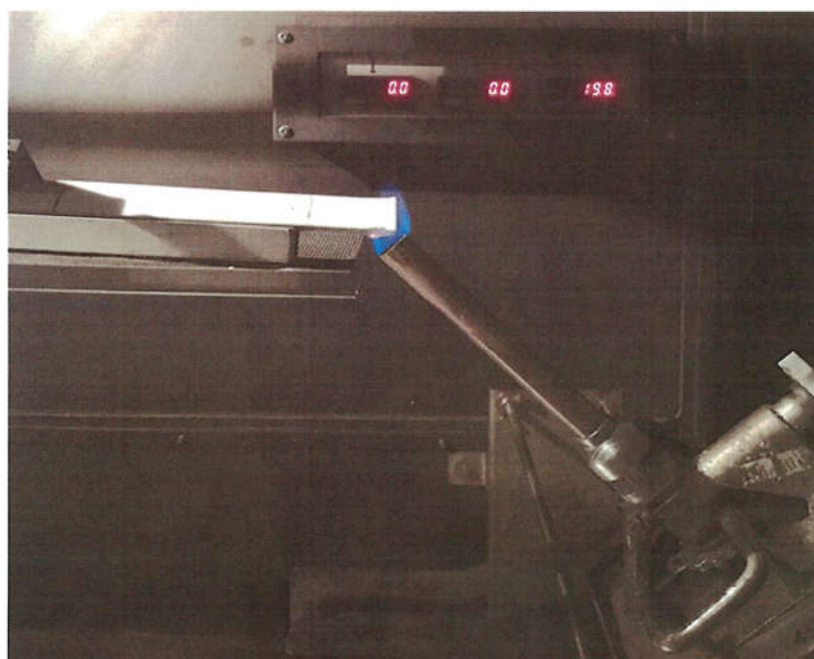
Photo of the position of the test specimen during the test:

Test standard:	ČSN EN 60695-11-10 ed. 2: 2014				
Test equipment:	Chamber Atlas HVUL2				
Ignition source:	Burner with an inner diameter 9.5 mm				
	The gas used: Methane 2.5				
Test conditions:	Blue flame height 20 mm, the exposure time 30s				
	No forced ventilation was used during the test				
	Temperature:	22,0 - 23,0°C			Humidity: 48,0 - 49,0%
Description of the sample (sample type, the color, the location in the product, the number of samples tested):	Test specimens of grey color 125x13x3mm, 3 pieces				
Conditioning of samples:	48 hours at 23±2°C and 50±5% relative humidity				
Conditioning of cotton indicator:	24 hours in desiccator 23±2°C				
Deviations from the standard:	no				
Test progress:	After removing the ignition flame, the test specimens do not burn. The flame did not exceed the 25 mm mark. A support fixture was used during the test due to the bending of the test specimens.				
Test specimen No.1	burning stopped before 25 mm

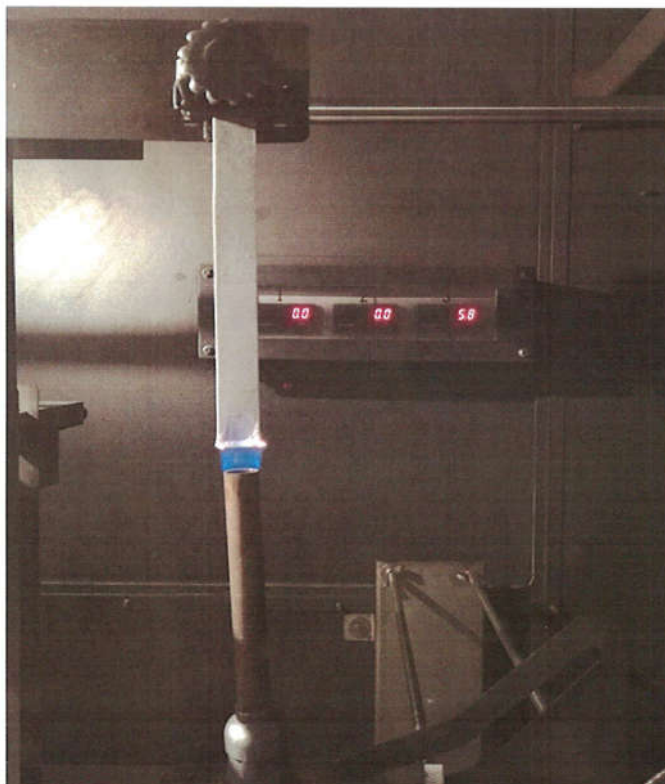
Photo of the position of the test specimen during the test:

Test standard:	ČSN EN 60695-11-10 ed. 2: 2014	
Test equipment:	Chamber Atlas HVUL2	
Ignition source:	Burner with an inner diameter 9.5 mm	
	The gas used: Methane 2.5	
Test conditions:	Blue flame height 20 mm, the exposure time 2 x 10s	
	No forced ventilation was used during the test	
	Temperature: 22,0 - 23,0°C	Humidity: 48,0 - 49,0%
Description of the sample (sample type, the color, the location in the product, the number of samples tested):	Test specimens of grey color 125x13x3mm, 10 pieces	
Conditioning of samples:	5 pieces - 48 hours in the climate chamber at 23±2°C and 50±5% relative humidity; 5 pieces -168 ±2 hours in the hot air oven at 70±2°C and cooled in desiccator min. 4 hours at room temperature	
Conditioning of cotton indicator:	24 hours in desiccator 23±2°C	
Deviations from the standard:	Not detected	
Test progress:	The test specimens do not burn after the first or after the second application of the flame. The material does not drip or ignite absorbent cotton.
