EGU HV LABORATORY

TEST REPORT No.: 11788/U/21

69 kV Composite insulator

SML 133 kN

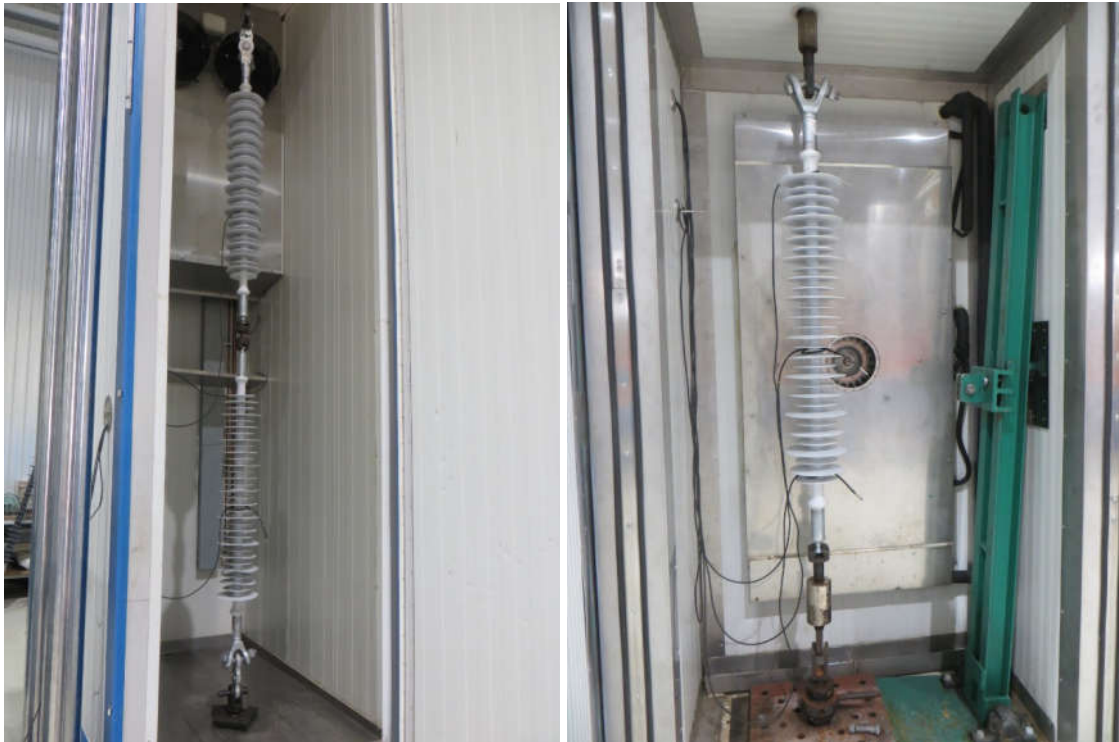
Figure 2
Test samples No. 1, 2 and 3, during thermal – mechanical test

Records of measured temperatures and mechanical tension during the thermal-mechanical testing are given in Graphs 2, 3, 4 and 5. The test arrangement during the thermal-mechanical test on the insulator is shown in Figure 2.

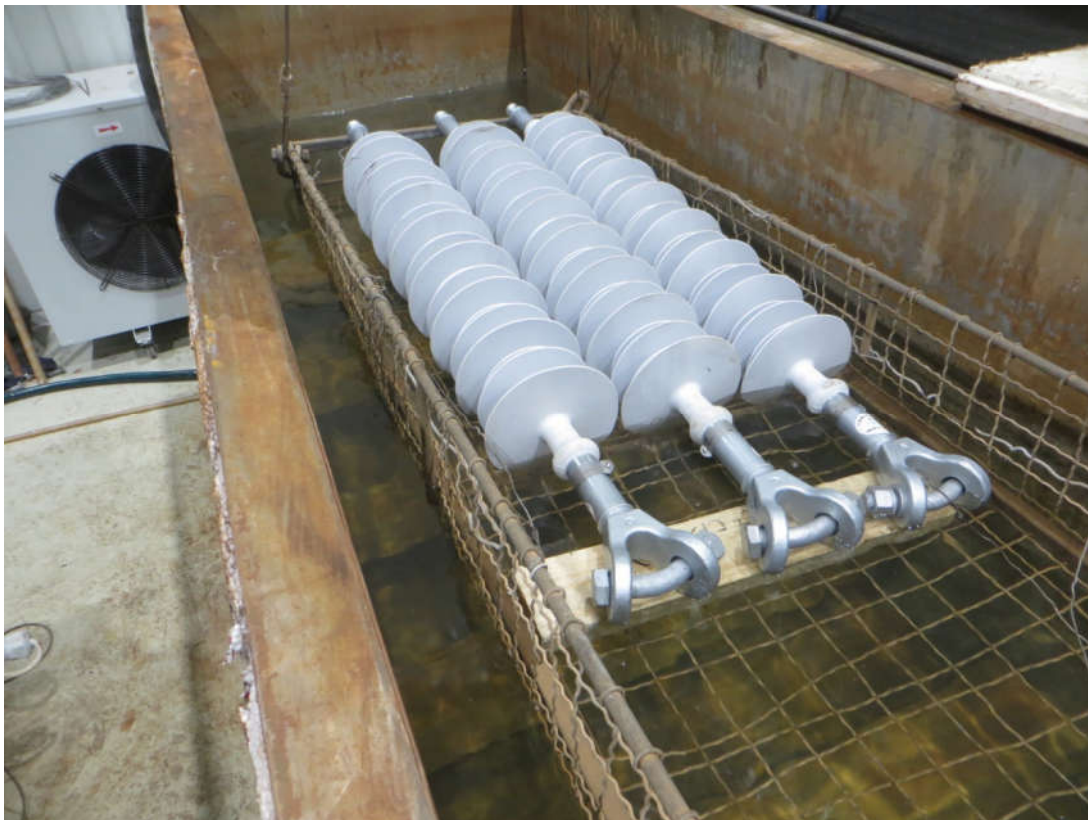
Figure 3
Test samples No. 1, 2 and 3, before watter penetration test

Three tested insulators No. 1, 2, 3 were immersed according to ANSI C29.11, clause 7.1.5 for 42 hours in boiling deionized water with 0,1 % by weight of NaCl (see Figure 3).

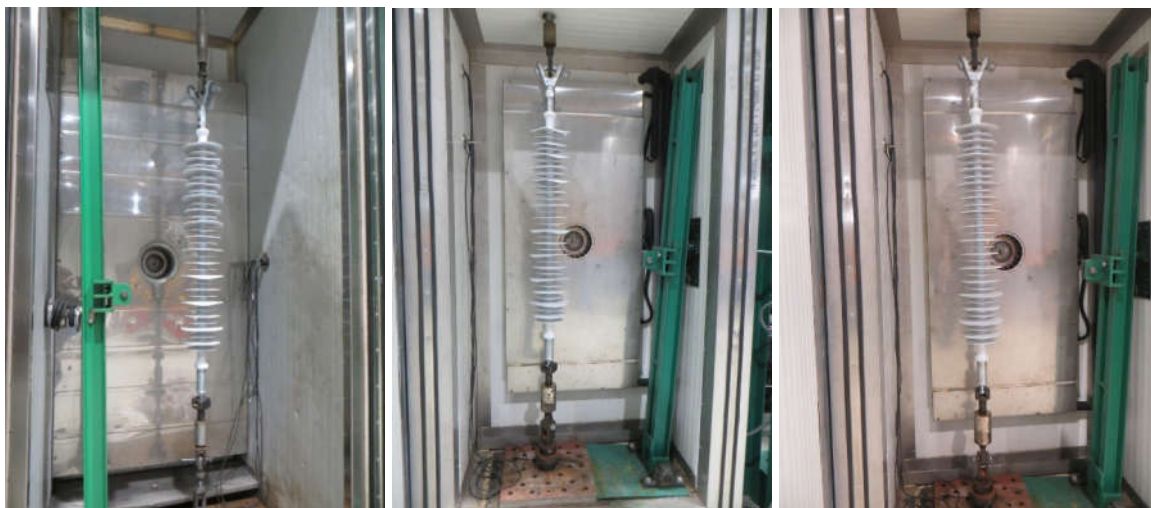
Figure 10

Test samples No. 4, 5 and 6, during the verification of the 96 hours mechanical load test, test

No failure (breakage or complete pull-out of the core or fracture of the metal fittings) occurred during 96 h test on insulators No. 4, 5 and 6.

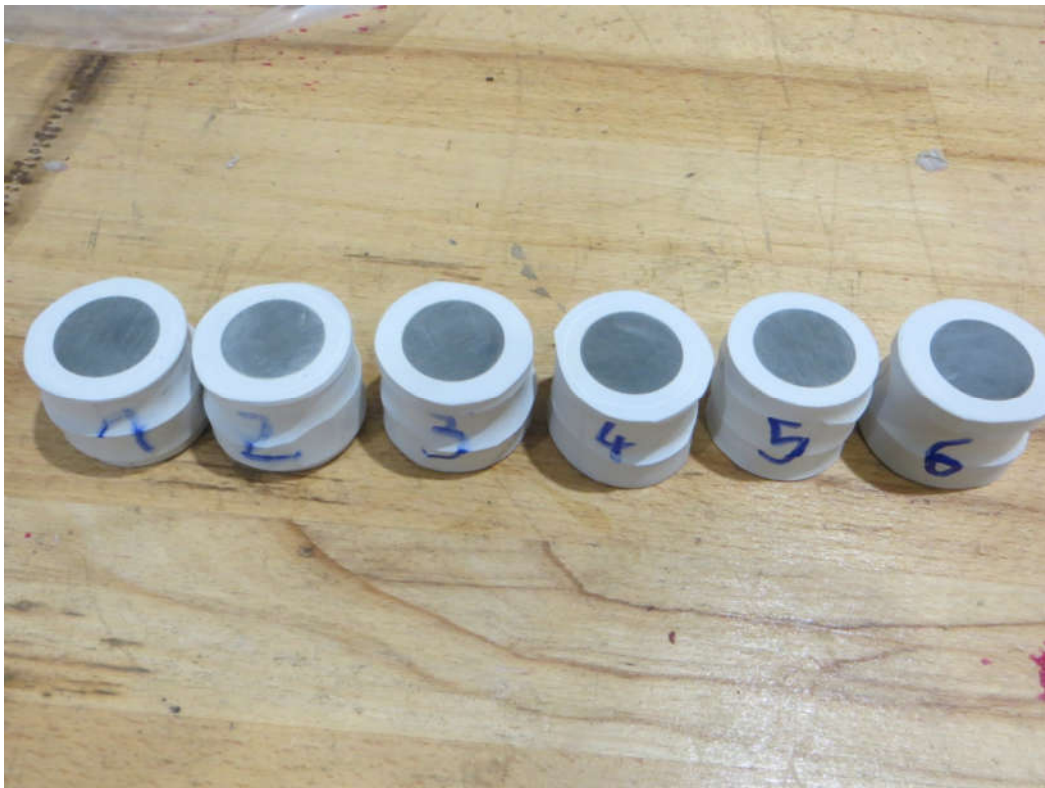
Figure 13
Test specimens after the voltage test – water diffusion test

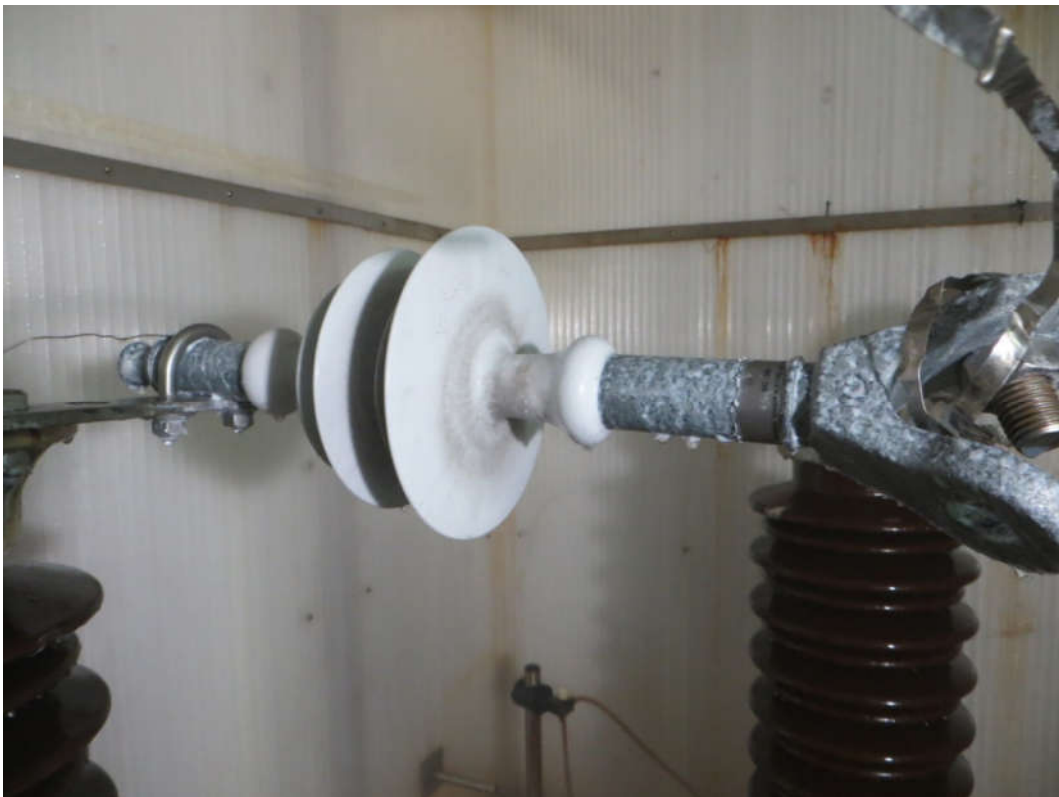
Figure 15
Test sample No. 2, horizontal position, after the housing tracking and erosion test

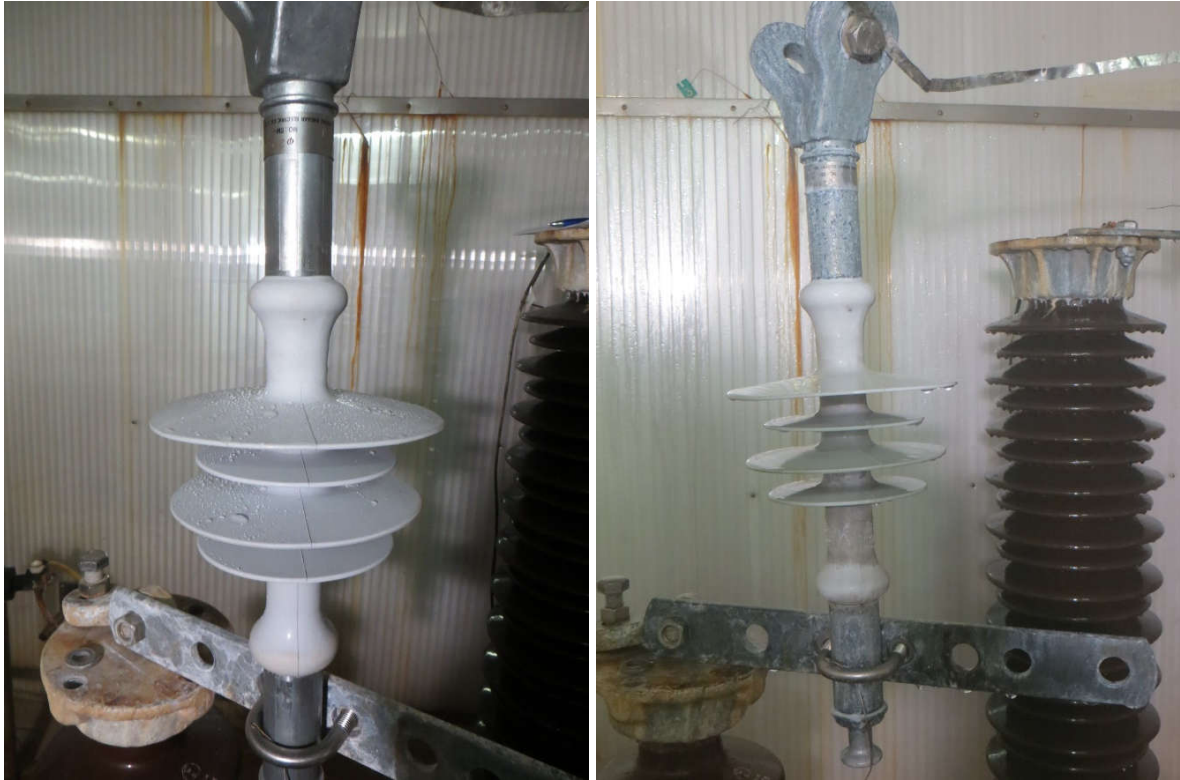
Figure 16

Test sample No. 1, vertical position, before and after the housing tracking and erosion test

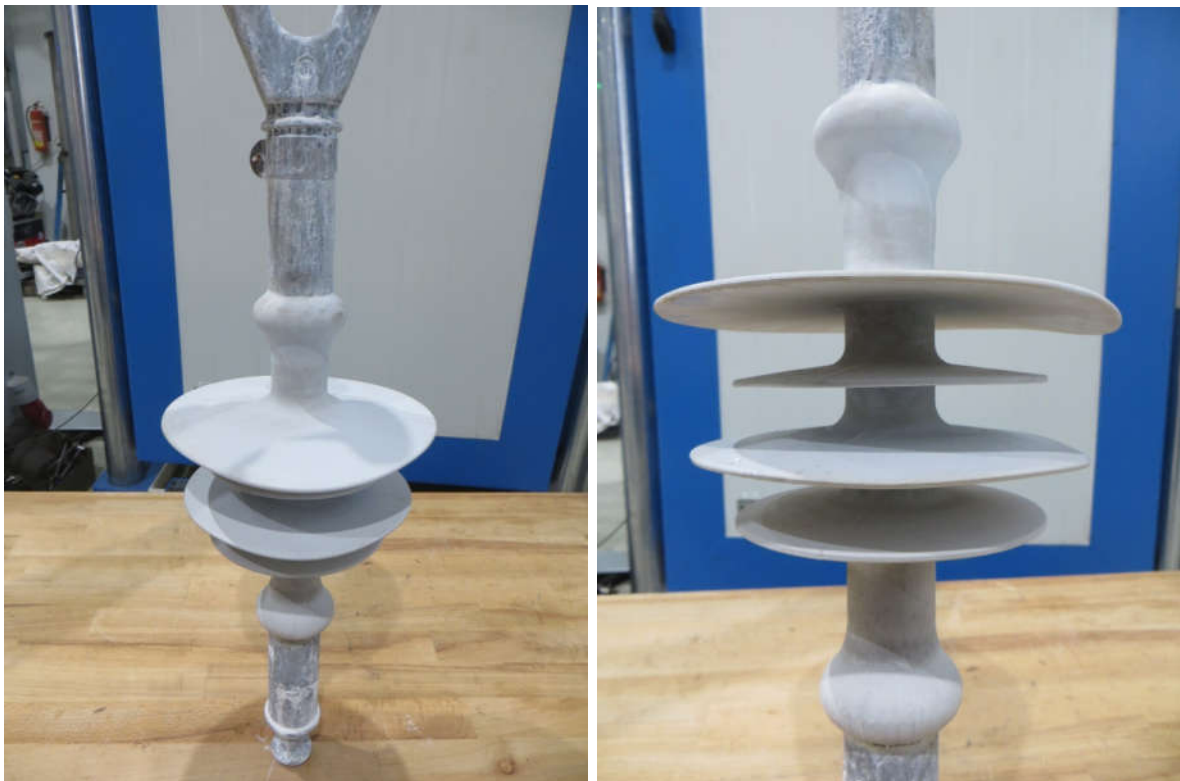
Figure 17

Test sample No. 1, vertical sample after the housing tracking and erosion test

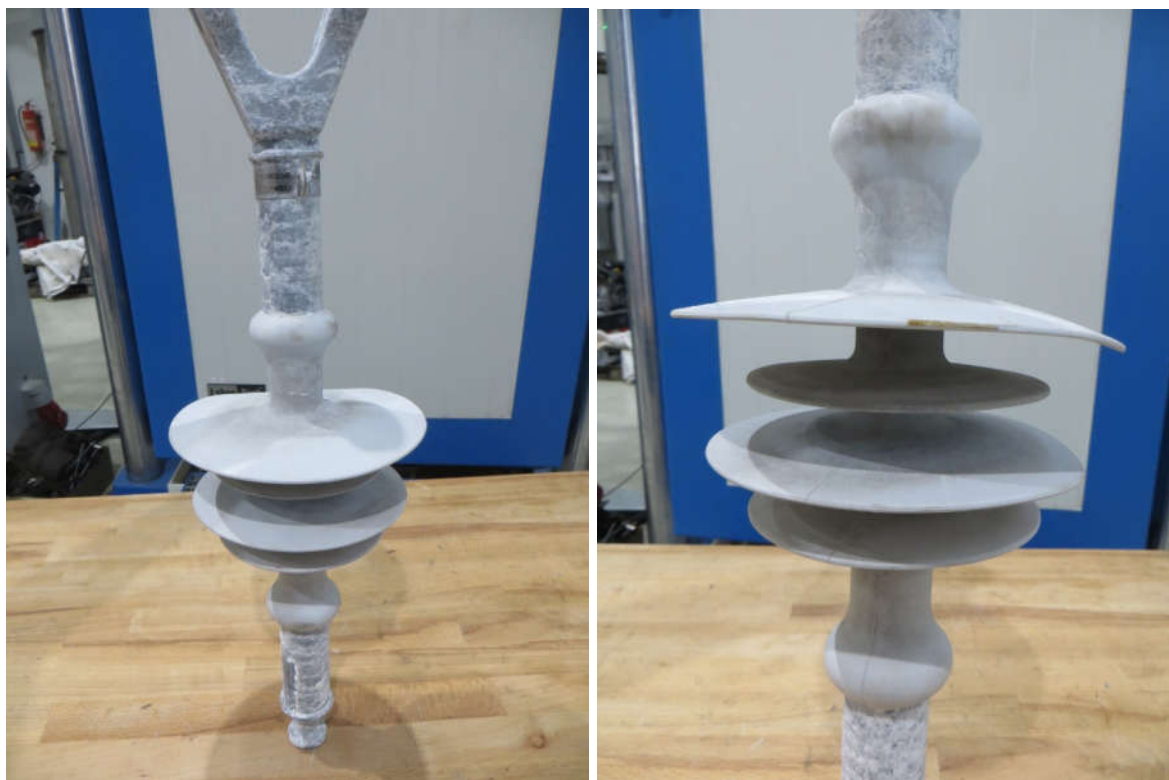
Figure 18
Test sample No. 1, vertical sample after the housing tracking and erosion test

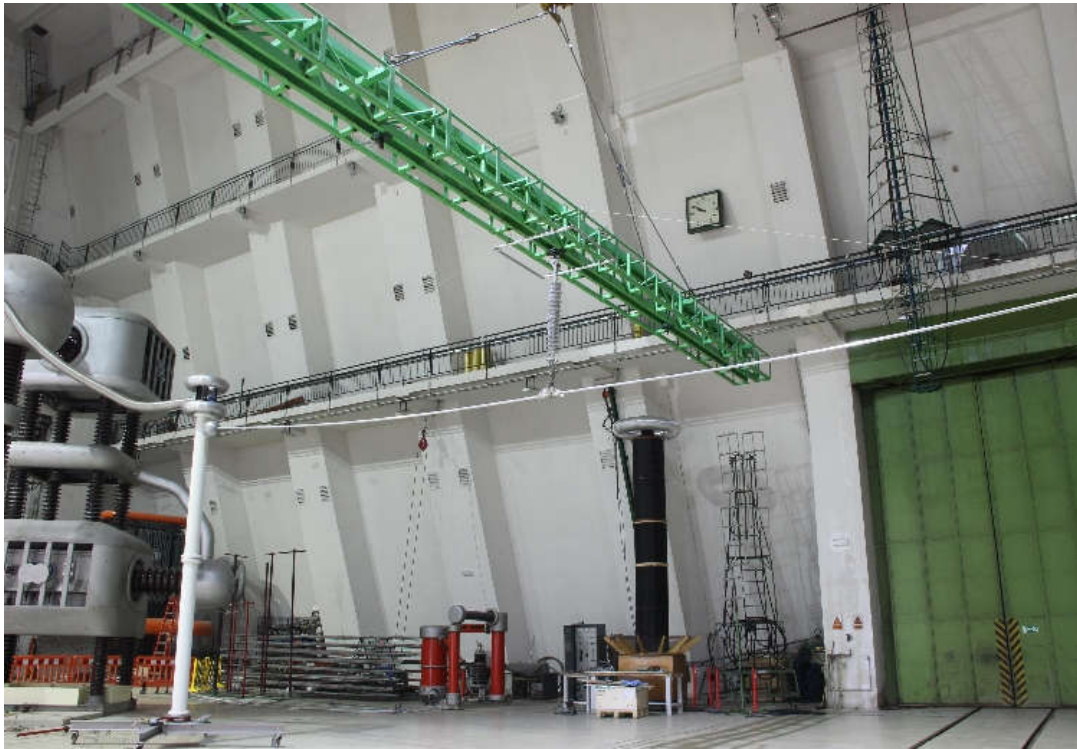
Figure 2
Test arrangement for RIV and corona tests

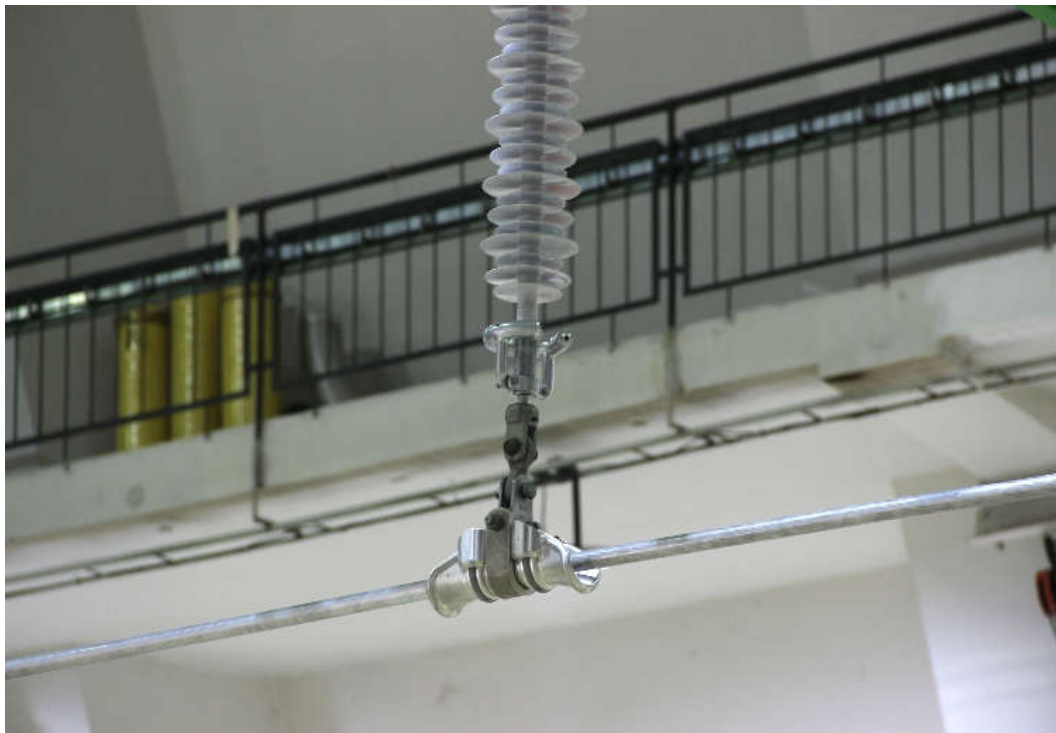
Figure 3
Test arrangement for RIV and corona tests

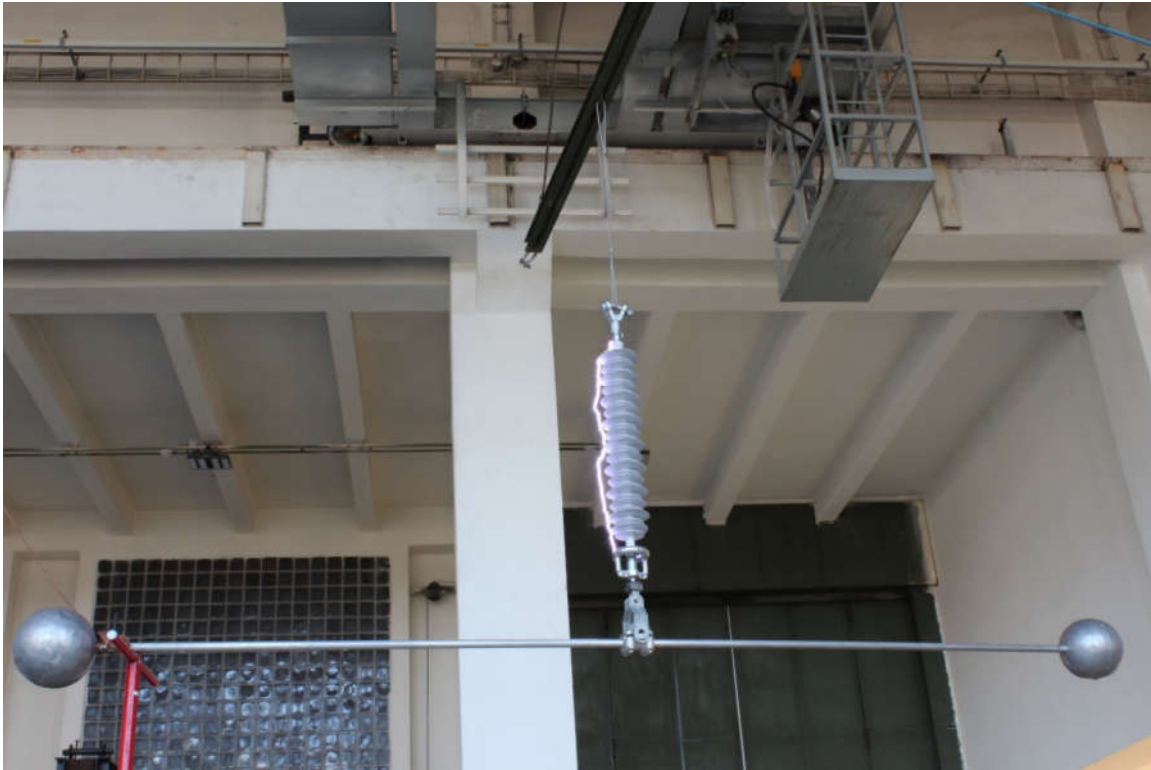
Figure 4
Test arrangement and flashover under the critical impulse flashover test

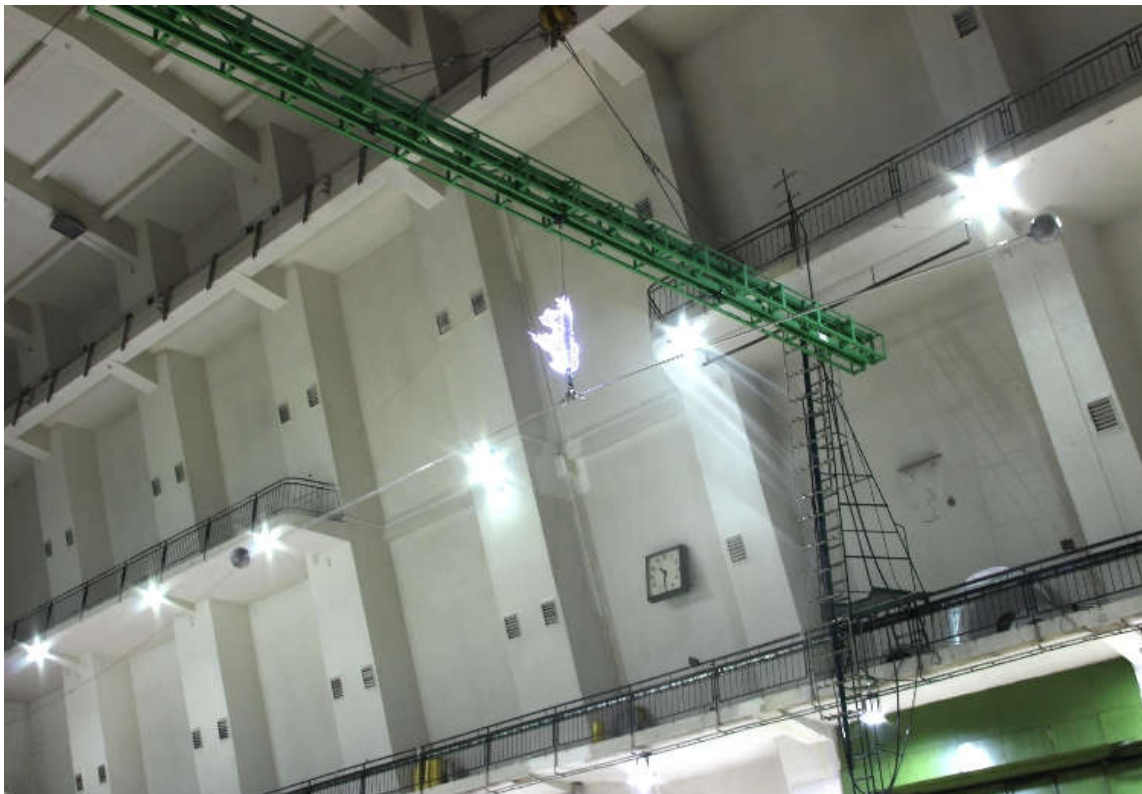
Figure 5
Test arrangement and flashover under the low-frequency wet flashover test

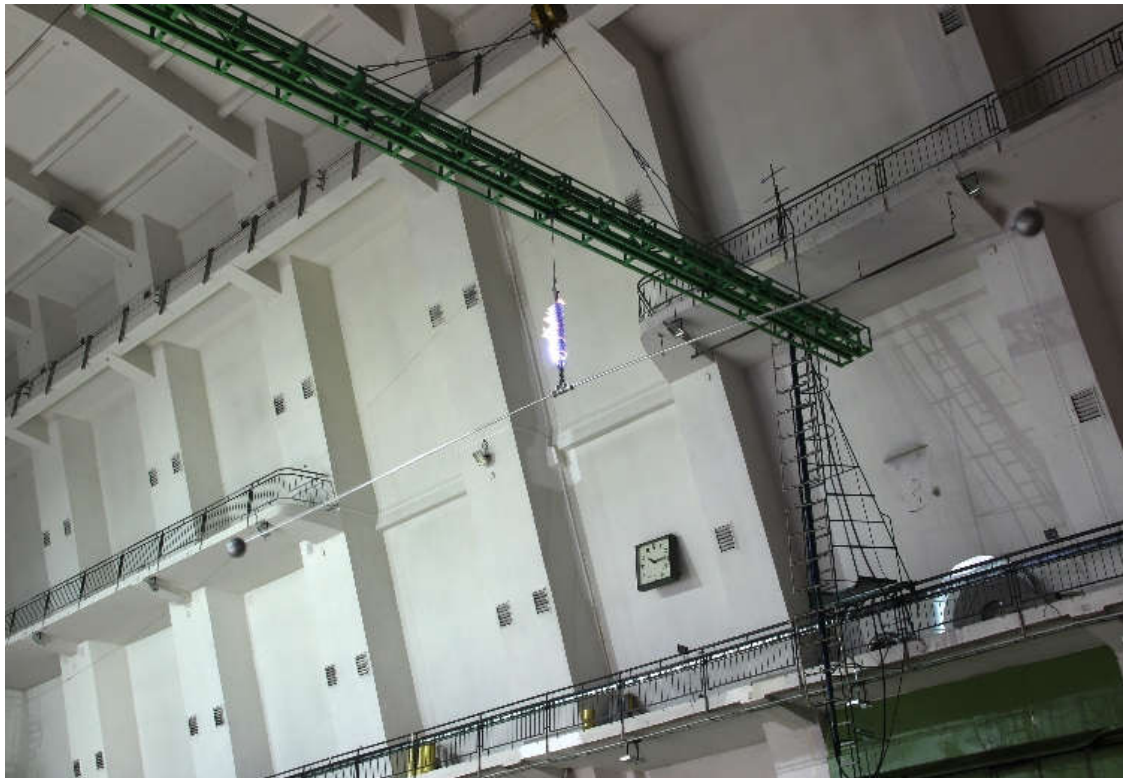
Figure 6
Test arrangement and flashover under the low-frequency dry flashover test
