EGU HV LABORATORY

TEST REPORT No.: 11788/I/21

TEST OBJECT: 161 kV Composite insulator

TYPE SPECIFICATION: SML 222 kN

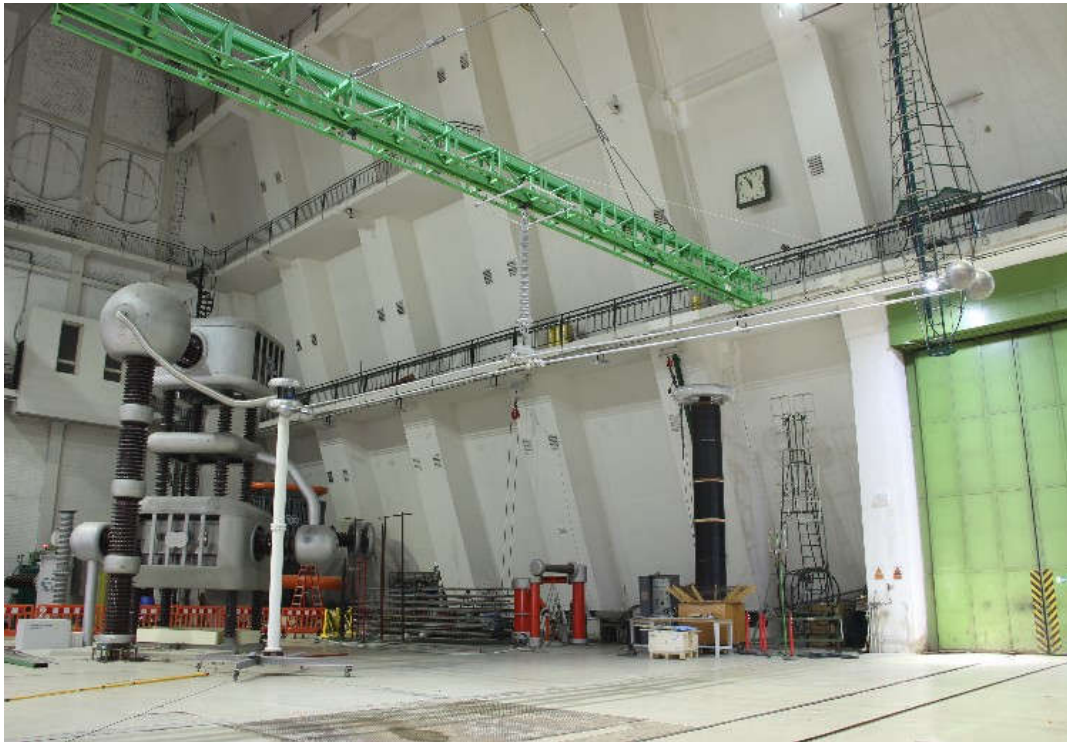
Figure 2
Test arrangement for RIV and corona tests

The test arrangement was set up according to CSA C411.4-16, clause 6.4.2.2 (see Figure 2). The bundle of double conductors with spacing 457 mm was simulated using an aluminium tube of 14 m length and 30 mm diameter. Both ends of the tubes were terminated with corona shielding spheres (screening electrode) with a diameter of 300 mm. Bundle of conductors was at a height of 4,4 m above the ground.

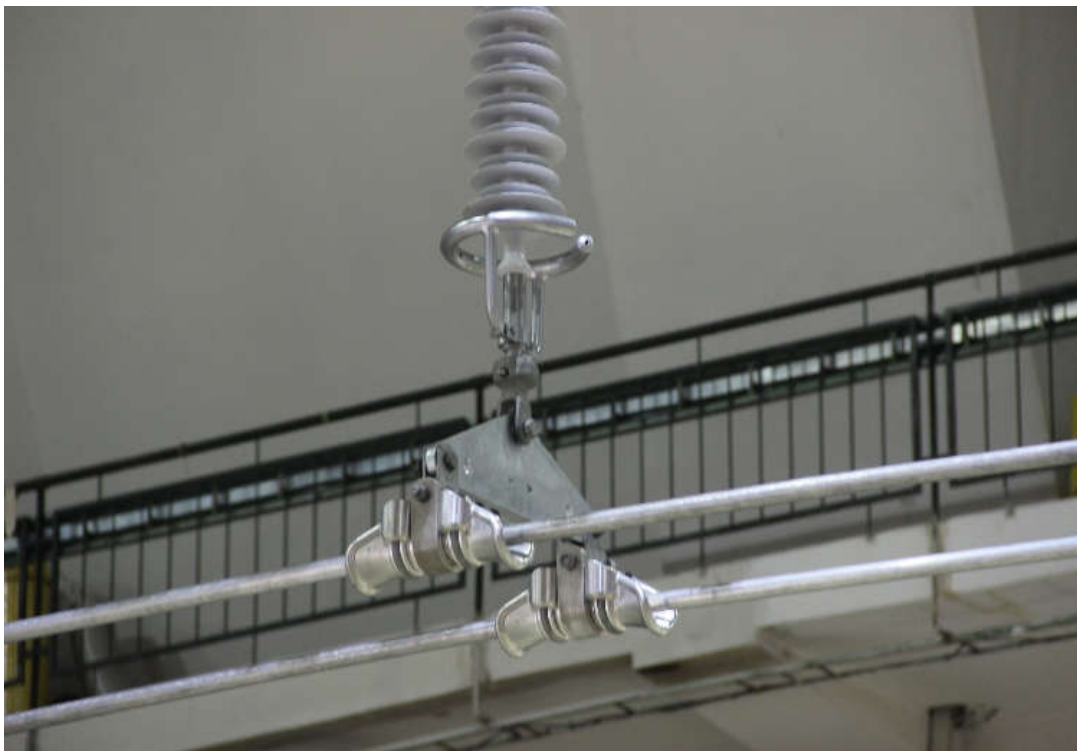
Figure 3
Test arrangement for RIV and corona tests

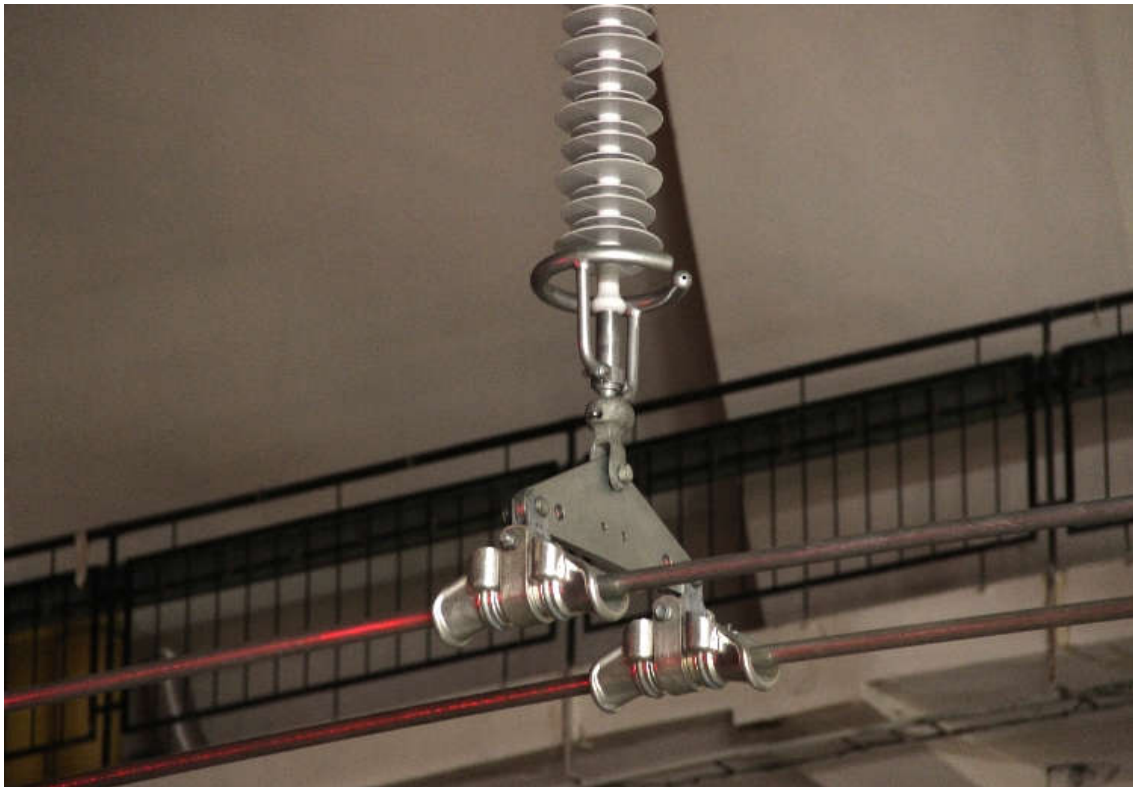
Figure 4
Test object at the test voltage of 117 kV – no positive corona

The test object at the specified test voltage is shown in Figure 4. The corona discharges are shown in Figure 5.

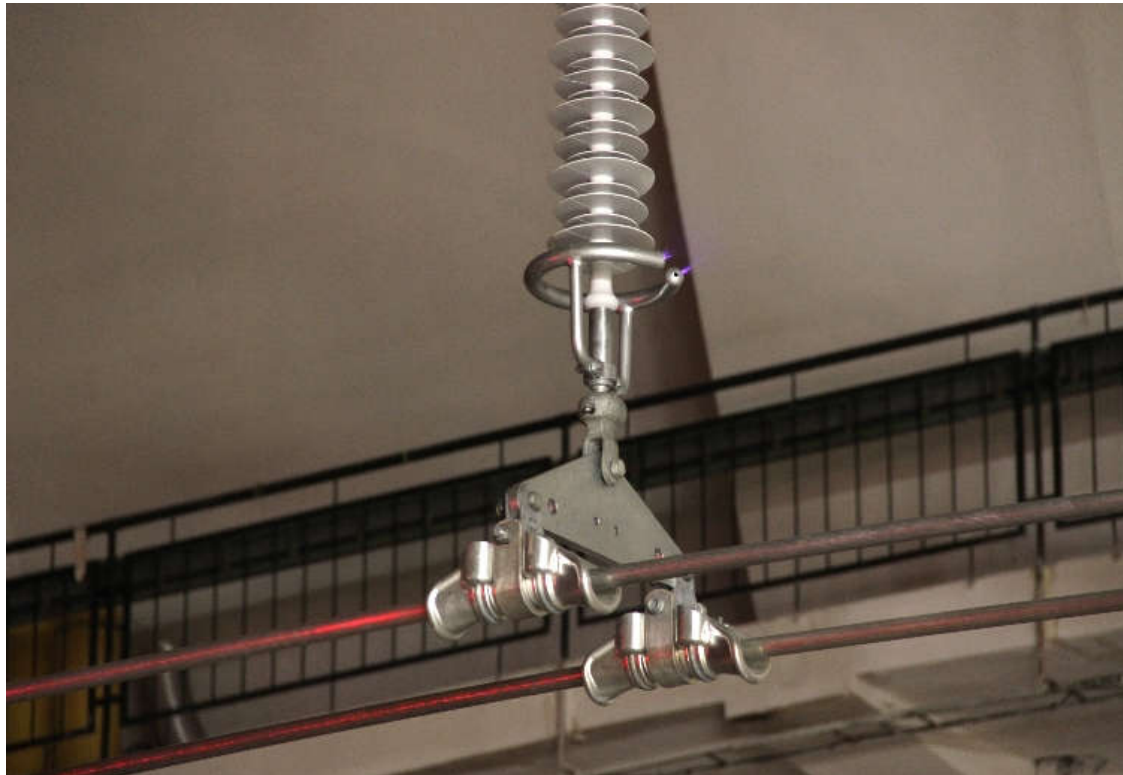
Figure 5
Test object at the test voltage of 213 kV

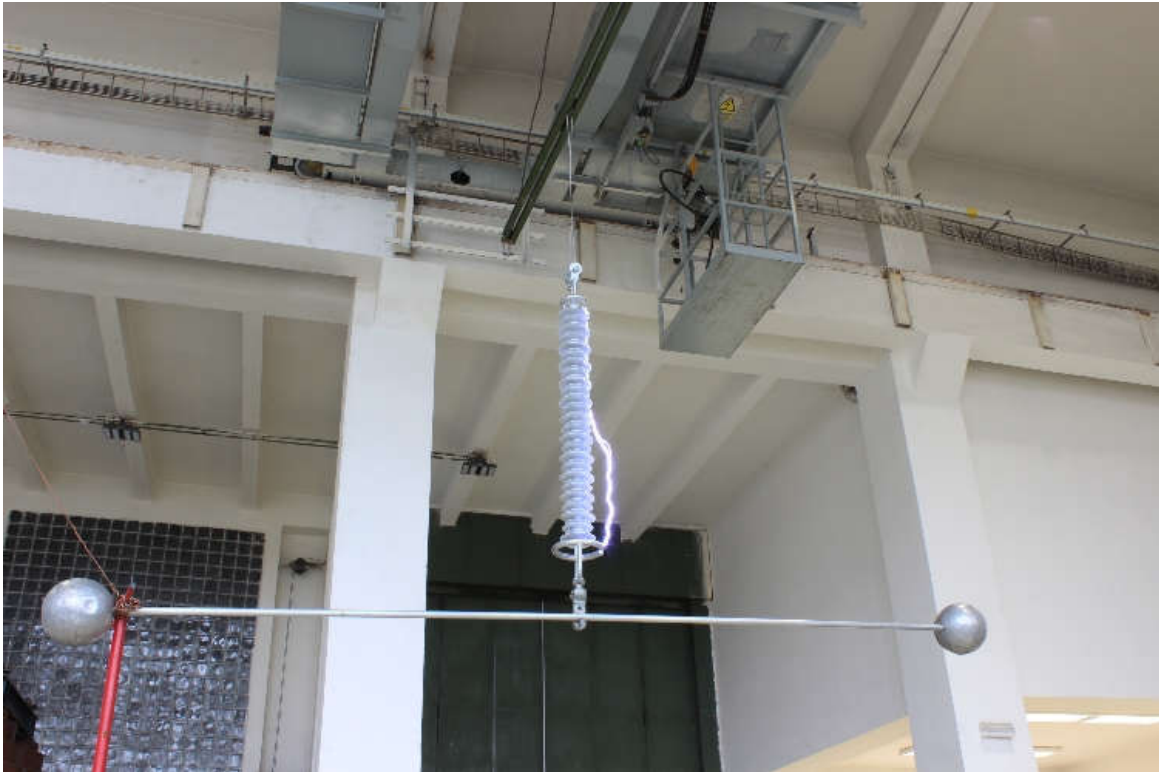
Figure 6
Test arrangement and flashover under the critical impulse flashover test

The test arrangement was set up in compliance with IEC 60383-1, clause 34 (see Figure 6).

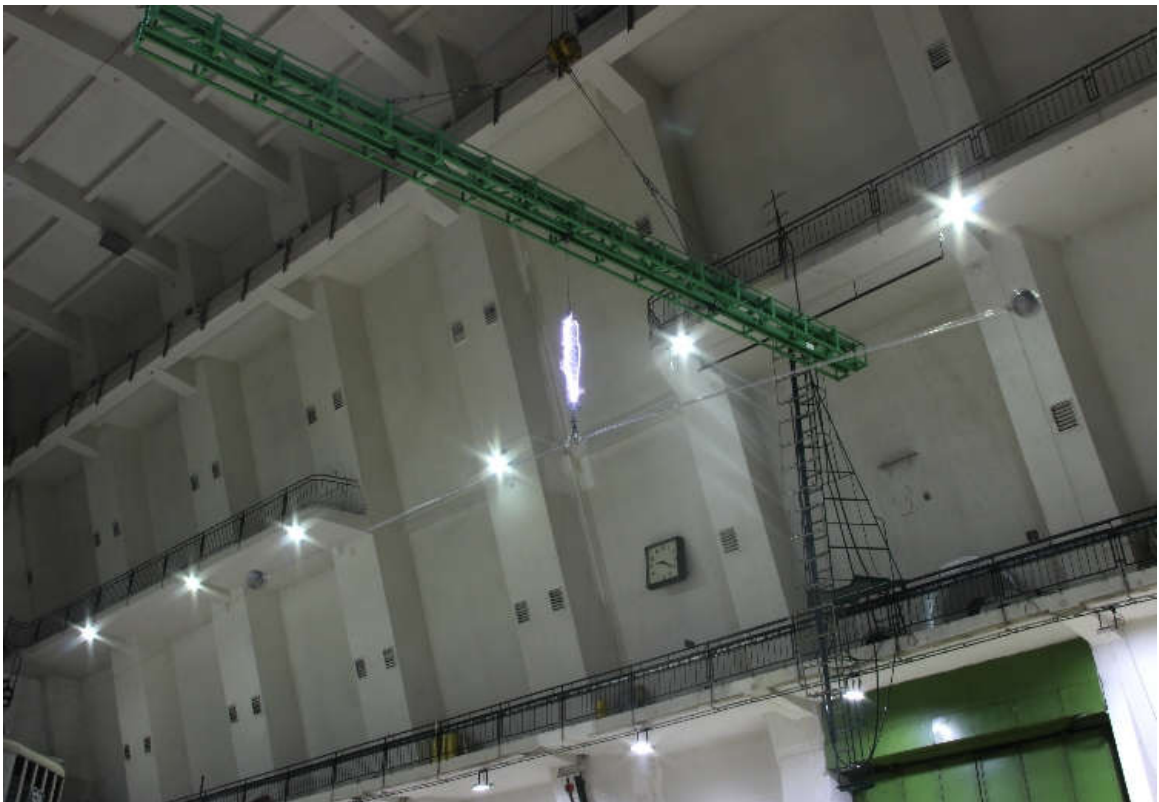
Figure 7
Test arrangement and flashover under the wet power frequency voltage flashover test

The test arrangement was set up in compliance with IEC 60383-1, clause 34 (see Figure 7).

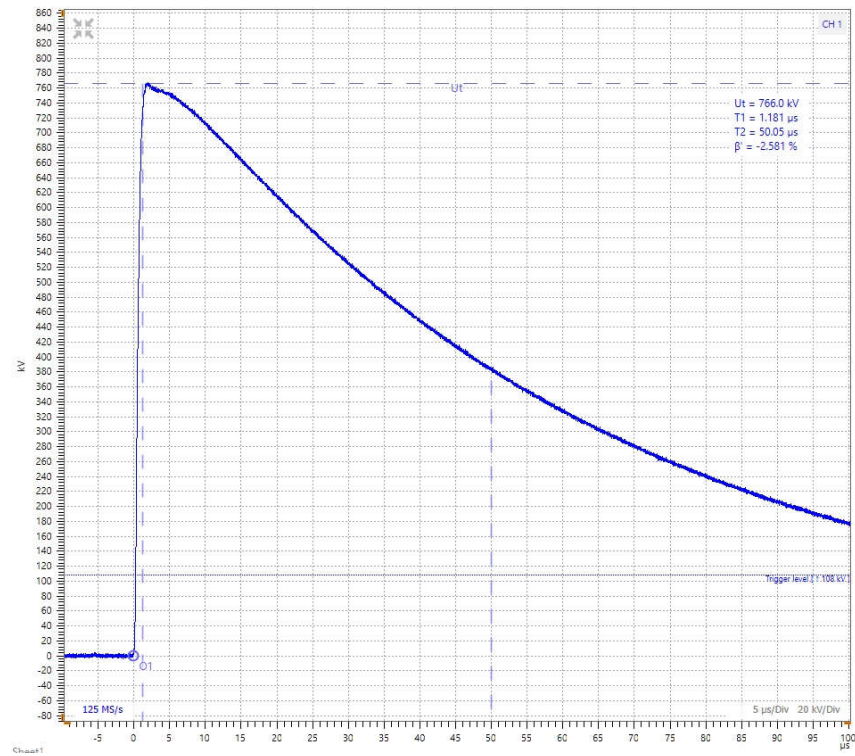
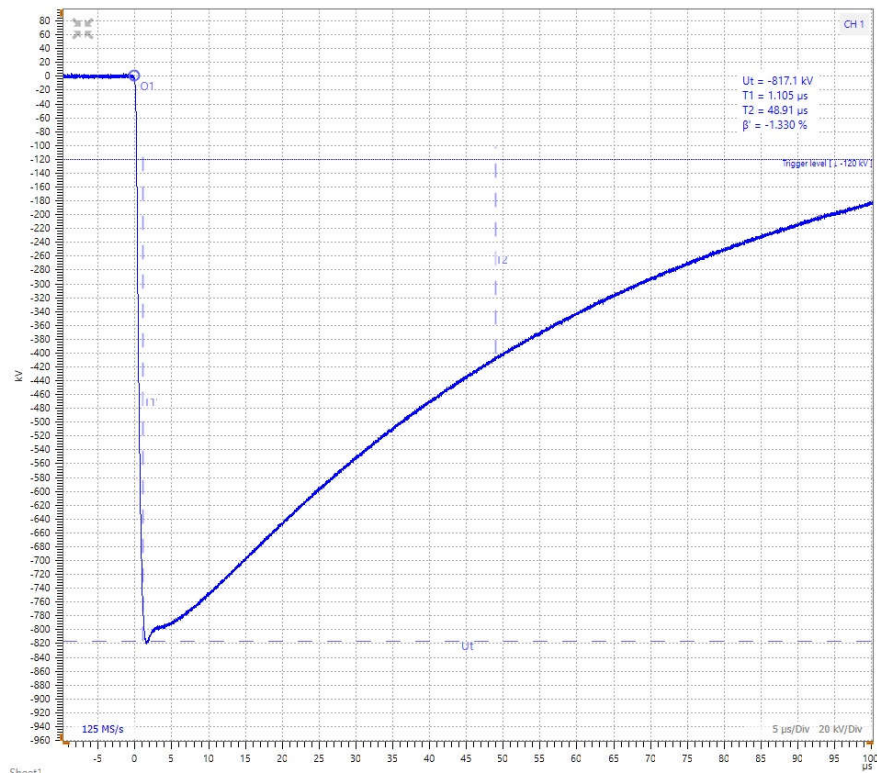
Graph 1
Representative wave shape of the lightning impulse 1,2/50 μs

The representative wave shape of the lightning impulse 1,2/50 μ s is given Graph 1.

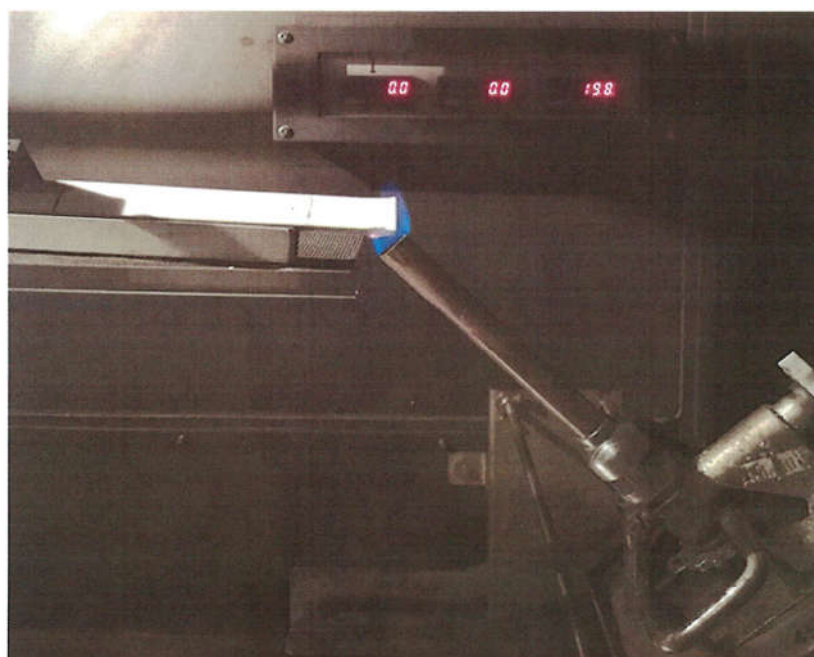
| Test No. 15 | Fire hazard testing - Horizontal and vertical flame tests - method A - horizontal burning test |

Photo of the position of the test specimen during the test:

| Test progress: | After removing the ignition flame, the test specimens do not burn. The flame did not exceed the 25 mm mark. A support fixture was used during the test due to the bending of the test specimens. | | | | |

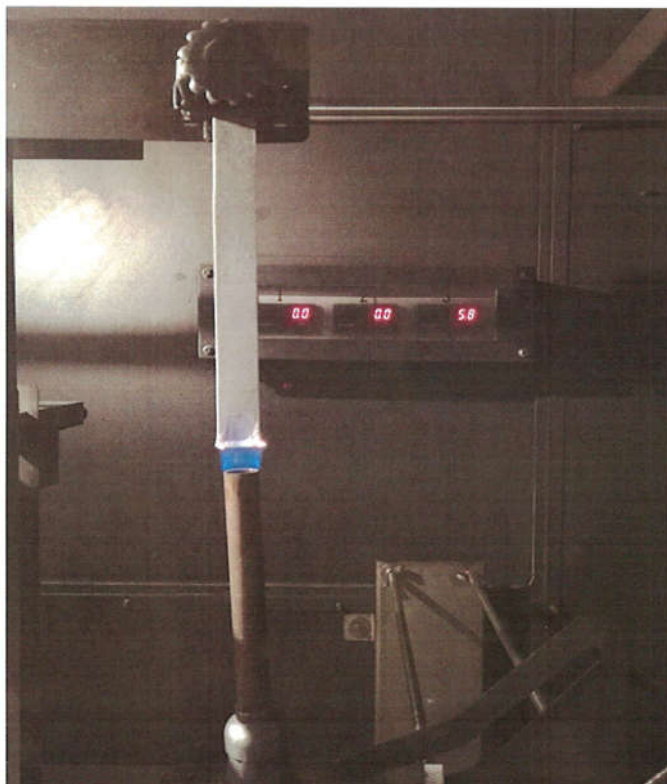
Fire hazard testing - horizontal and vertical flame tests - method
B - vertical burning test

Photo of the position of the test specimen during the test:

| Test progress: | The test specimens do not burn after the first or after the second application of the flame. The material does not drip or ignite absorbent cotton. | |

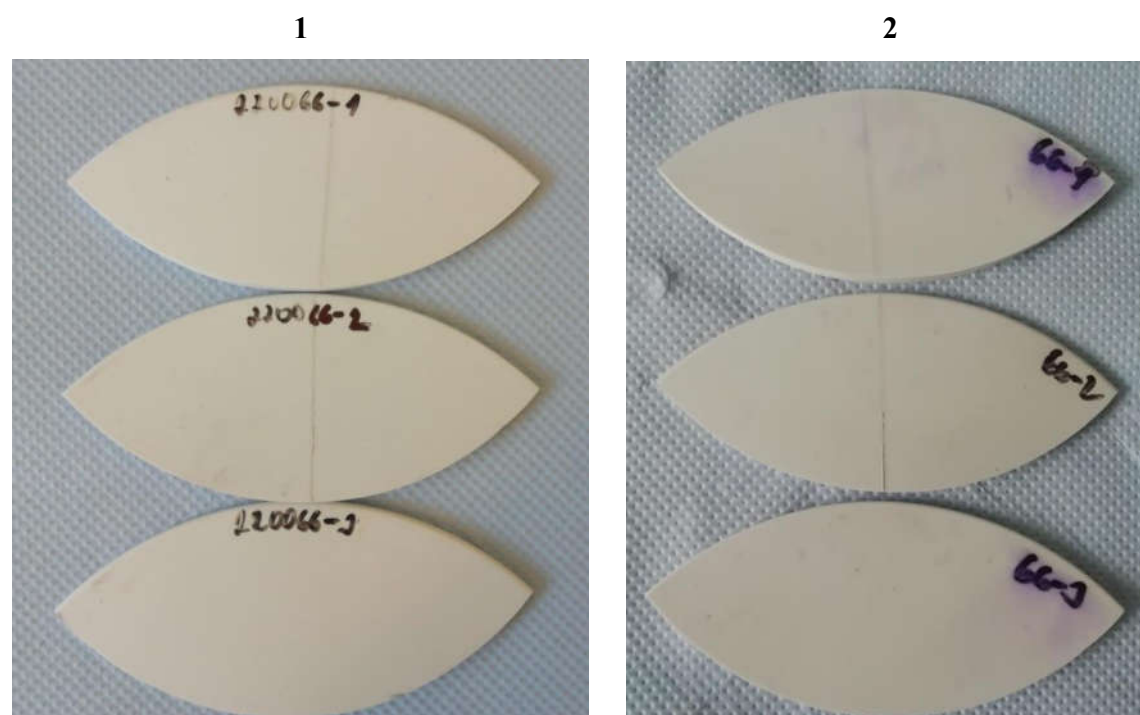
THE PHOTOS OF TEST SAMPLES AFTER 1000 HOURS OF EXPOSURE UNDER XENON LAMPS ACCORDING TO ASTM D2565-16

Pic 1 : Exposure after 1000hrs (top face)

Pic 2 : Exposure after 1000hrs (lower face)
