## EGU HV LABORATORY

## TEST REPORT No.: 11788/Q/21

345 kV Composite insulator

### TYPE SPECIFICATION: SML 222 kN

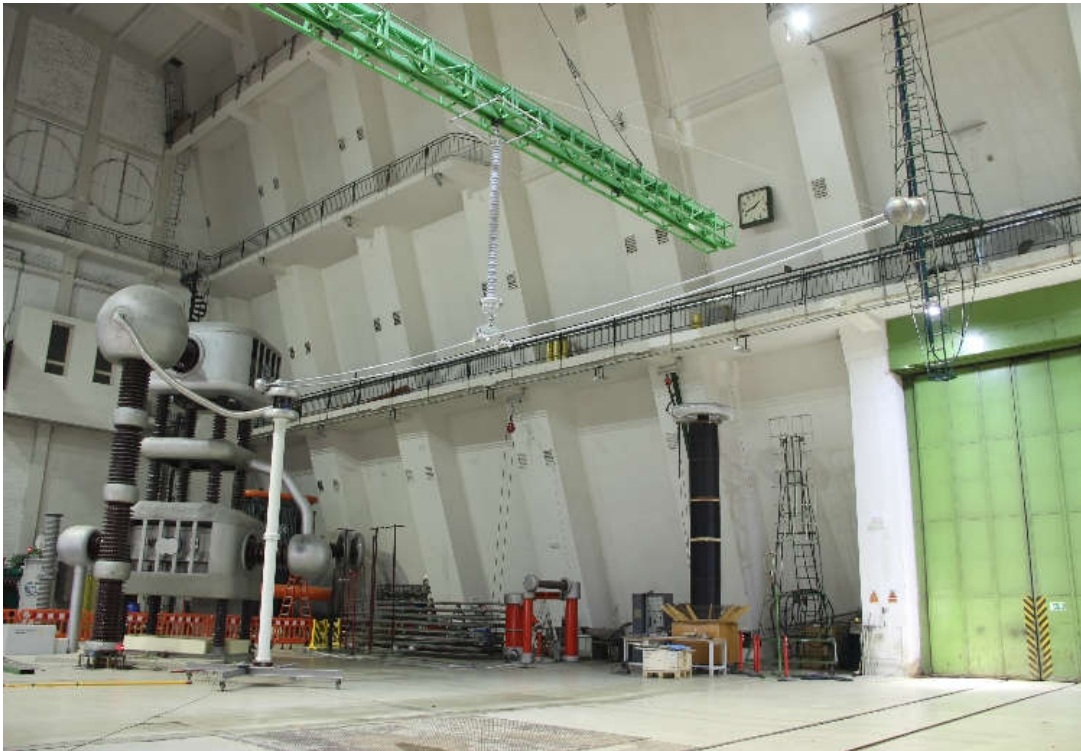
**Figure 2**  
**Test arrangement for RIV and corona tests**

The test arrangement was set up according to ANSI C29.11, clause 8.2.8.1 and customer requirements (see Figure 2). The bundle of double conductors with spacing 457 mm was simulated using an aluminium tube of 14 m length and 30 mm diameter. Both ends of the tubes were terminated with corona shielding spheres (screening electrode) with a diameter of 300 mm. Bundle of conductors was at a height of 5,1 m above the ground.

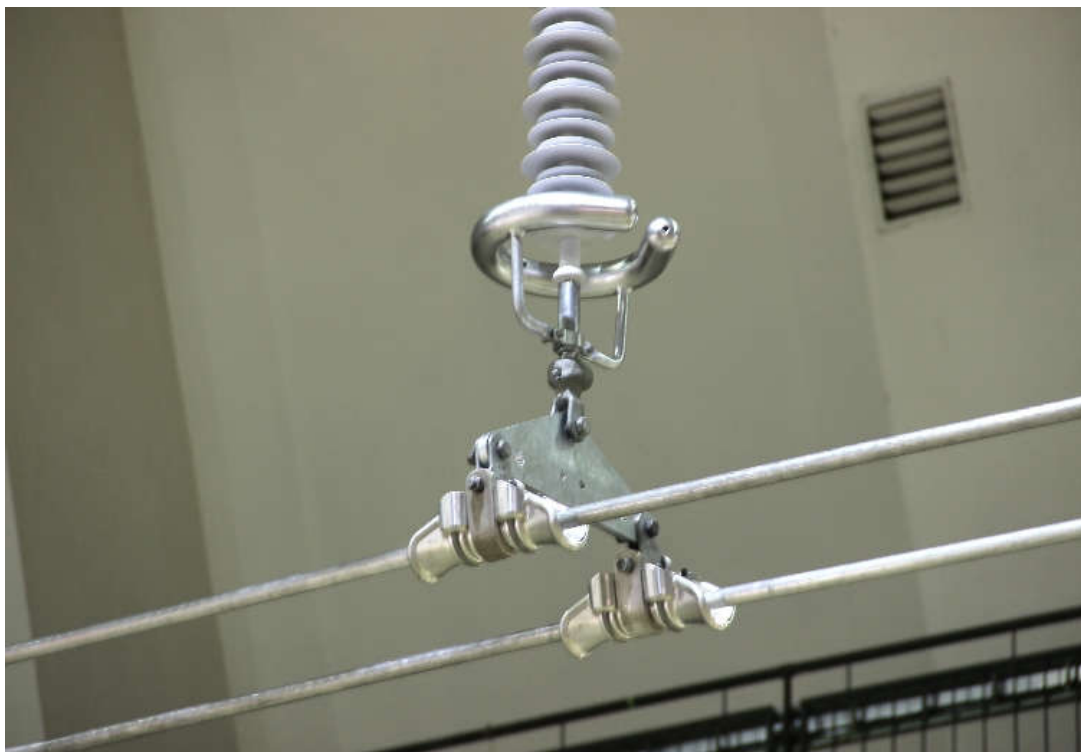
**Figure 3**  
**Test arrangement for RIV and corona tests**

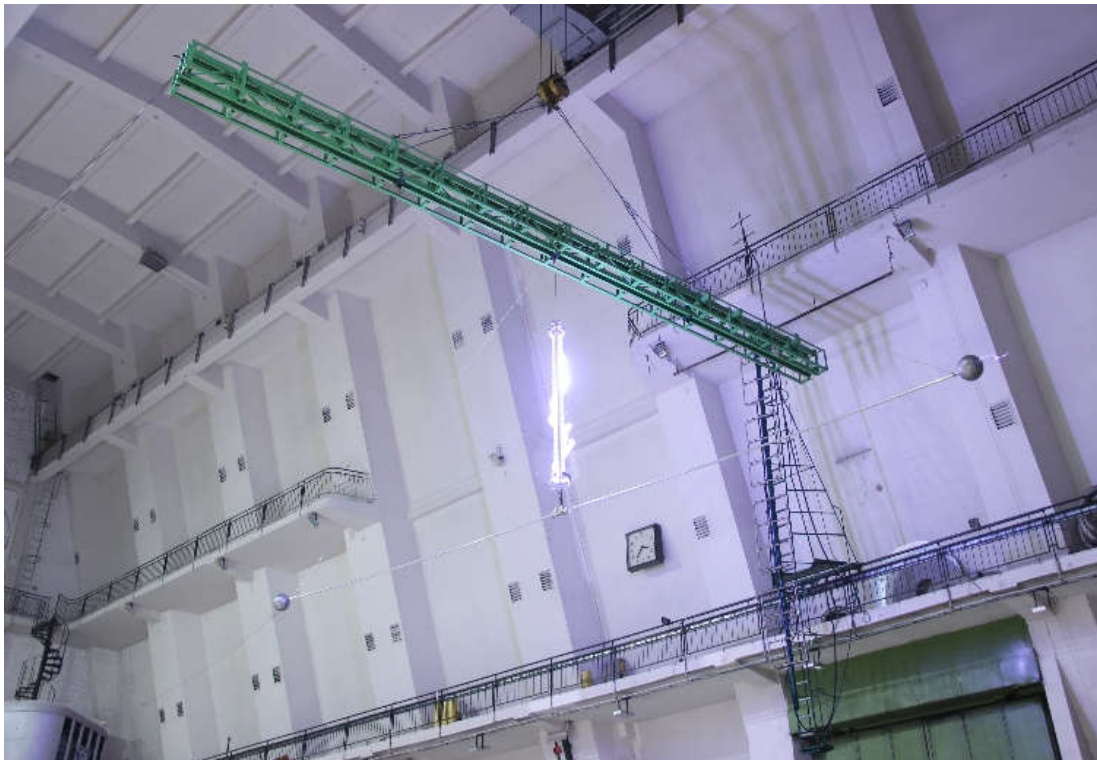
**Figure 6**  
**Test arrangement and flashover under the low-frequency dry flashover test**

The test arrangement was set up in compliance with ANSI C29.11, clause 8.2.1.2 and 8.1 (see Figure 6).
