EGU HV LABORATORY

TEST REPORT No.: 11788/X/21

138 kV Composite insulator

SML 222 kN

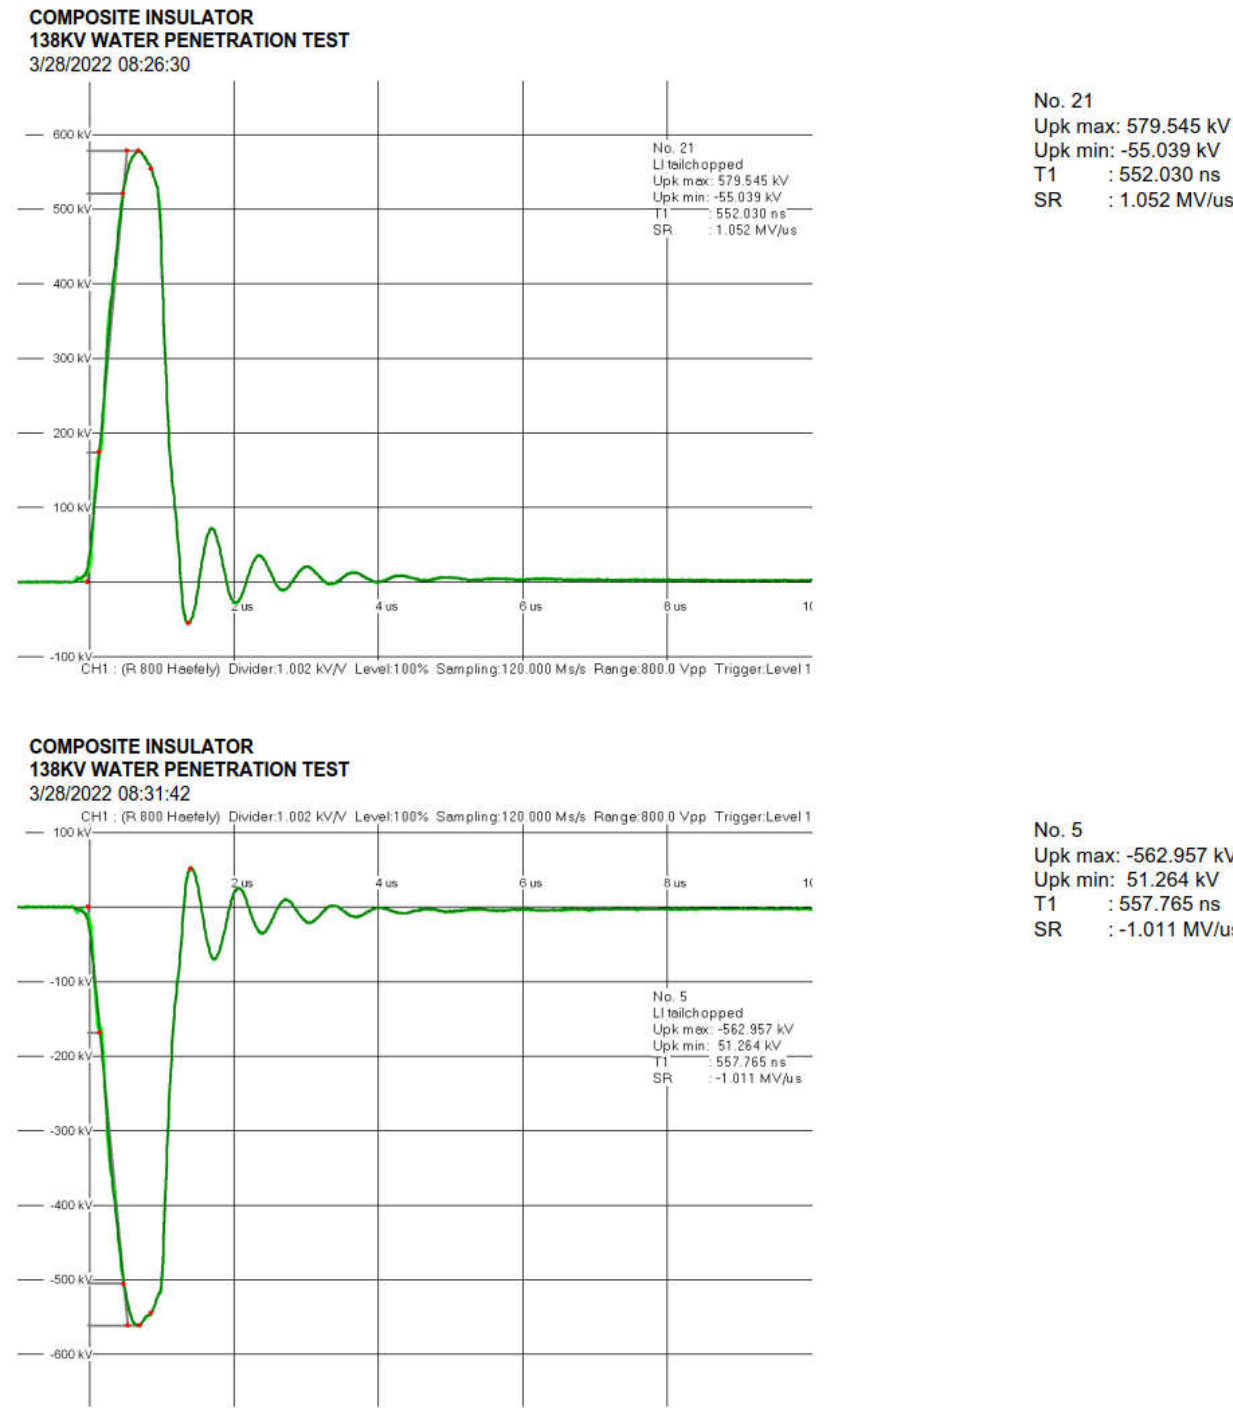
Graph 1
Representative wave shape of steep front impulse (water penetration test)

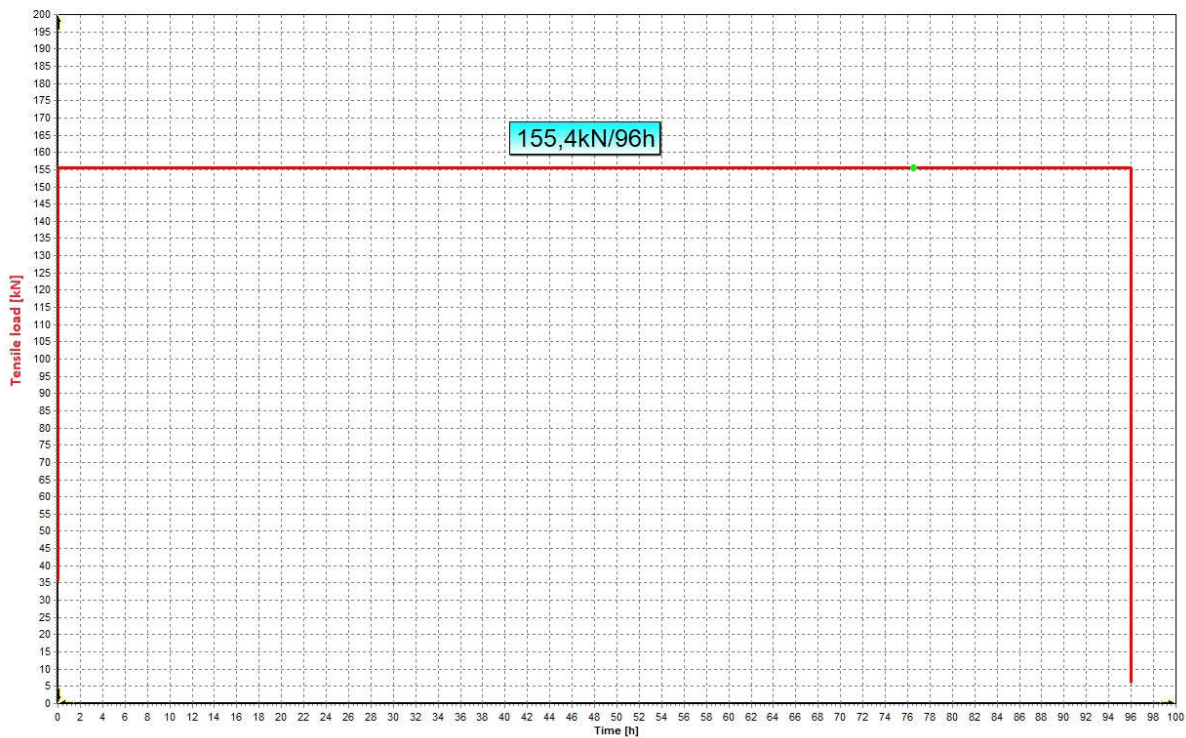
Graph 13
Record of 96 hours mechanical loading test, mechanical load-time test,
test samples No. 1, 2 and 3

All the insulators No. 1, 2, 3, 4 were subjected to a tensile load applied between couplings. The tensile load was increased rapidly but smoothly, from zero up to 155 kN (70 % of SML, SML = 222 kN) and then maintained at this value for 96 hours. The insulators under the test are shown in Figure 23. Applied load during testing is shown in Graph 13.

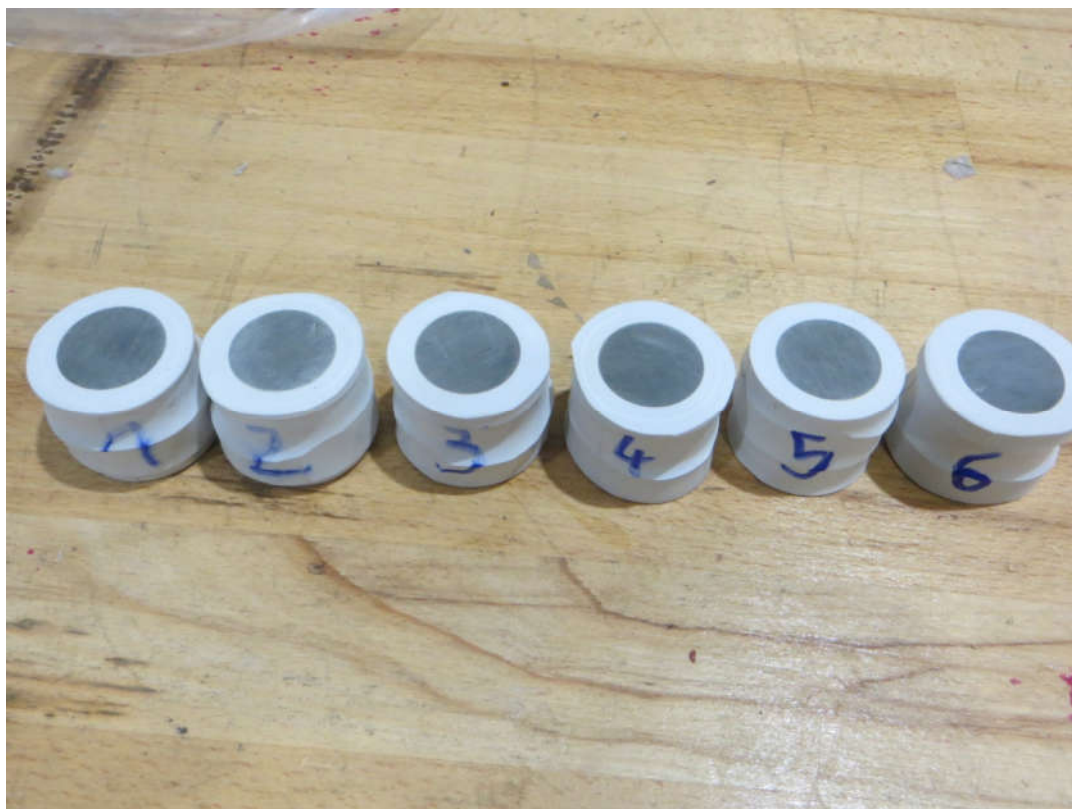
Figure 4
Test specimens during the voltage test – water diffusion test

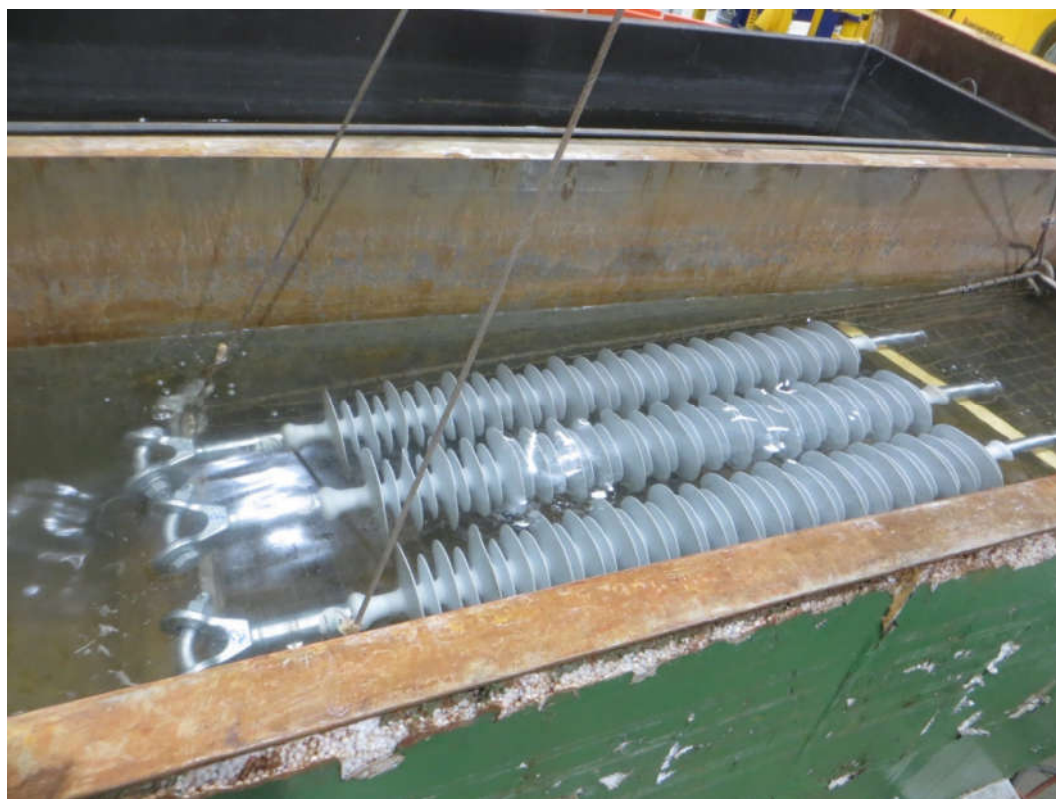
Figure 5
Test specimens after the voltage test – water diffusion test

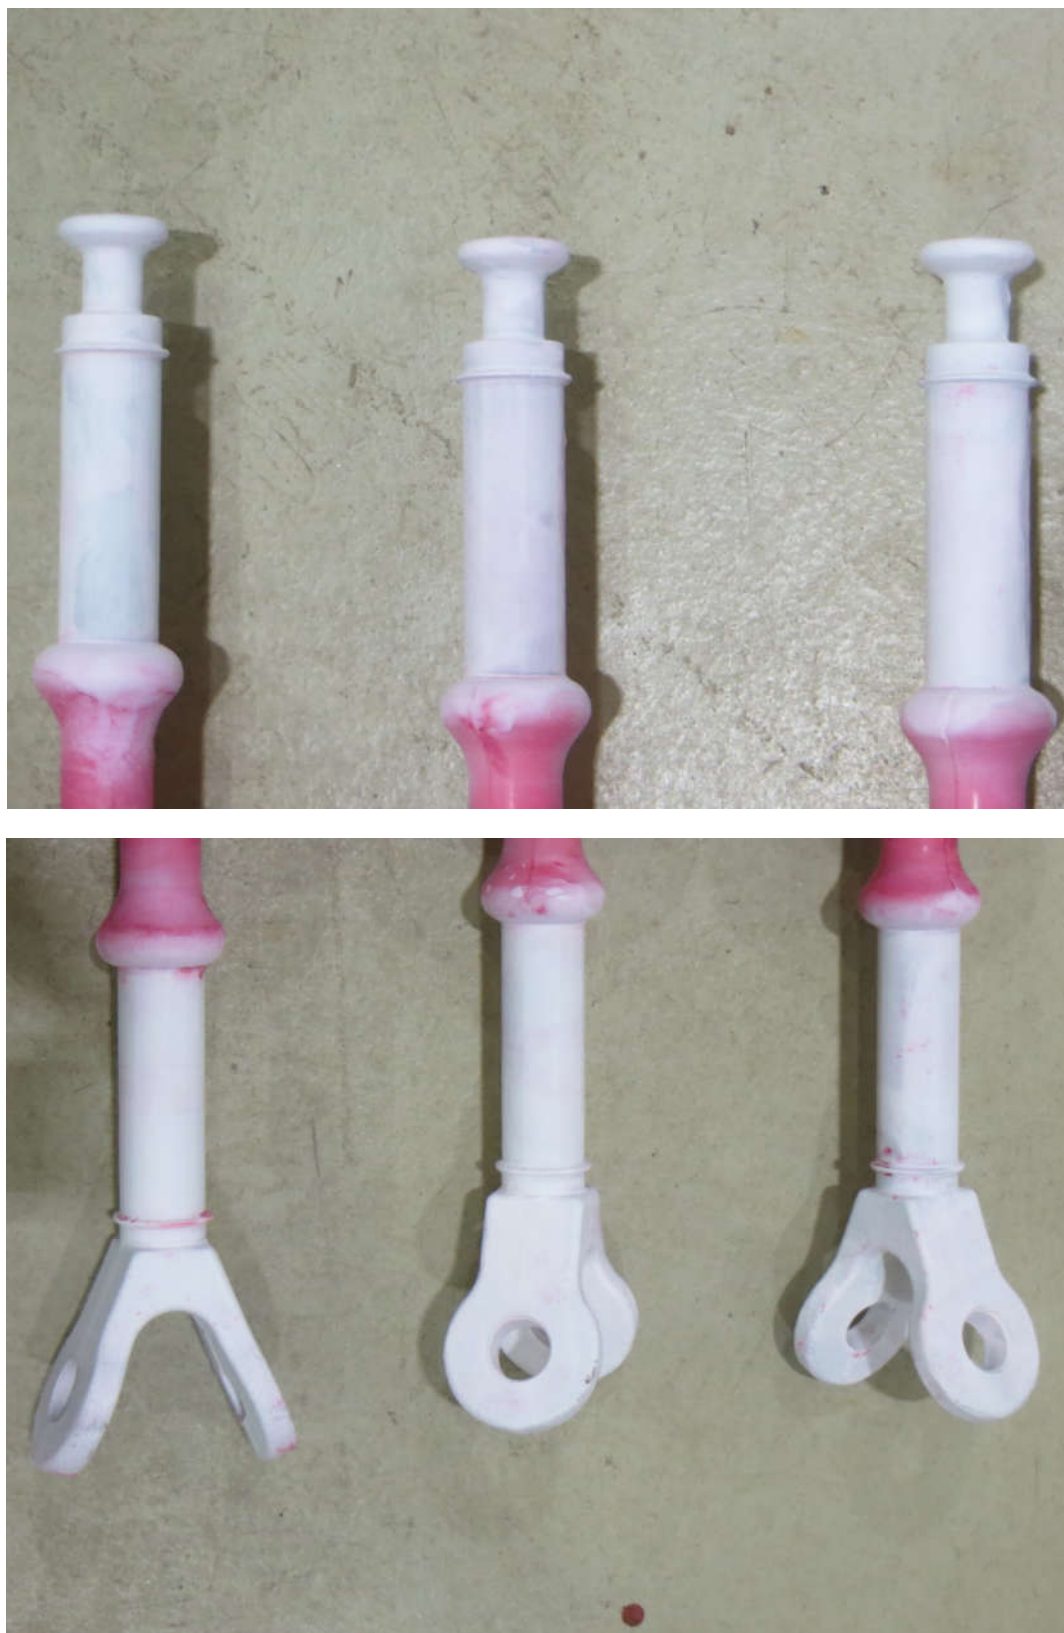
Figure 14

Test samples No. 1, 2 and 3 during diagnostic testing of the fittings, thermal-mechanical test

Dye penetration test of metal end fittings were carried out according to CSA C411.4-16, clause 5.7.3.1 c). Both ends of insulators were subjected to the dye penetration test. After the penetration test the test specimens were inspected. The insulators after the dye penetration test are shown in Figures 14 and 15.

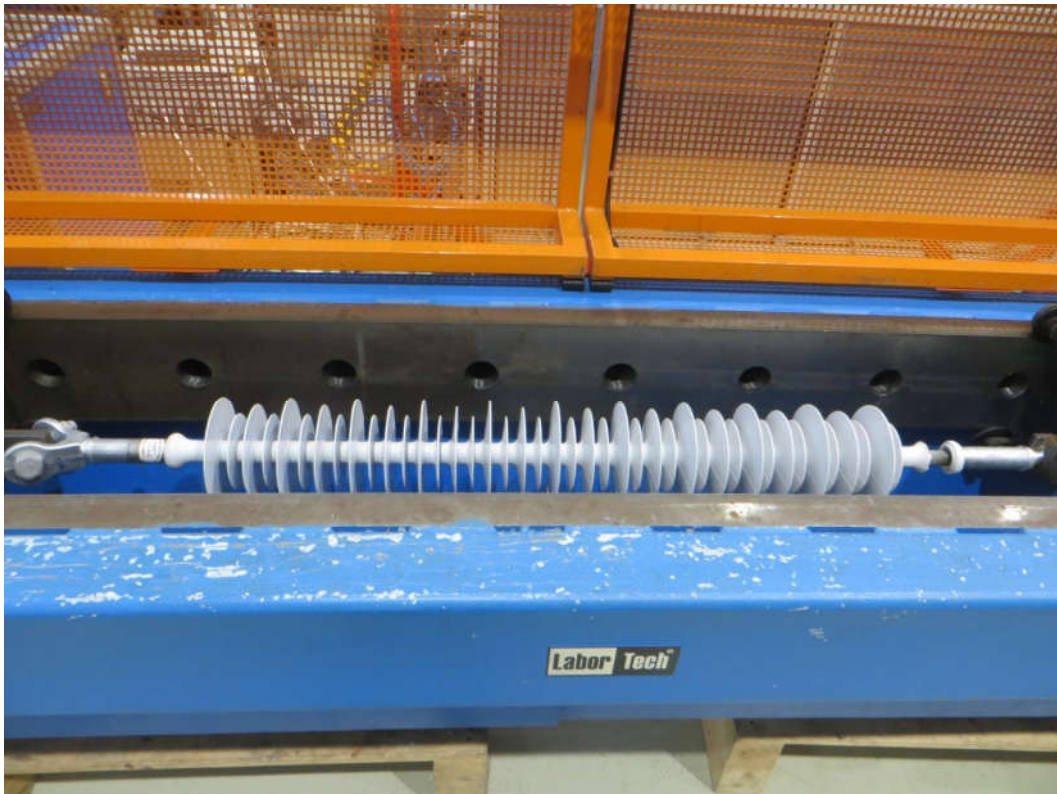
Figure 16
Test sample No. 1, after the mechanical failing load test, assembled core load-time test

The samples after mechanical failing load test are shown in Figure 16, 17, 18 and 19.

Test sample No.	Type of failure	Composite insulator failing load (kN)
1	Pull out of the core from the end fitting	296,9
2	Pull out of the core from the end fitting	309,8
3	Pull out of the core from the end fitting	263,0
Average of the failing load		289,0
60 % of average of the failing load		173,9

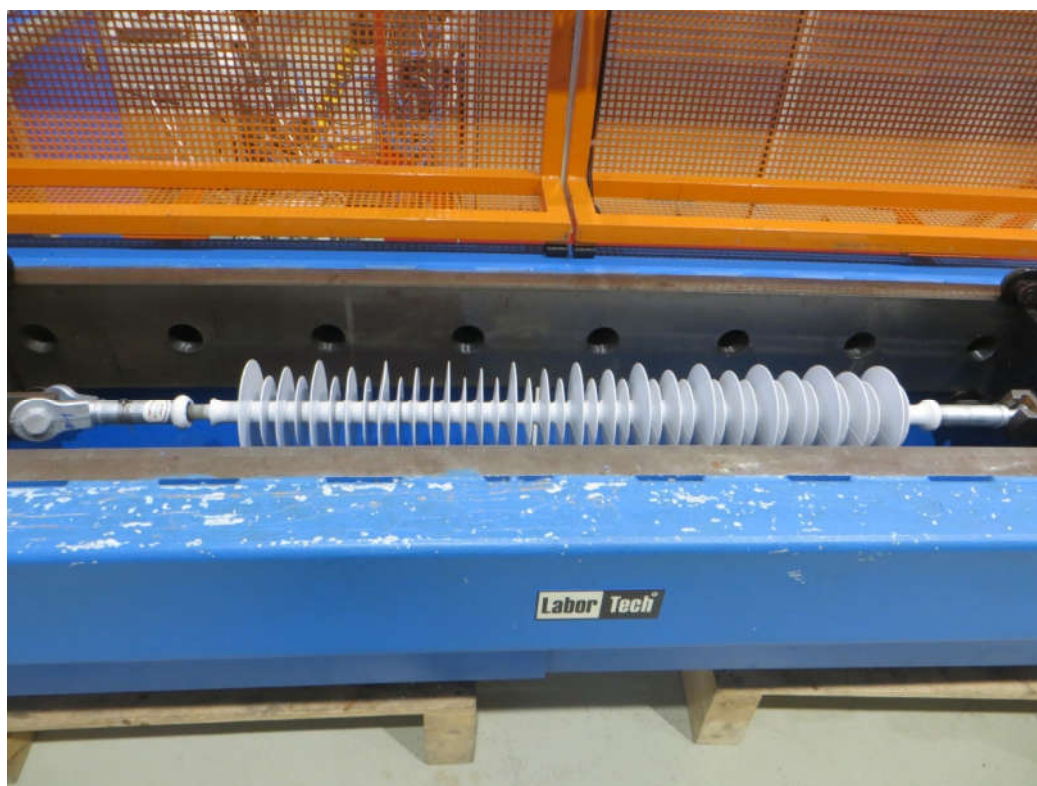
Figure 23
Test samples No. 1, 2, 3 and 4 during the verification of the 96 hours mechanical load test,
mechanical load-time test

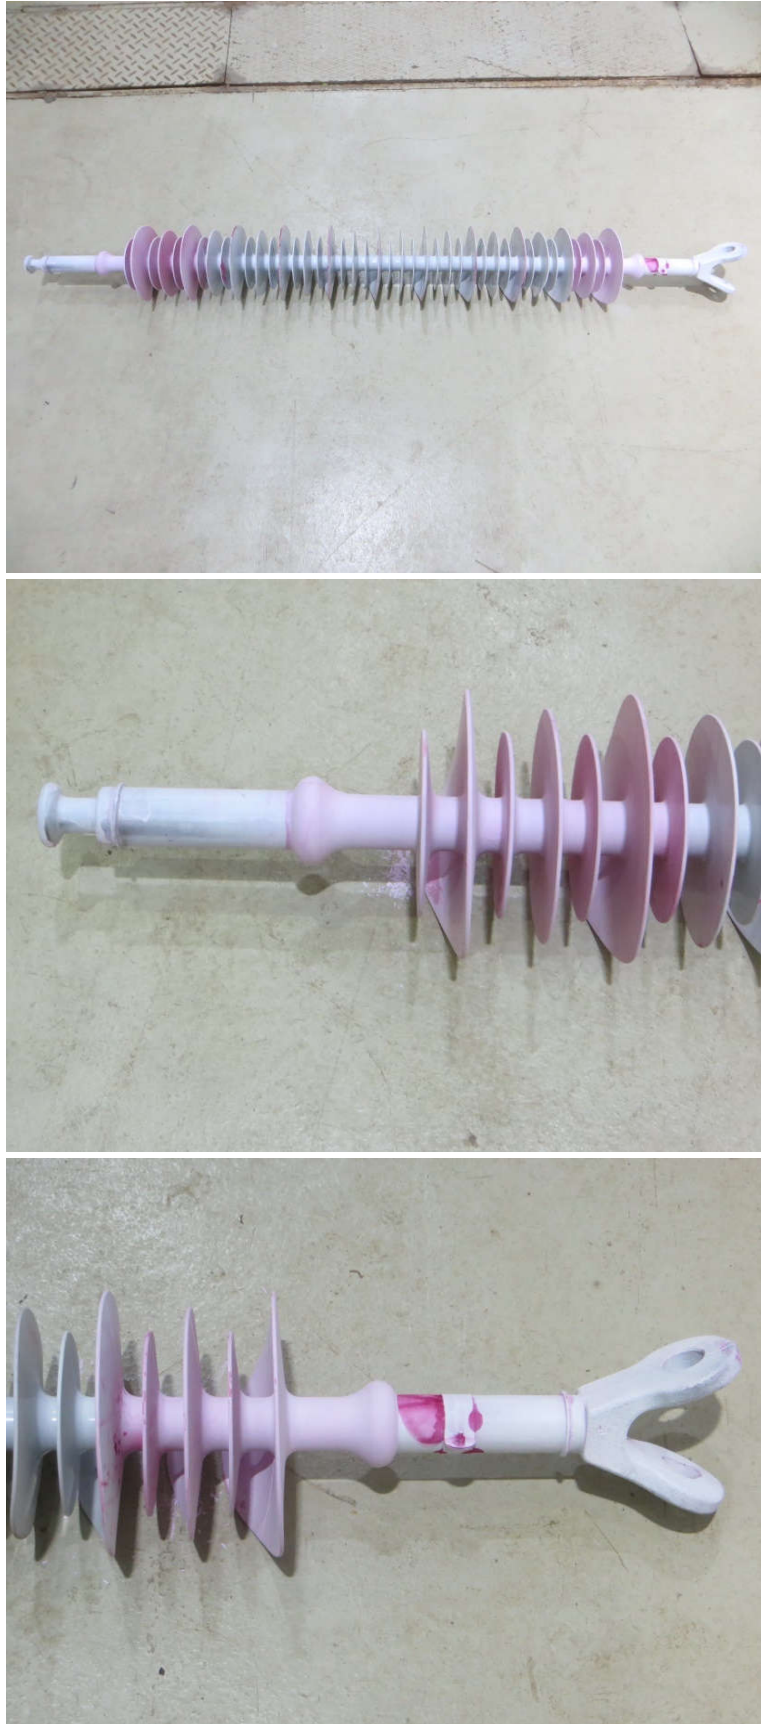
Figure 26
Test sample No. 3 after the mechanical failing load test, mechanical load-time test

Three remaining insulators No. 1, 2 and 3 were then again subjected to the tensile load applied between the couplings. The tensile load was increased rapidly but smoothly from zero approximately to 167 kN (75 % of SML) and then gradually increased in a time between 30 s to 90 s to 222 kN (100 % of SML). The load was sustained for the 60 s. Then the load was increased up to the failure of the insulator. Record of applied tensile load during testing are shown in Graphs 14, 15 and 16. The insulators after the failing load tests are shown in Figures 24, 25 26 and 28.

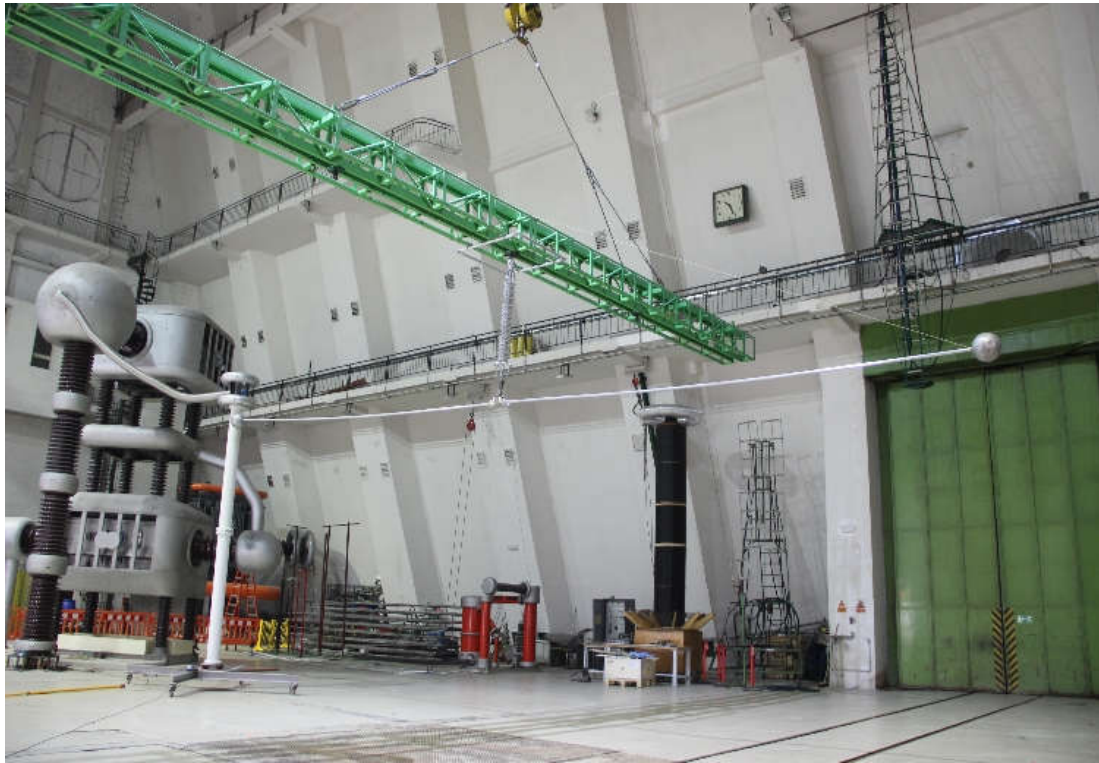
Figure 2
Test arrangement for RIV and corona tests

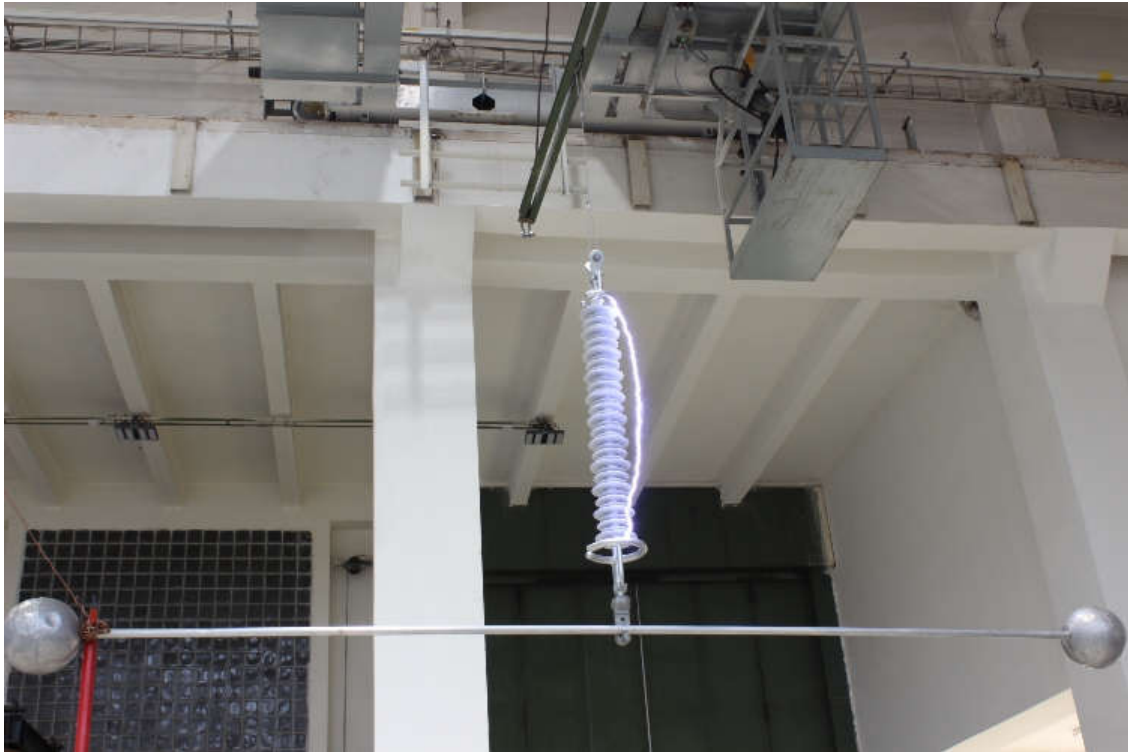
Figure 6
Test arrangement and flashover under the critical impulse flashover test

Test sample No.	1		2		3	
Impulse polarity	+	–	+	–	+	–
Atm. conditions:						
air pressure (kPa)	100,0	100,0	99,9	99,9	100,0	100,0
air temperature (°C)	17,0	17,0	16,5	16,5	16,7	16,7
relative humidity (%)	28,1	28,1	28,2	28,2	28,9	28,9
Correction factors:						
air density correction factor k_1	0,997	0,997	0,998	0,998	0,998	0,998
humidity correction factor k_2	0,947	0,958	0,948	0,956	0,949	0,954
atmospheric correction factor K_t	0,945	0,955	0,946	0,955	0,948	0,953
Critical impulse flashover voltage (kV)	744	782	748	779	750	767
Polarity	+			-		
Average critical impulse flashover value of the three insulators (kV)	747			776		
Measured arcing distance: 1 151 mm						
Drawing specified critical impulse flashover voltage: 780 kV						
CSA C411.-16, Table 2 specified critical impulse flashover voltage: 780 kV

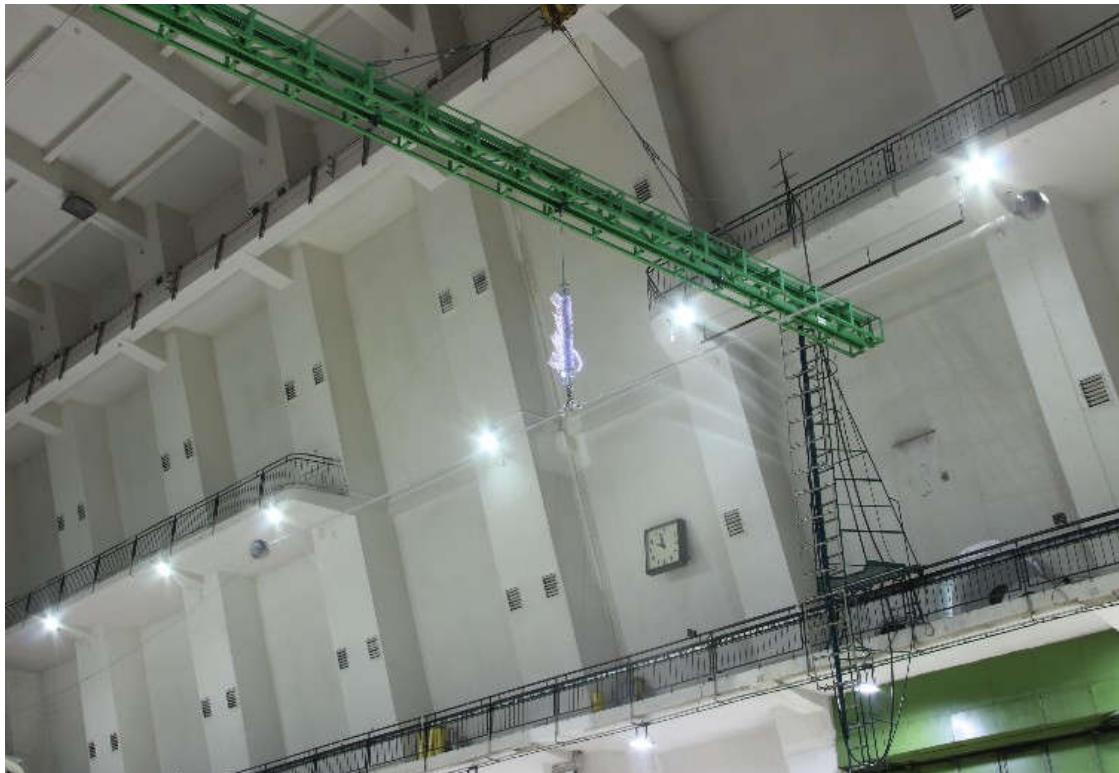
Figure 7
Test arrangement and flashover under the wet power frequency voltage flashover test

Test sample No.	1	2	3
Atm. conditions:			
air pressure (kPa)	98,8	98,8	98,8
air temperature (°C)	16,0	16,0	16,0
relative humidity (%)	45,1	45,1	45,1
Rain parameters:			
vertical (mm/min)	1,6	1,6	1,6
horizontal (mm/min)	1,2	1,2	1,2
Conductivity (μS/cm)	100	100	100
Correction factors:			
air density correction factor k ₁	0,989	0,989	0,989
humidity correction factor k ₂	1,000	1,000	1,000
atmospheric correction factor K _t	0,989	0,989	0,989
Flashover voltage	392 kV	404 kV	401 kV
The average wet flashover voltage of the three insulators	399 kV		
Measured arcing distance: 1 151 mm			
Drawing specified wet power frequency flashover voltage: 393 kV

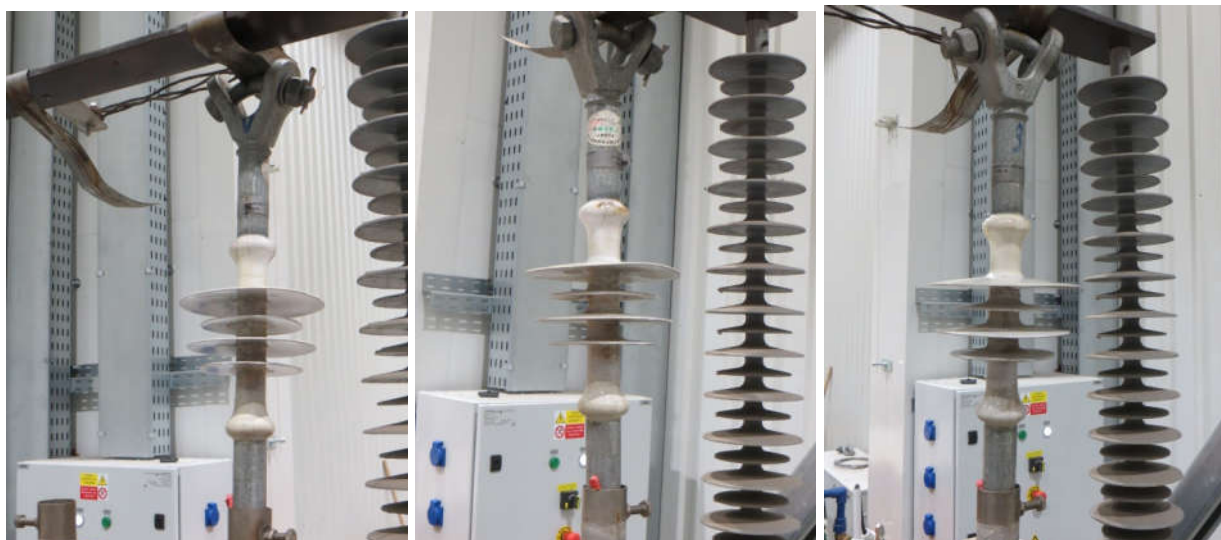
Figure 7
Composite insulator 133 kV, SML 222 kN, test samples No. 1, 2 and 3,
before start of the tracking end erosion test

The test arrangement of the tracking and erosion test before start is shown in Figure 7. Test samples after tracking and erosion test are shown in Figure 8, 9, 10, 11 and 12.

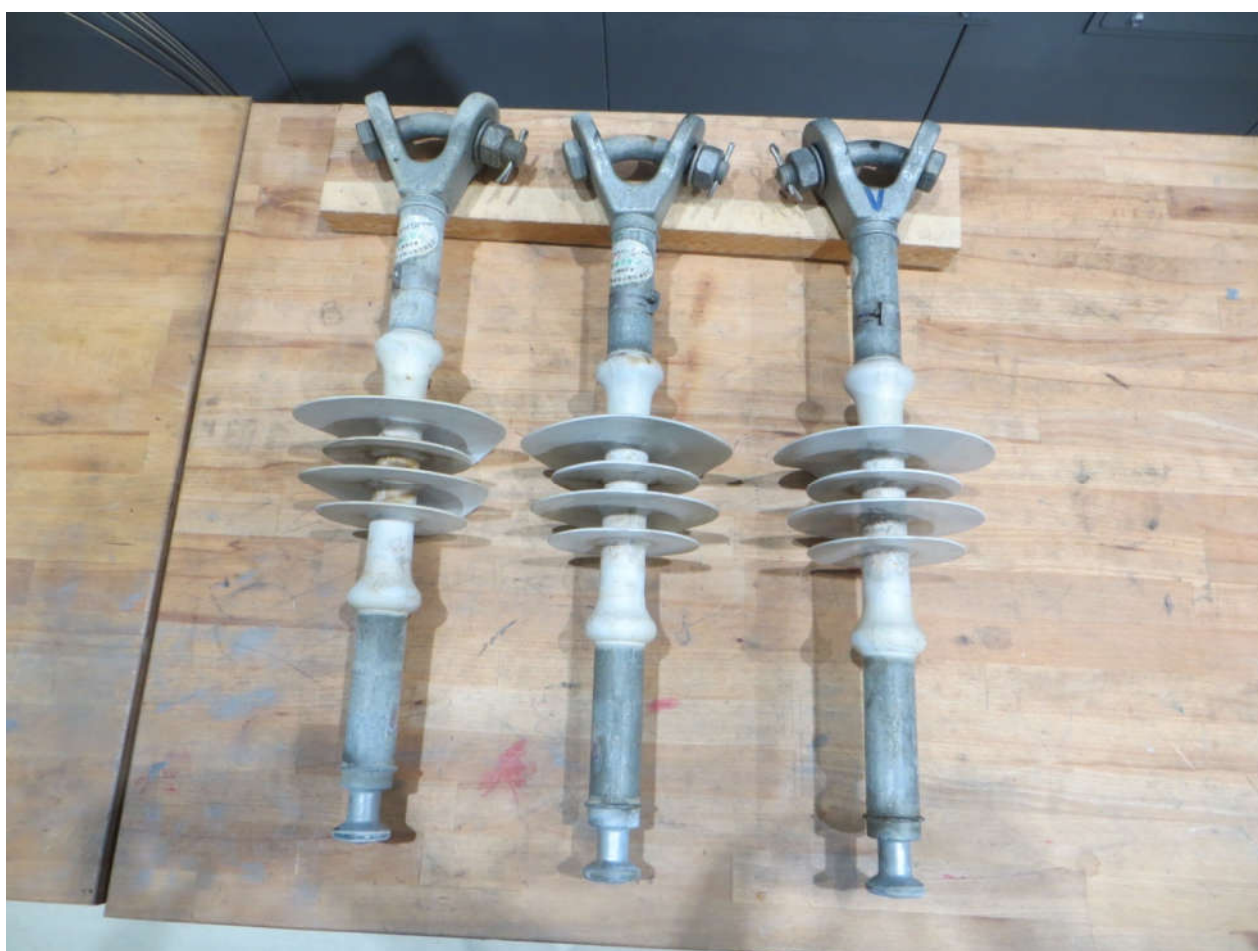
Figure 8
Composite insulator 133 kV, SML 222 kN, test samples No. 1, 2 and 3,
after tracking end erosion test
