TEST REPORT 12206/B/23

138 kV Composite line insulator

138 kV / 111 kN

ANSI C29.12-2020, ANSI C29.11-2020

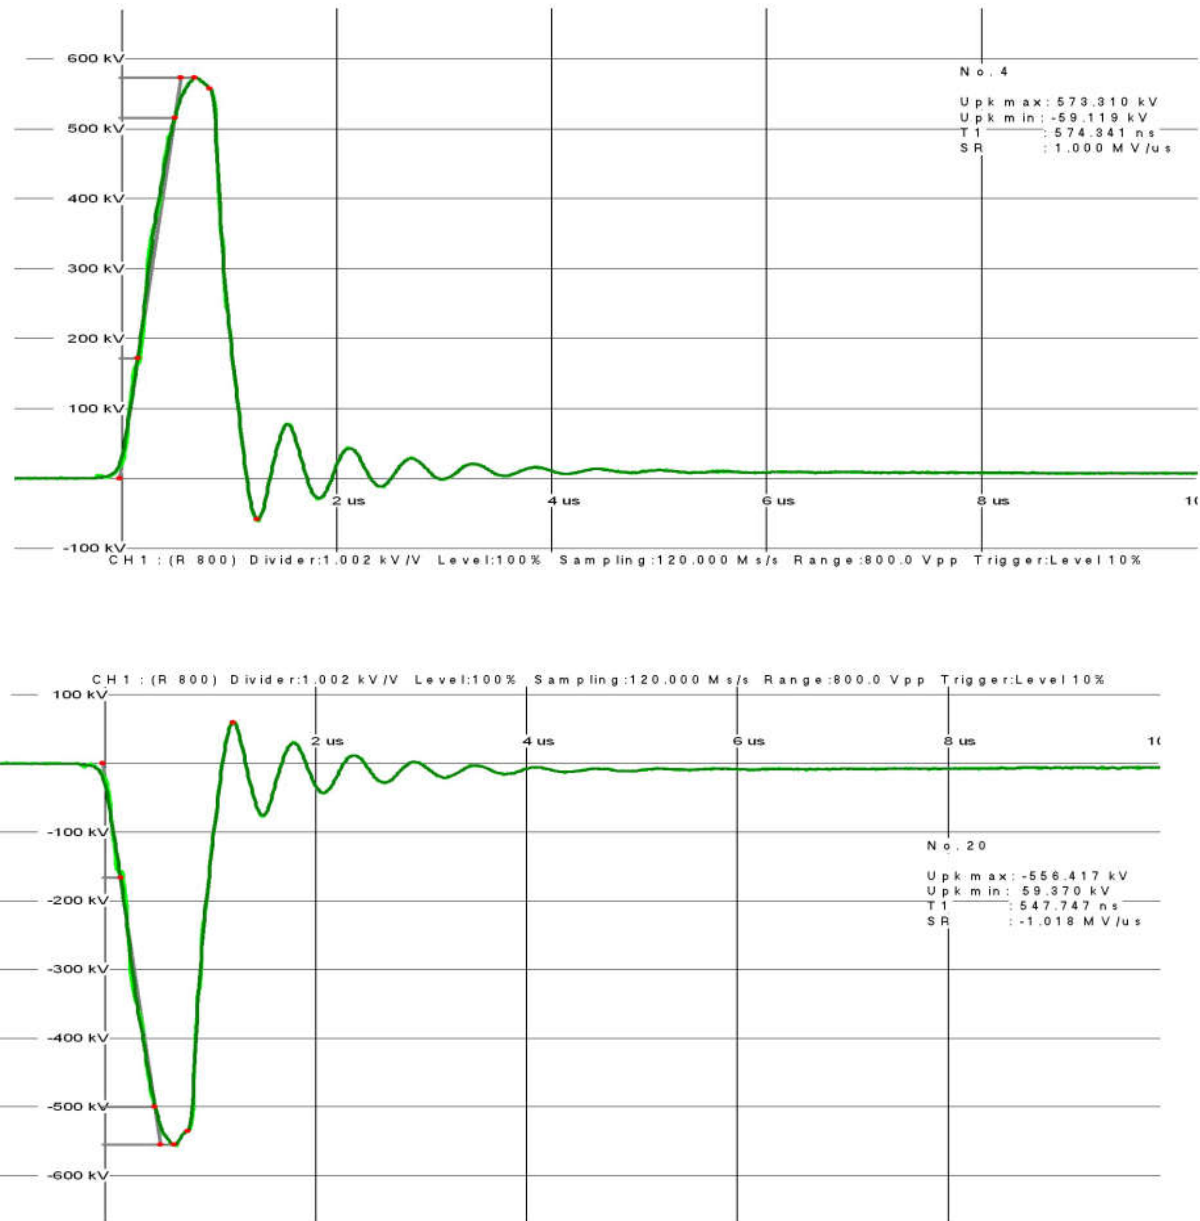
Figure 2 Representative wave shape of the linearly front chopped impulse

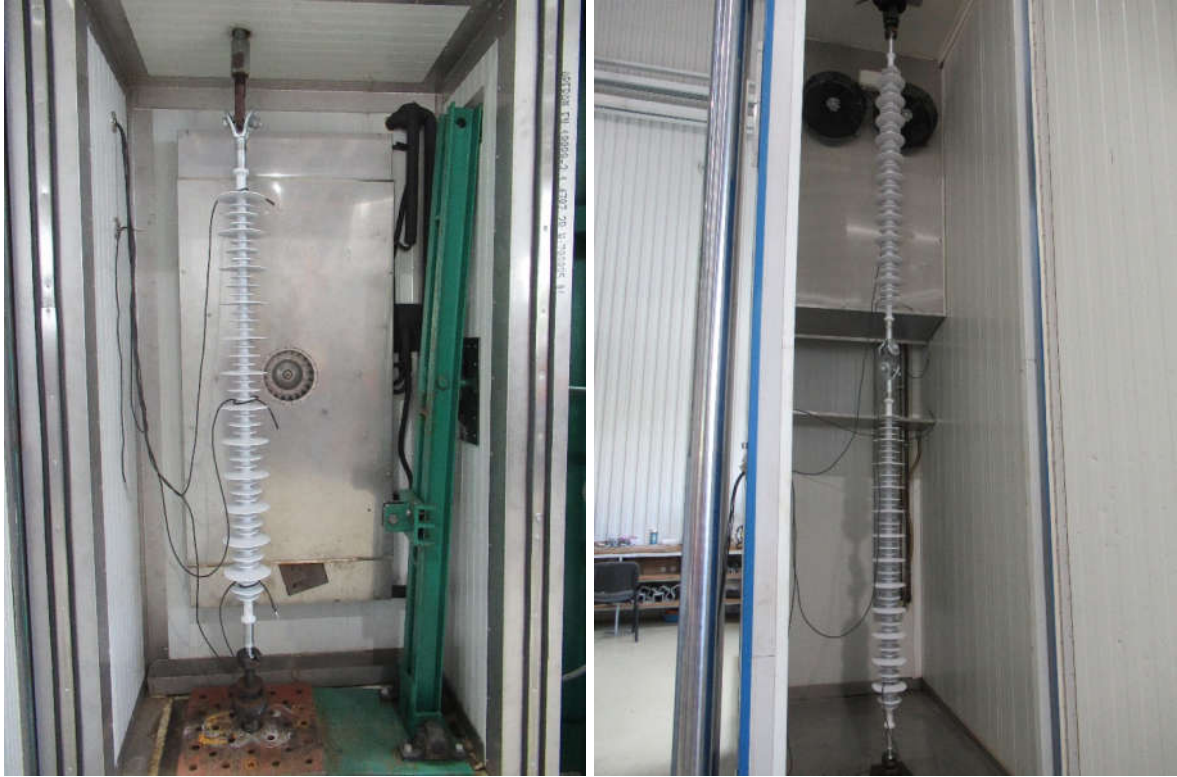
Figure 11 Test samples during thermal mechanical test

Records of measured temperatures and mechanical load during the thermal-mechanical testing are given in Figure 3, Figure 4, Figure 5 and Figure 6. The test arrangement during the thermal-mechanical test on the insulator is shown in Figure 11.

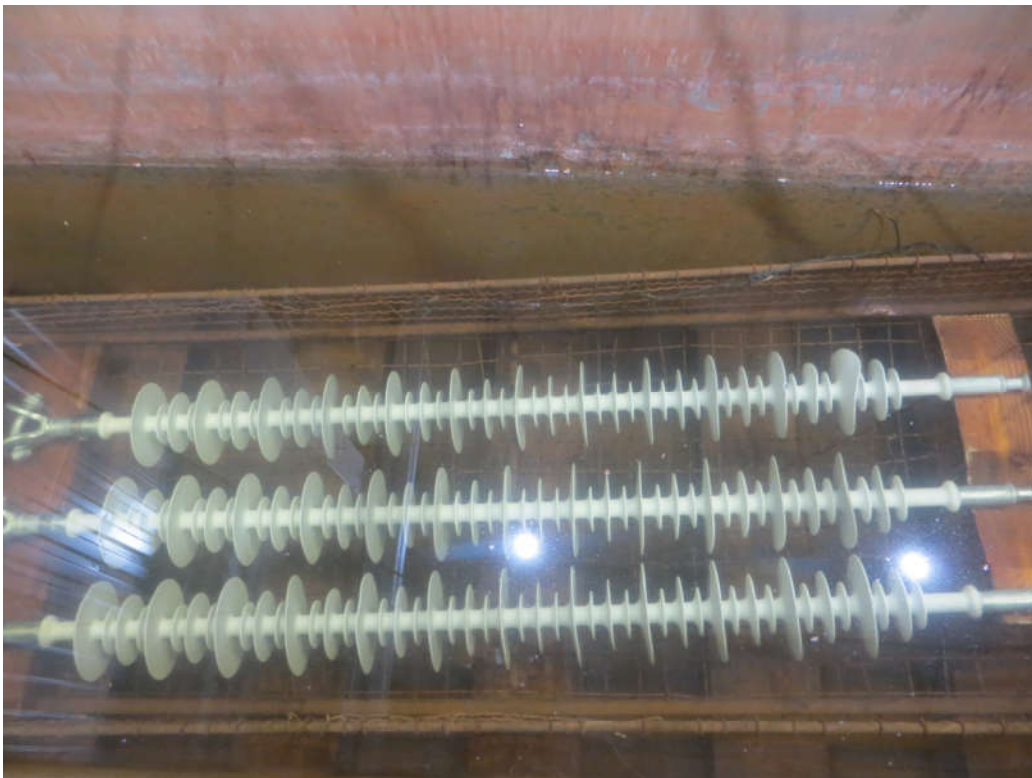
Figure 12 Test samples during water penetration test

Three tested insulators were immersed for 42 hours boiling in water with 0,1% by weight of NaCl. At the end of boiling, the insulators remained immersed until the water cooled to approx. 50 °C and maintained at this temperature until the verification tests started (see Figure 12).

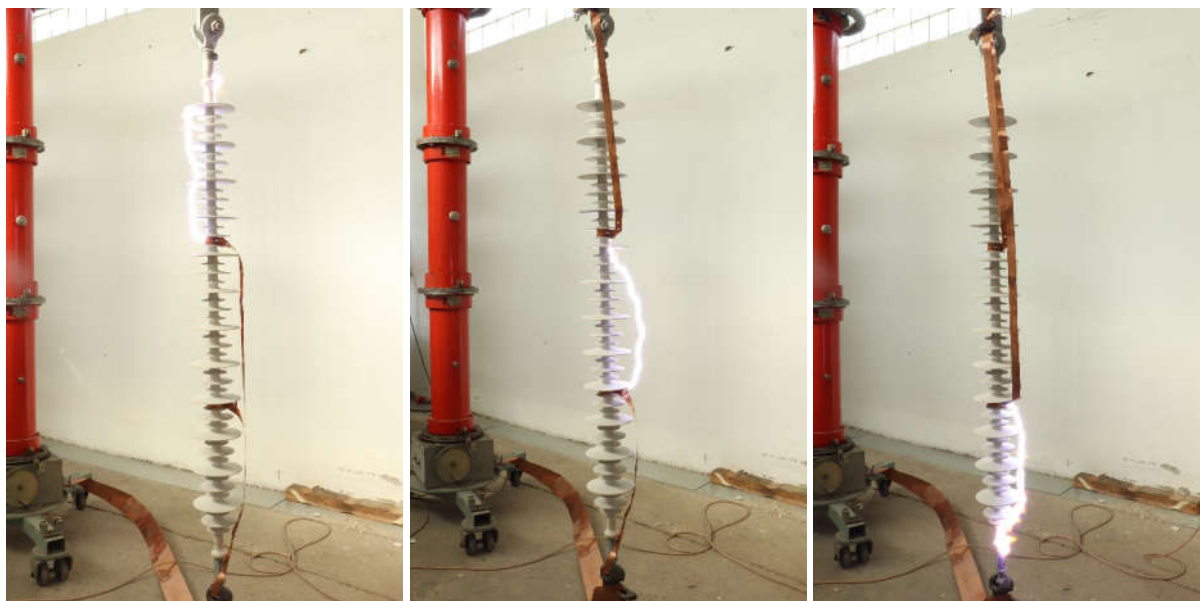
Figure 13 Test sample during the linearly rising front chopped impulse voltage test

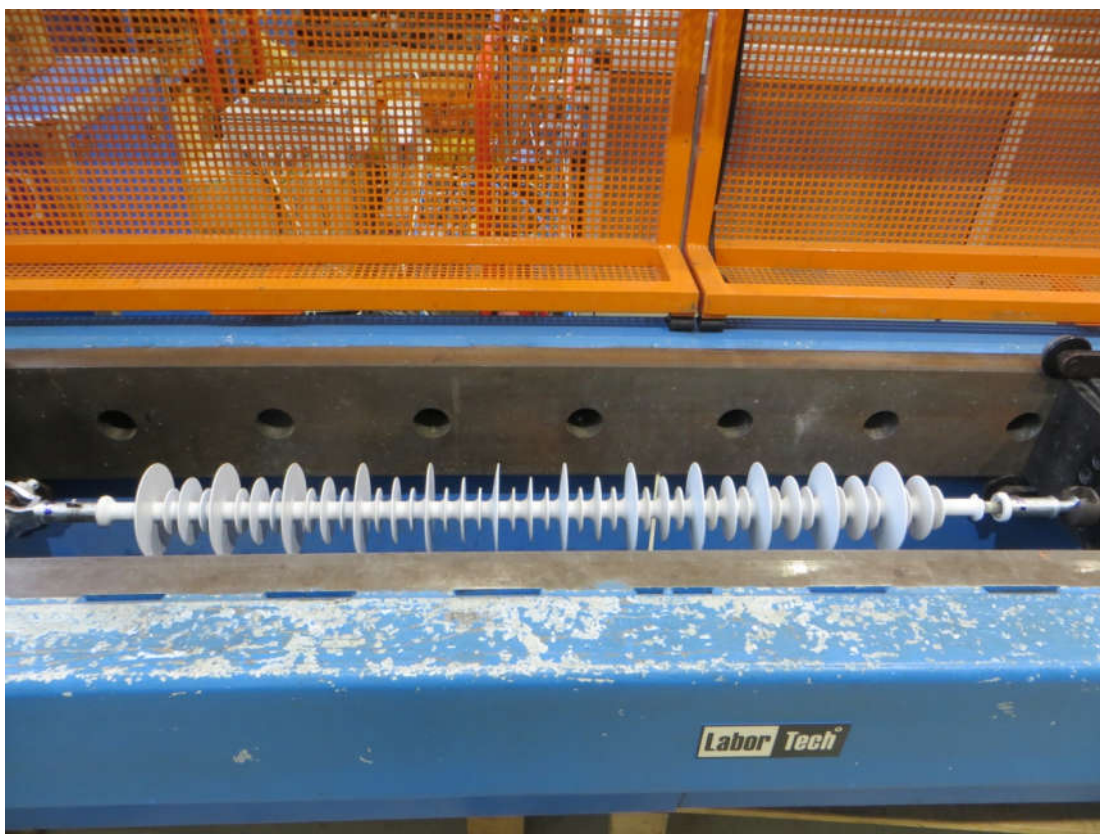
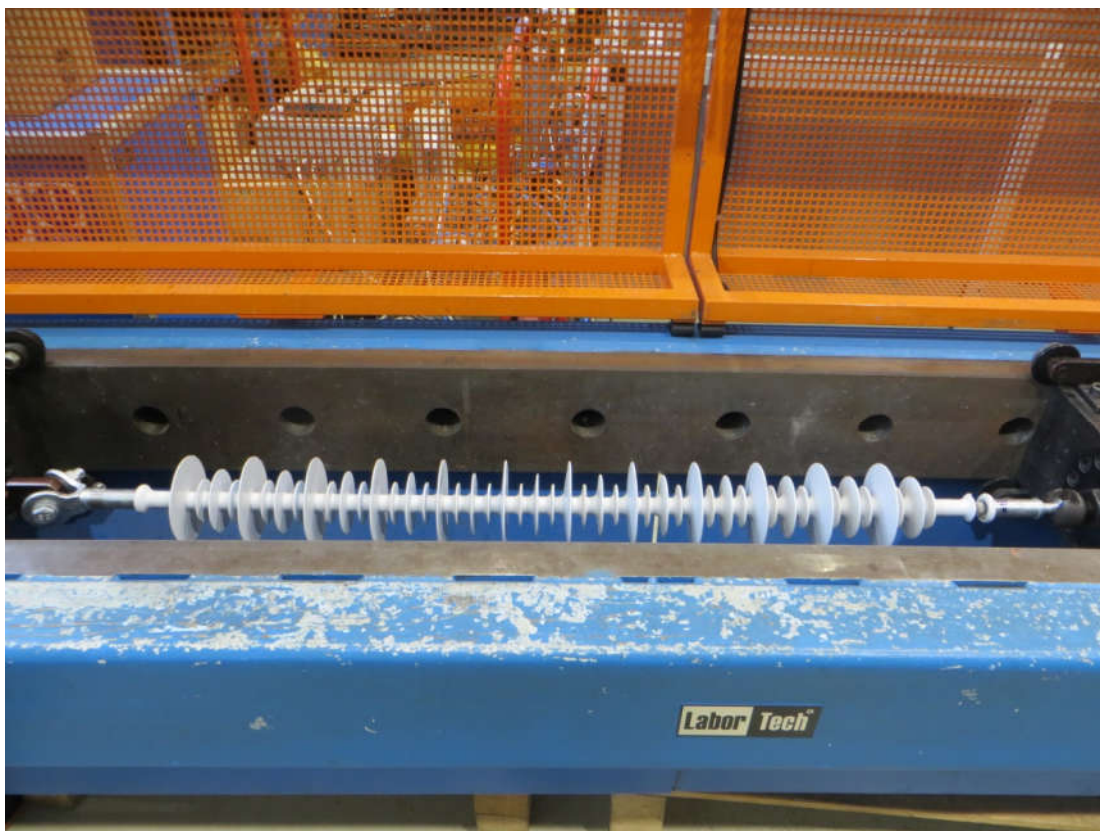
Figure 15 Mechanical failing load test, test sample No. 6

Figure 16 Mechanical failing load test, test sample No. 7

Figure 17 Mechanical failing load test, test sample No. 8

Figure 18 Test samples No. 6, 7 and 8 after mechanical failing load test

Test was carried out according to ANSI C29.11, clause 7.2.1.2. Three insulators No. 6, 7 and 8 were subjected to tensile load applied between couplings. The tensile load was increased rapidly but smoothly from zero to approximately 75 % of expected mechanical failing load and then gradually increased in a time between 30 s to 90 s until breakage of the core or complete pull-out occurs (see Figure 15, Figure 16, Figure 17 and Figure 18). The average of the three failing loads was calculated.

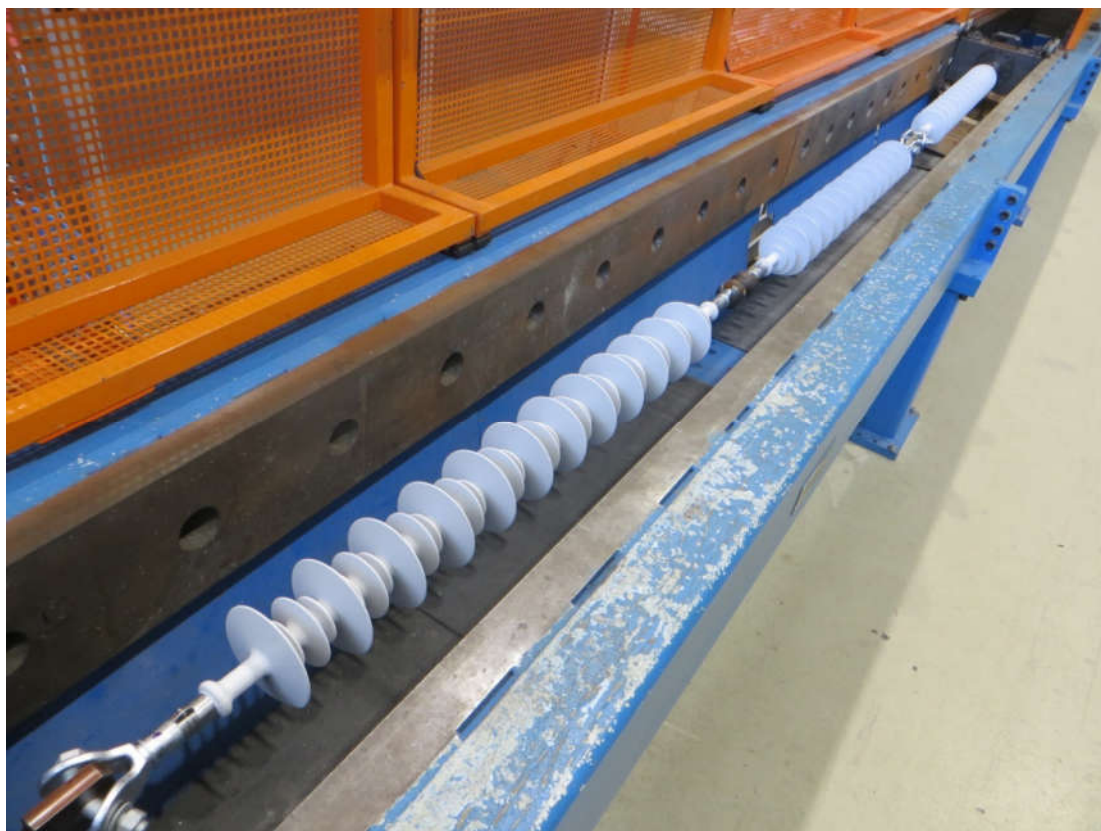
Figure 19 Withstand tensile load test, test samples No. 9, 10 and 11

Test was carried out according to ANSI C29.11, clause 7.2.1.3. Three insulators No. 9, 10 and 11 were subjected to a tensile load applied between couplings. The tensile load was increased rapidly but smoothly, from zero up to 60 % of the average failing load and then maintained at this value for 96 hours.

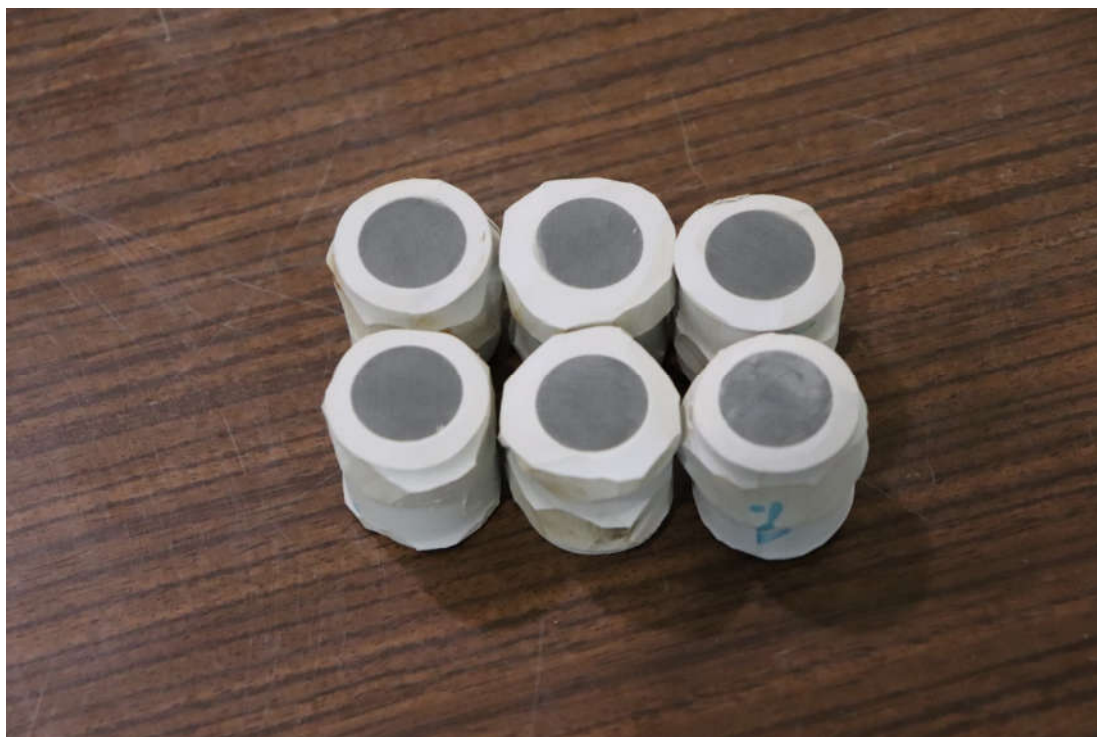
Figure 21 Test specimens, water diffusion test

Figure 22 Test specimens during the voltage test (water diffusion test)

No puncture or external flashover occurred. The leakage current did not exceed maximum allowable current of 1 mA (r.m.s.).

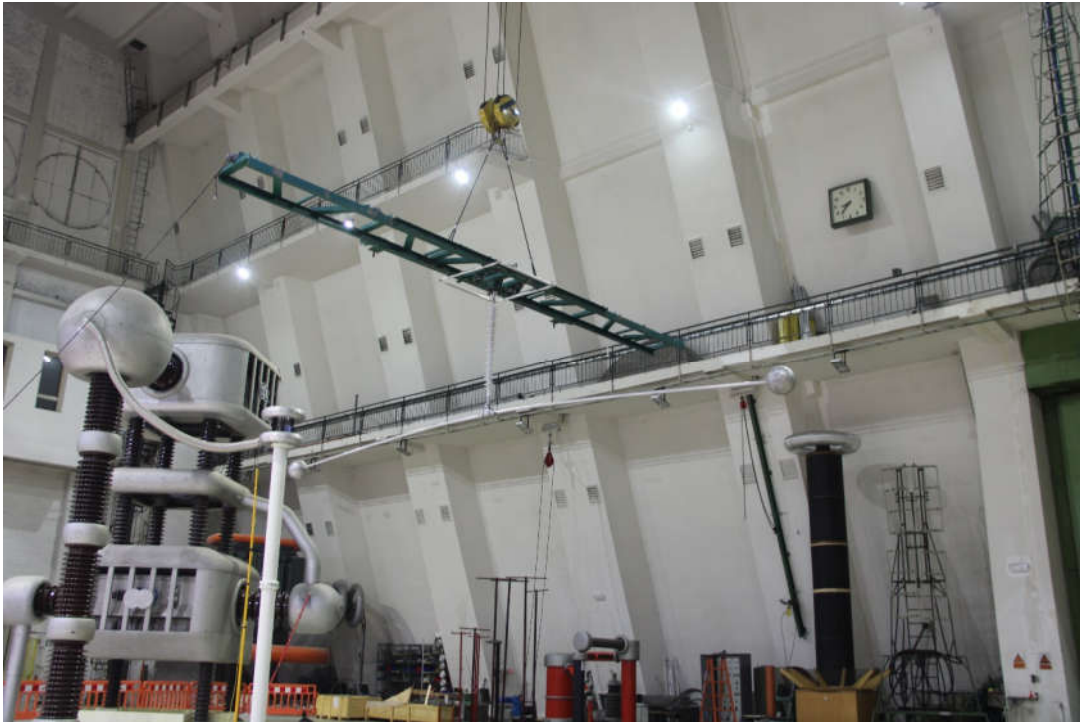
Figure 3 Test arrangement under the radio – influence voltage test

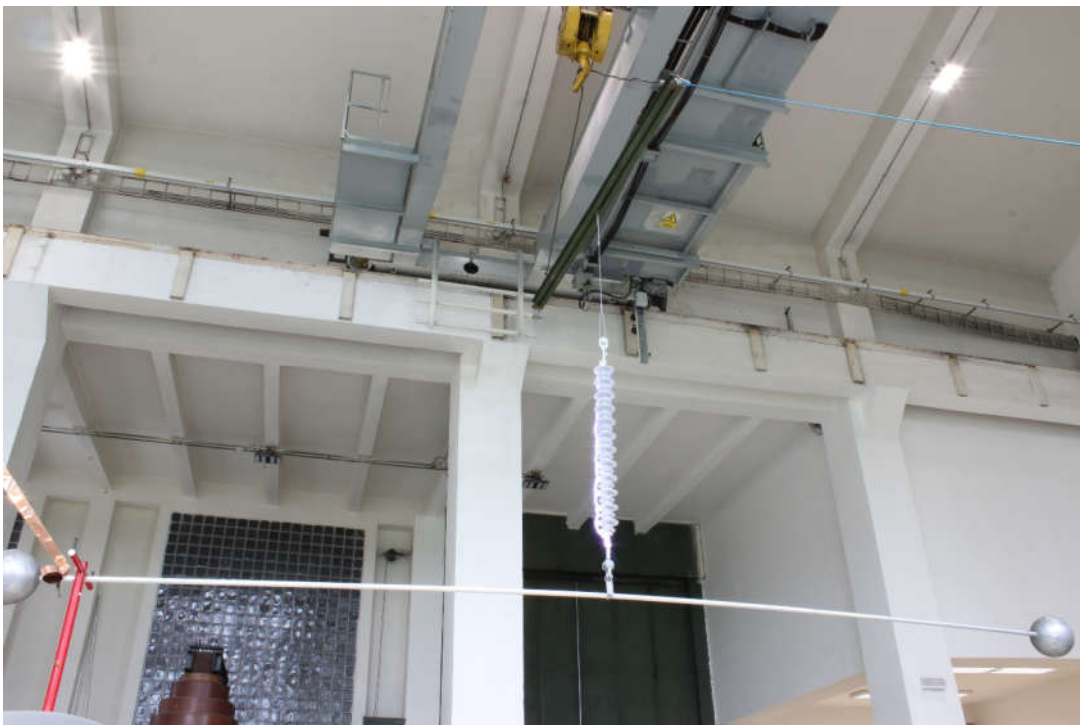
Figure 4 Test arrangement and flashover under the critical impulse flashover test

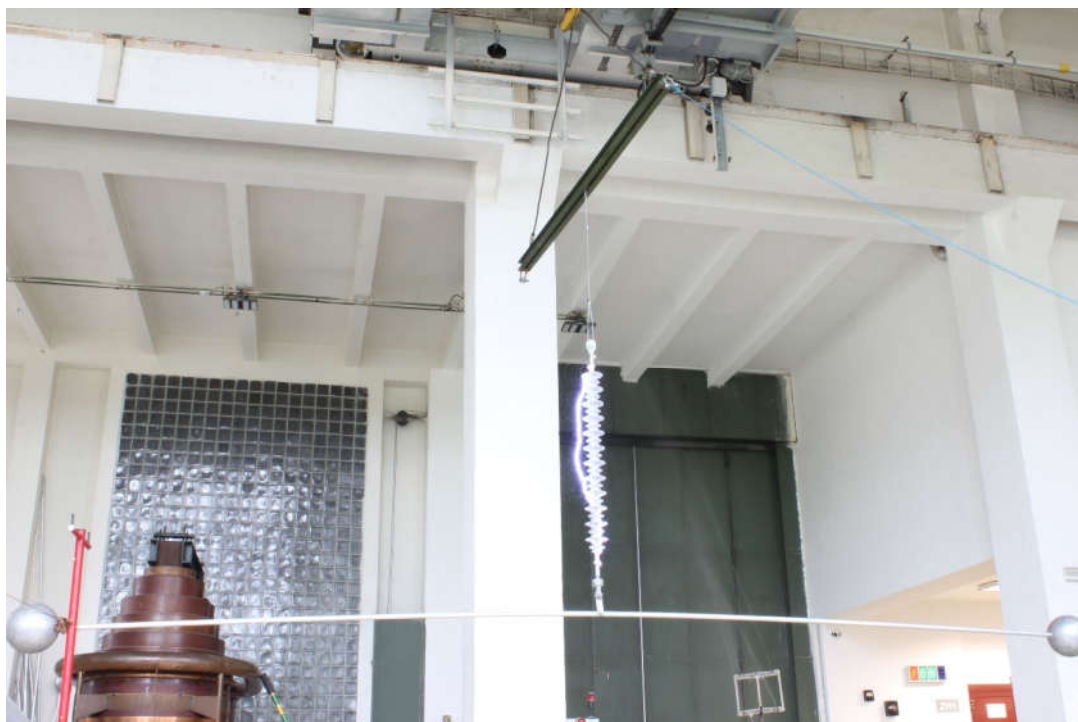
Figure 5 Test arrangement and flashover under the low-frequency wet flashover test

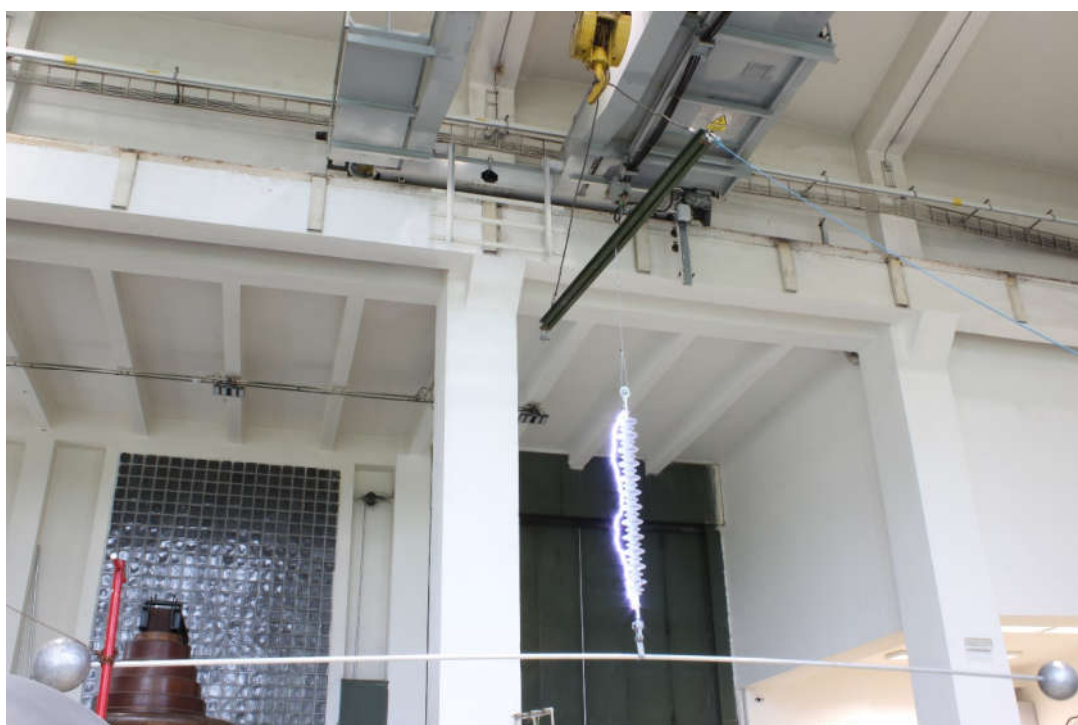
Figure 6 Test arrangement and flashover under the low-frequency dry flashover test

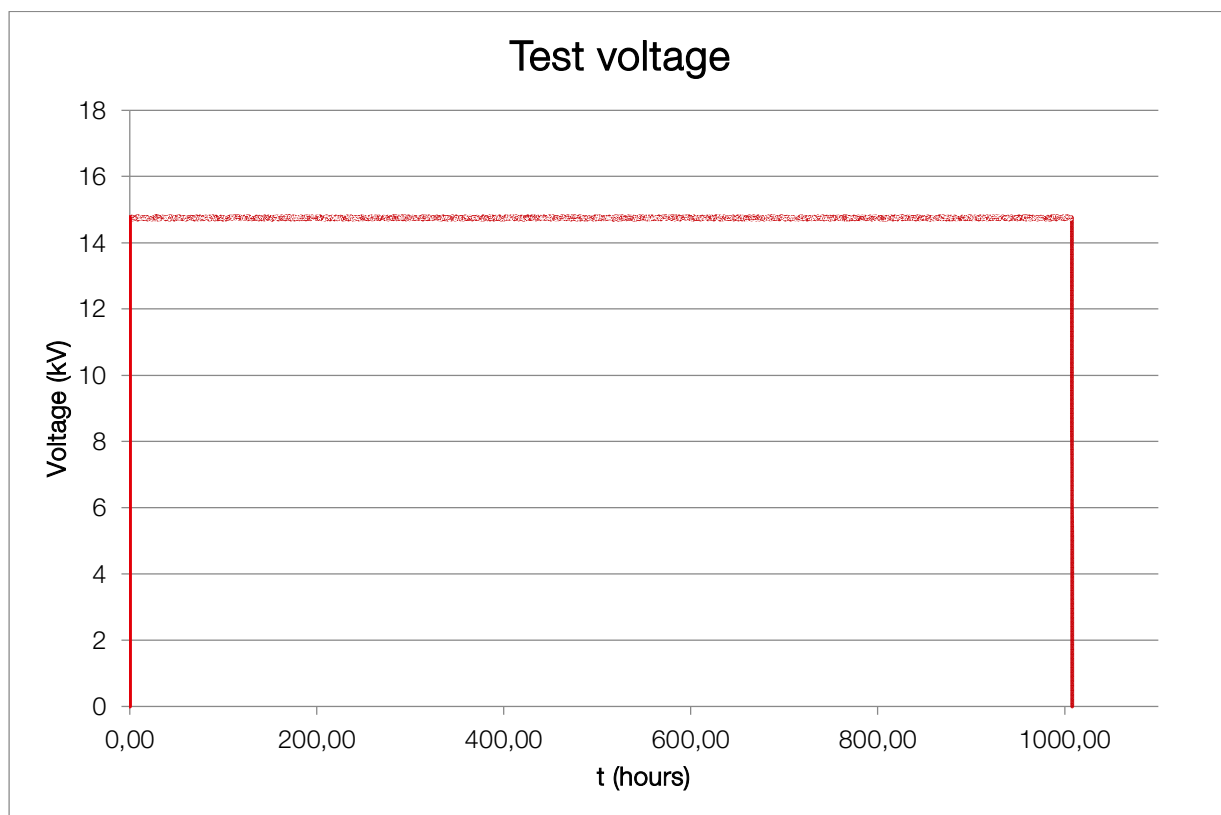
Figure 2 Record of the test voltage during the housing tracking and erosion test

Test conditions: Test conditions are according to ANSI C29.11, clause 7.3.3. Ambient temperature within the duration of the 1000h test is 20 °C ±5 K. Weekly interruptions of the test for inspection purposes shall not exceed 1 h. The interruptions are not counted in test duration.

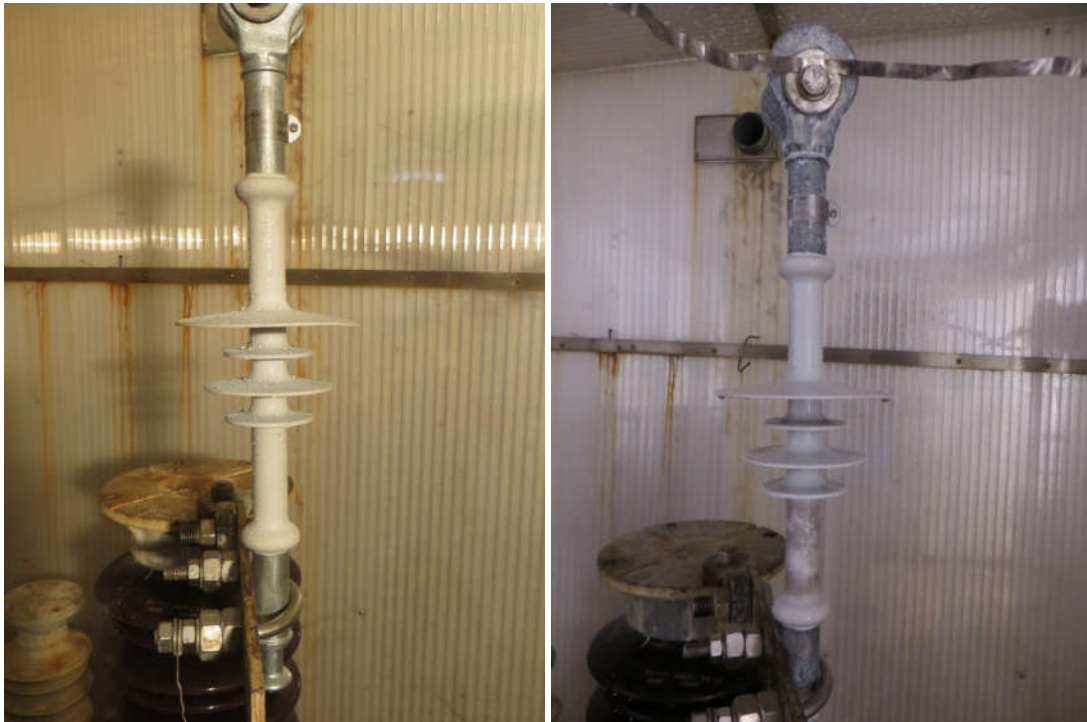
Figure 3 Test sample in vertical test position, before and after housing tracking and erosion test

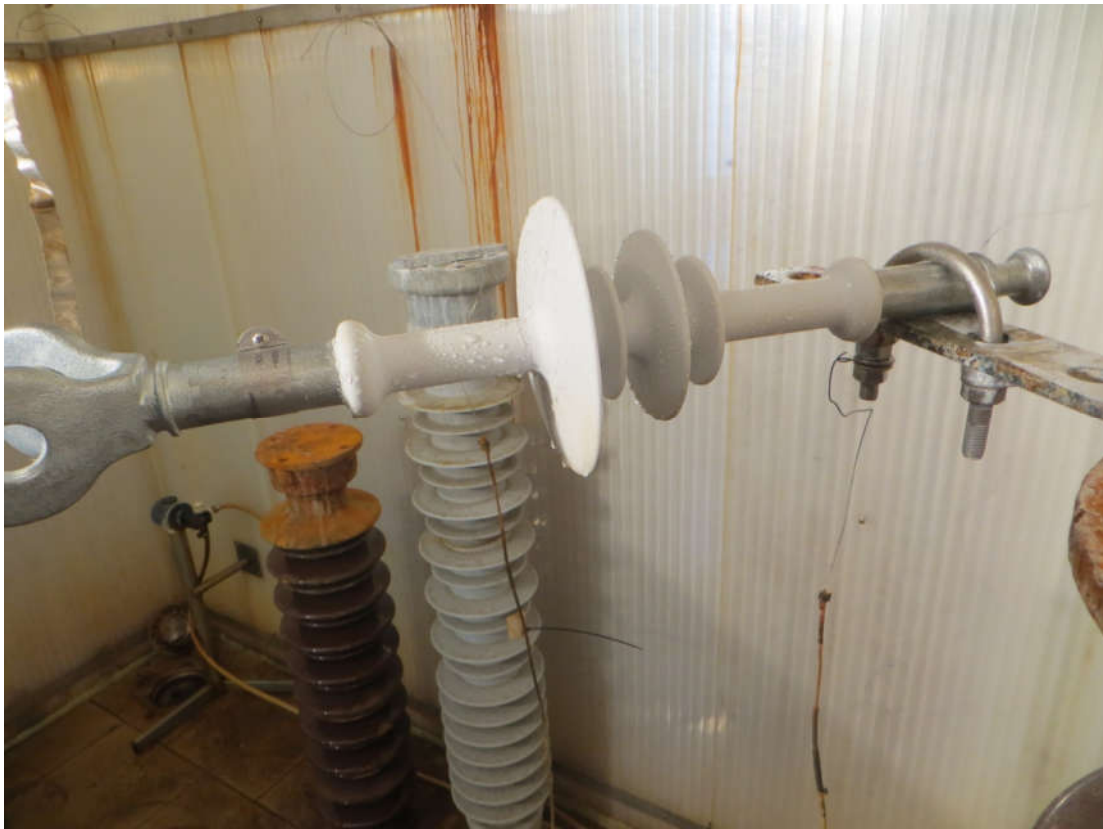
Figure 4 Test sample in horizontal test position, before housing tracking and erosion test

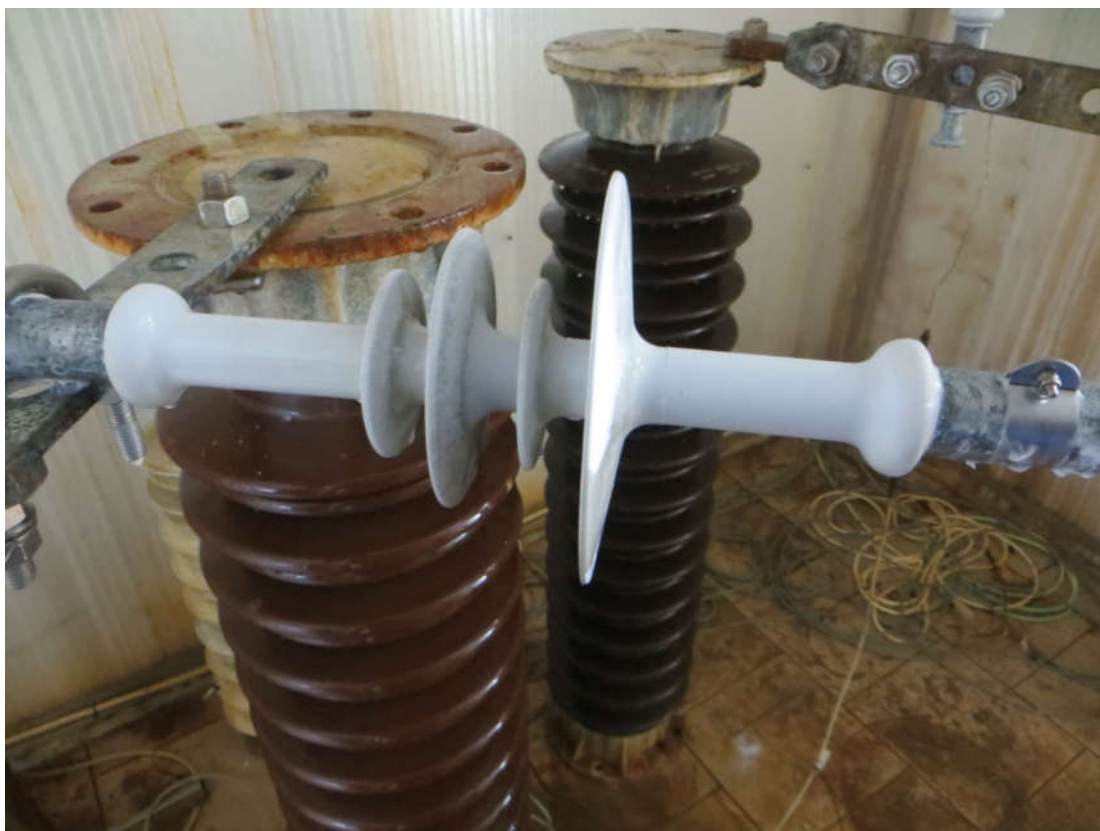
Figure 5 Test sample in horizontal test position, after housing tracking and erosion test
