TEST REPORT No.: 11788/L/21

TEST OBJECT: 500 kV Composite insulator

TYPE SPECIFICATION: SML 222 kN

5051-22

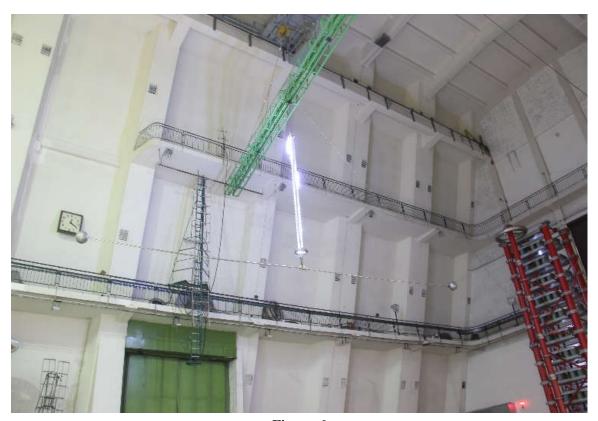
Figure 6
Test arrangement and flashover under the critical impulse flashover test

The test arrangement was set up in compliance with IEC 60383-1, clause 34 (see Figure 6).

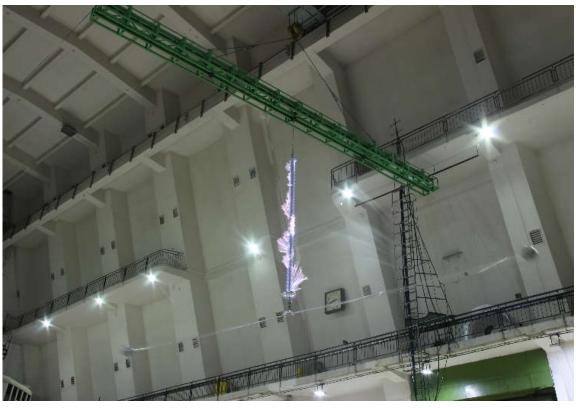
Figure 7
Test arrangement and flashover under the wet power frequency voltage flashover test

The test arrangement was set up in compliance with IEC 60383-1, clause 34 (see Figure 7).

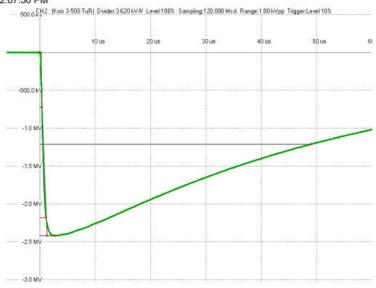
Upk : 2.213 MV T1 : 1.490 us T2 : 49.727 us

Upk : -2.418 MV T1 : 1.286 us T2 : 49.035 us

Graph 1 Representative wave shape of the lightning impulse 1,2/50 μs

The representative wave shape of the lightning impulse 1,2/50 µs is given Graph 1.

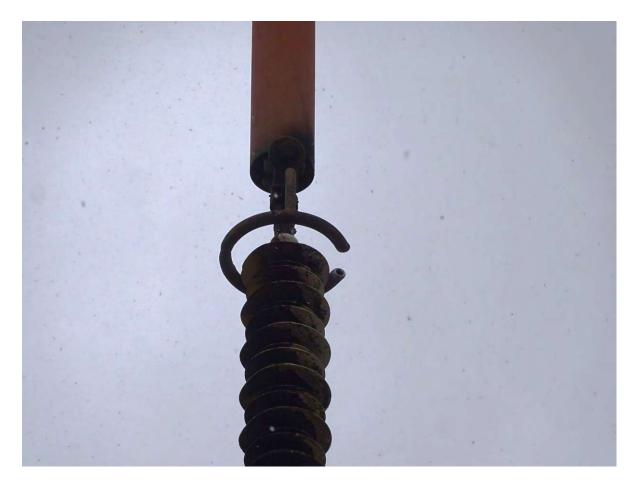
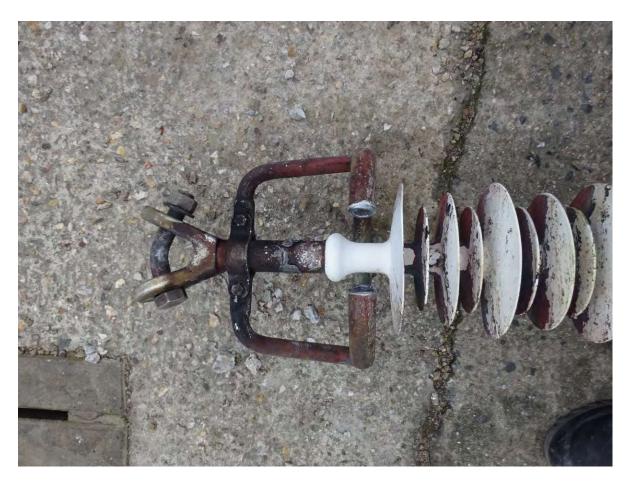
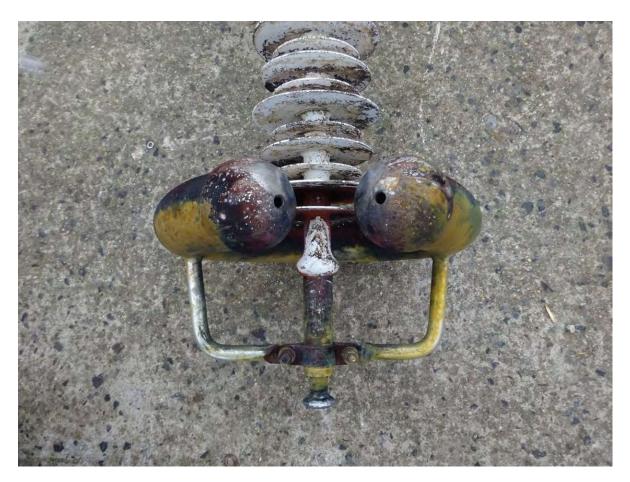
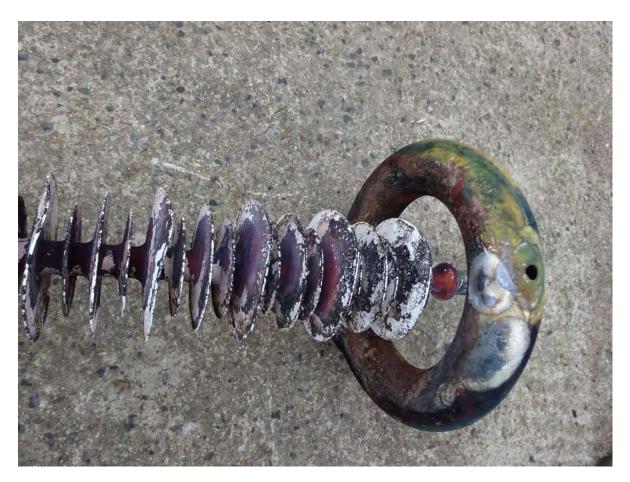
No housing damage, no exposure of the fiberglass core. Discoloration and burning of the surface.

Partial melting and arc puddling; galvanized coating damaged; burning on the surface.

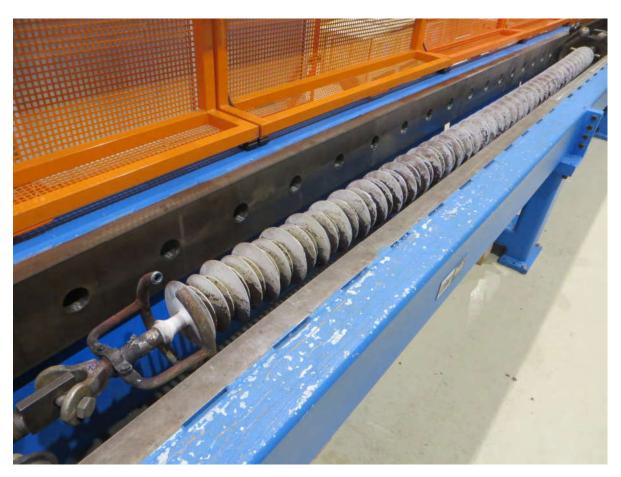
8.2 Photographs before tests

Insulator unit in same condition.

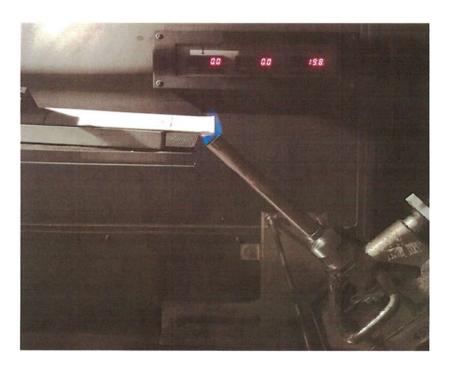
Photo of the position of the test specimen during the test:

Test re	2000	o. 59/20)22/EN	
Test standard:	ČSN EN 6069	95-11-10 ed	. 2: 2014		
Test equipment:	Chamber At	las HVUL2			
	Burner with an inner diameter 9.5 mm				
Ignition source:	The gas used	d: Methane	2.5		
	Blue flame h	Blue flame height 20 mm, the exposure time 30s			
Test conditions:	No forced ve	entilation w	as used durir	ng the test	
	Temperatur		22,0 - 23,0°	-	48,0 - 49,0%
Description of the sample (sample type, the color, the location in the product, the number of samples tested):			70 56	x3mm, 3 pieces	
Conditioning of samples:	48 hours at	23±2°C and	50±5% relat	ive humidity	
Conditioning of cotton indicator:	24 hours in	desiccator 2	23±2°C		
Deviations from the standard:	no				
Test progress:	After removing the ignition flame, the test specimens do not burn. The flame did not exceed the 25 mm mark. A support fixture was used during the test due to the bending of the test specimens.				
Test specimen No.1	burning stop	pped before	25 mm
