TEST REPORT No.: 11788/P/21

CUSTOMER:	Jiangsu Shemar Electric Co., Ltd. 66 Haiwei Road 226 017 Nantong, Jiangsu China
TEST OBJECT:	230 kV Composite insulator
TYPE SPECIFICATION:	SML 222 kN
TEST STANDARDS:	ANSI C29.12-2020, ANSI C29.11-2020, NEMA 107:2016, IEEE Std 4:2013

TEST OBJECT:	230 kV Composite insulator
TYPE SPECIFICATION:	SML 222 kN
DRAWING No.:	21SM510758 Rev. A
MANUFACTURER:	Jiangsu Shemar Electric Co., Ltd.
DATE OF DELIVERY:	2021-12-09
DATE OF TESTS:	From 2022-02-28 till 2022-03-24
ORDER No.:	Contract 23/21
TESTS WITNESSED BY:	N/A

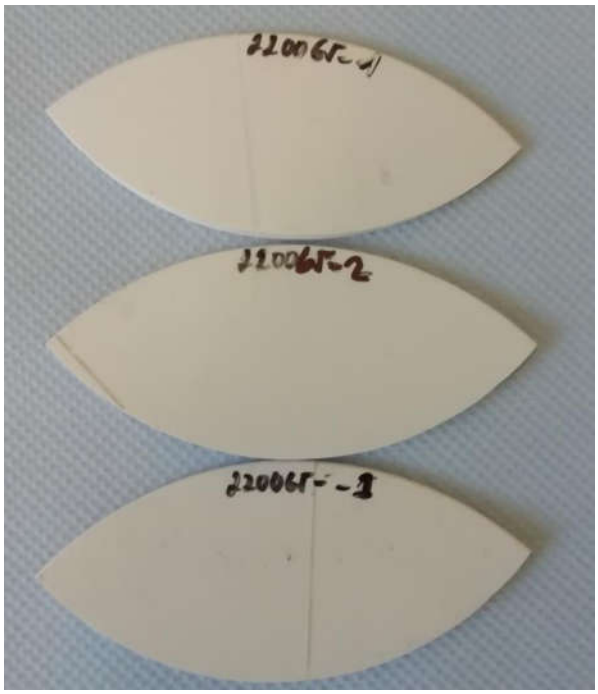
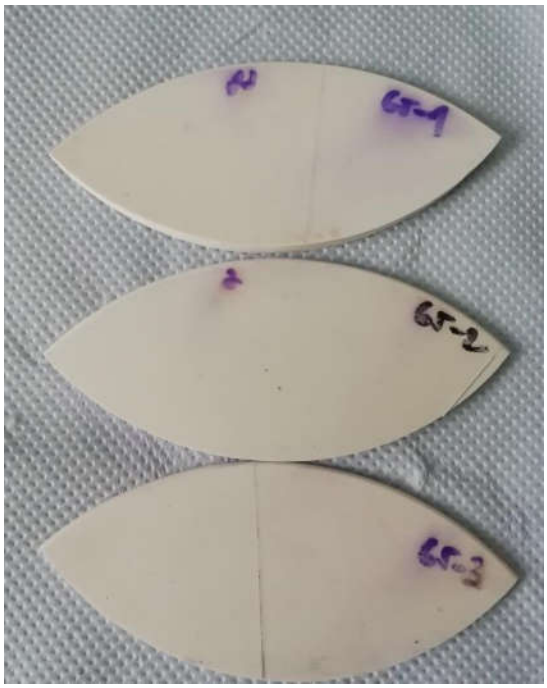
Sample name	Internal Lab Number	Surface failure	Cracking	Flaking
		ČSN EN ISO 4628-1	*ČSN EN ISO 4628-4*	*ČSN EN ISO 4628-5*
		degree + verbal	*degree*	*degree*
250 hours				
HTV	22 0065/1	**0, no visual changes**	**0 (S0)**	**0 (S0)**
	22 0065/2	**0, no visual changes**	**0 (S0)**	**0 (S0)**
	22 0065/3	**0, no visual changes**	**0 (S0)**	**0 (S0)**
500 hours				
HTV	22 0065/1	**0, no visual changes**	**0 (S0)**	**0 (S0)**
	22 0065/2	**0, no visual changes**	**0 (S0)**	**0 (S0)**
	22 0065/3	**0, no visual changes**	**0 (S0)**	**0 (S0)**
750 hours				
HTV	22 0065/1	**0, no visual changes**	**0 (S0)**	**0 (S0)**
	22 0065/2	**0, no visual changes**	**0 (S0)**	**0 (S0)**
	22 0065/3	**0, no visual changes**	**0 (S0)**	**0 (S0)**
1000 hours				
HTV	22 0065/1	**0, no visual changes**	**0 (S0)**	**0 (S0)**
	22 0065/2	**0, no visual changes**	**0 (S0)**	**0 (S0)**
	22 0065/3	**0, no visual changes**	**0 (S0)**	**0 (S0)**

Pic 1 : Exposure after 1000hrs (top face)
Pic 2 : Exposure after 1000hrs (lower face)

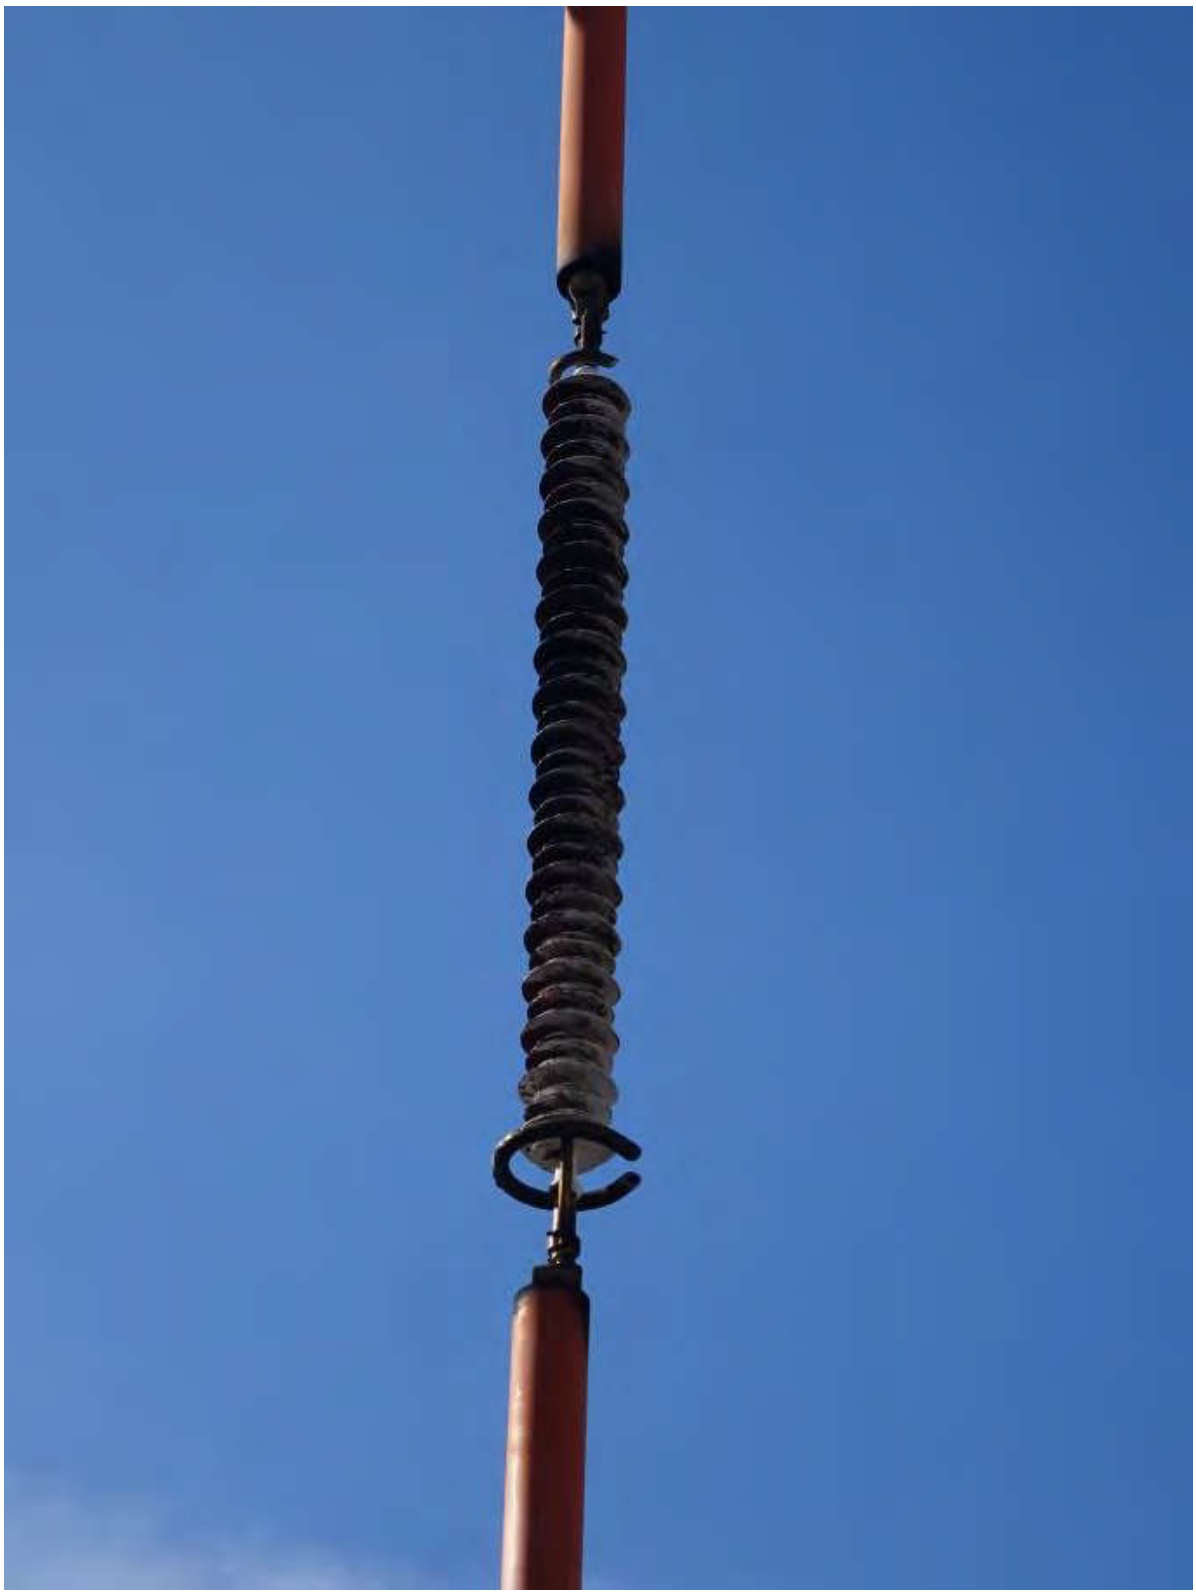
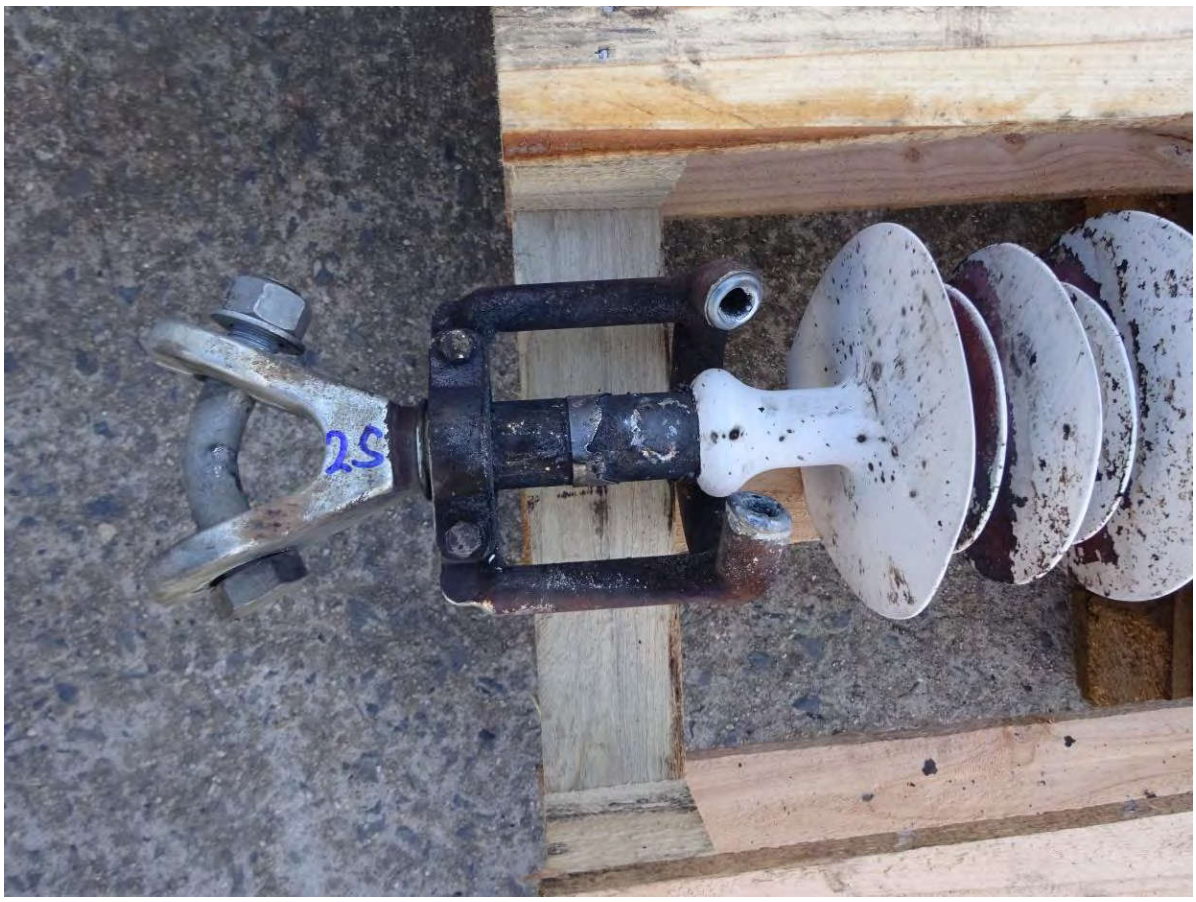
Insulating components:
No housing damage, no exposure of the fiberglass core. Discoloration and burning of the surface.

Metallic insulator components:
Partial melting and arc puddling; galvanized coating damaged; burning on the surface.

Corona rings and other protective metallic parts:
Partial metallic evaporation of the grading rings (see pages 30 – 33).

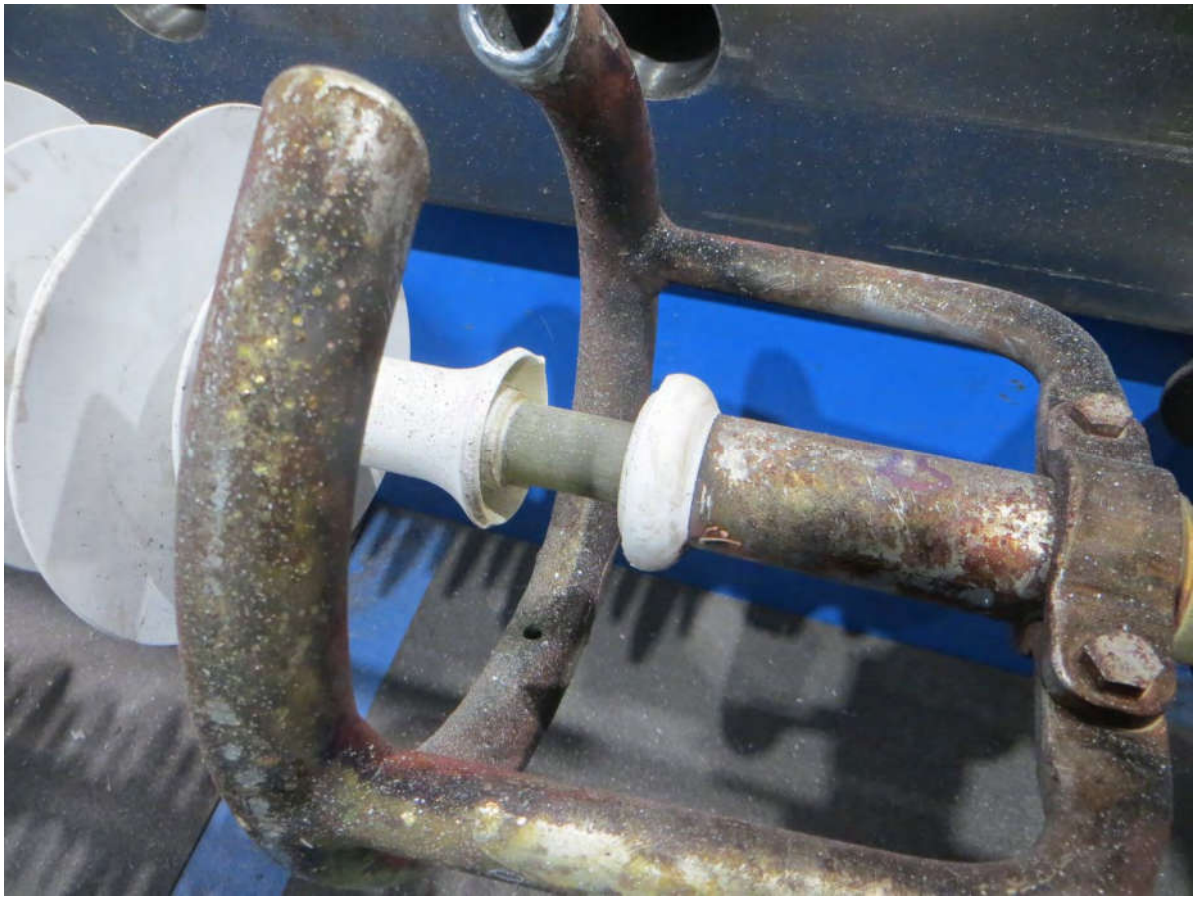
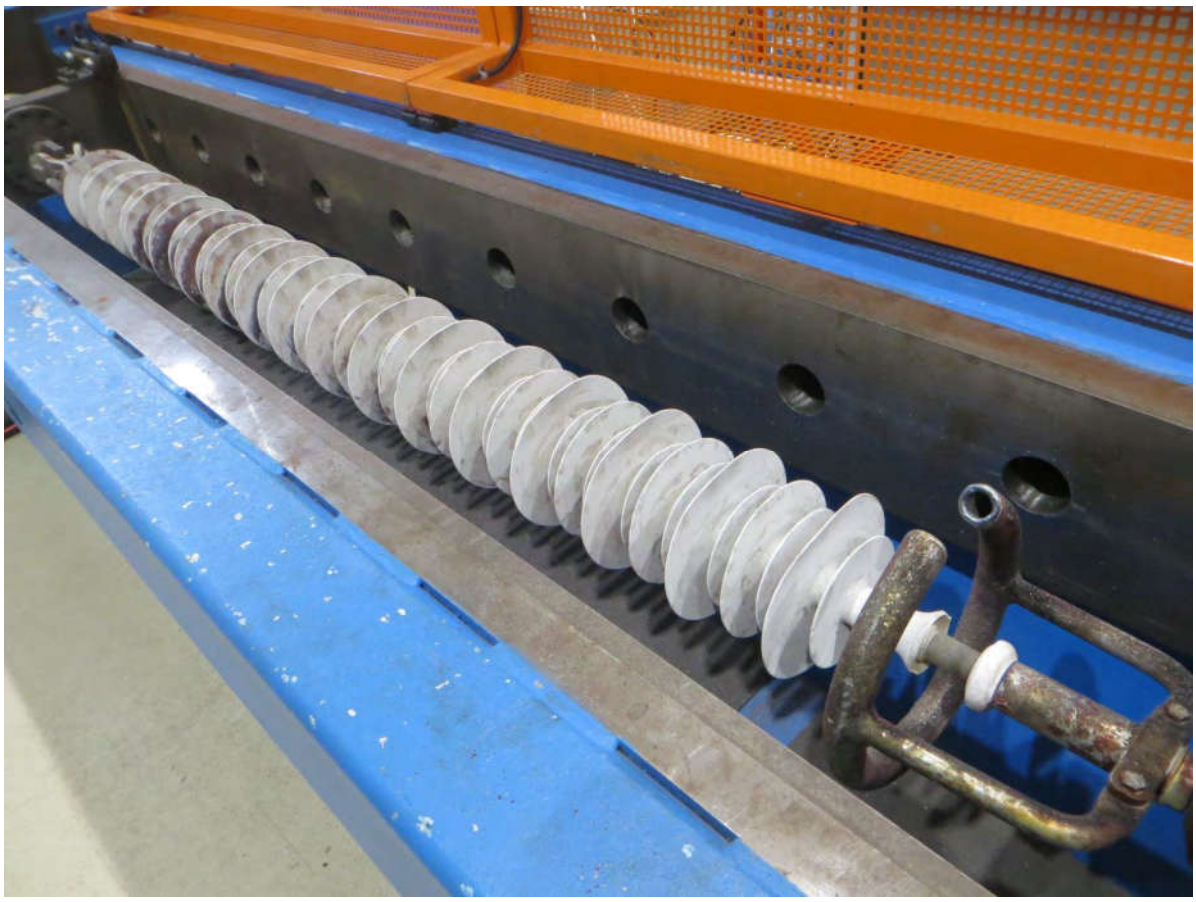
Insulator unit (2S) reached the end of mechanical failing load test.

Insulator separation during the test	Not permitted	Fulfilled
Burning, breaking of sheds or ribs, glaze removal, melting of galvanized surfaces	Permitted	Fulfilled
Exposure of the fiberglass core (composite insulators only)	Not permitted	Fulfilled
Dry power frequency flashover to check for puncture (class B only)	All units shall be tested and external flashover shall occur.	Not Applicable
Mechanical failing load test	The failing load on all selected units shall be at least 70 % of SFL or SML.	Fulfilled
Tests on fittings and conductors	By agreement	Not Applicable
