TEST REPORT No.: 11788/J/21

TEST REPORT	No.: 11788/J/21	
TEST OBJECT:	230 kV Composite insulator	
TYPE SPECIFICATION:	SML 222 kN	
DRAWING No.:	21SM510758 Rev. B	
MANUFACTURER:	Jiangsu Shemar Electric Co., Ltd.	
DATE OF DELIVERY:	2021-12-09	
DATE OF TESTS:	From 2022-02-28 till 2022-03-24	
ORDER No.:	Contract 23/21	
TESTS WITNESSED BY:	N/A

KEMA TEST REPORT

Object	Composite insulator unit with grading rin	gs
Туре	FXBW-230kV/222kN	Serial No
	230 kV - 20 kA - 50 Hz	
Client	Jiangsu Shemar Electric Co., Ltd., No. 66 Haiwei Road, Sutong Science and Jiangsu 226017, People's Republic of Chi	Technology Industrial Park, Nantong City, na
Manufacturer	Insulator units: Jiangsu Shemar Electric Co., Ltd., No. 99 Yishou Road (South), Rugao, Jiang People's Republic of China ^{*)}	ısu 226553,
	Protective fittings: Jiangsu Shemar Electric Co., Ltd., No. 99 Yishou Road (South), Rugao, Jiang People's Republic of China ^{*)}	su 226553,
Tested by	Zkušebnictví, a.s KEMA Labs Podnikatelská 547, Prague 9, the Czech R	Republic
Date of tests	7 March 2022	
Test specification	The tests have been carried out in accord chapter 3 'Tests carried out'.	dance with the client's instructions, see
	· 1927 ·	E .
	CY FUX

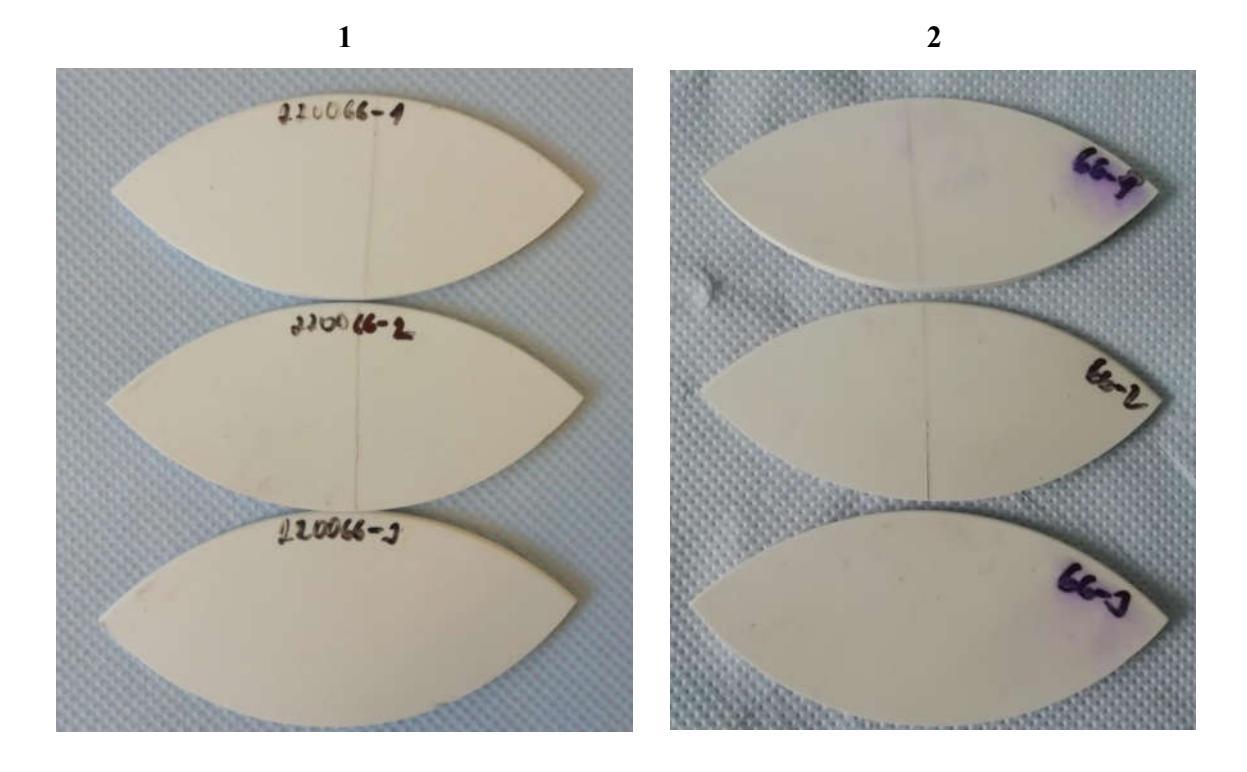
Pic 1 : Exposure after 1000hrs (top face) Pic 2 : Exposure after 1000hrs (lower face)
