TEST REPORT No.: 11788/W/21
CUSTOMER:	Jiangsu Shemar Electric Co., Ltd. 66 Haiwei Road 226 017 Nantong, Jiangsu China
TEST OBJECT:	69 kV Composite insulator
TYPE SPECIFICATION:	SML 133 kN
TEST STANDARDS:	CSA C411.4-16, CSA C411.1-16, IEC 60060-1 Ed. 3.0:2010

TEST REPORT	No.: 11788/W/21
TEST OBJECT:	69 kV Composite insulator
TYPE SPECIFICATION:	SML 133 kN
DRAWING No.:	21SM510755 Rev. B XL21LS172, Rev. 01
MANUFACTURER:	Jiangsu Shemar Electric Co., Ltd.
DATE OF DELIVERY:	2021-12-09
DATE OF TESTS:	From 2022-01-03 till 2022-04-01
ORDER No.:	Contract 23/21
TESTS WITNESSED BY:	N/A
ANNEX	Test report SYNPO, No. T 375/006 Test report Testpolymer EU, No. 59/2022/EN

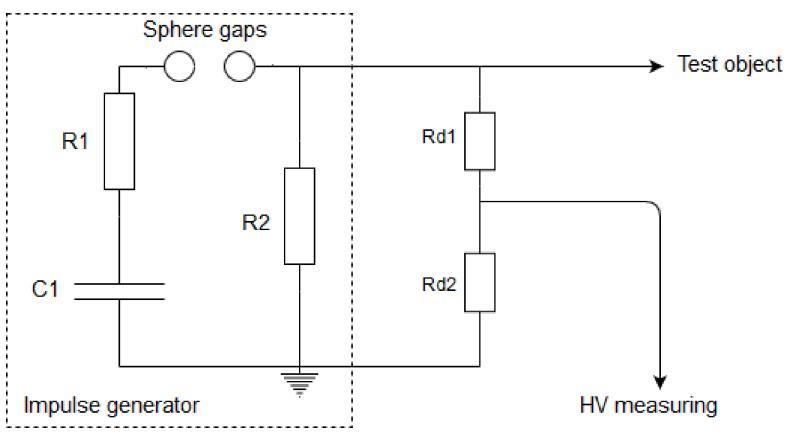
impulse generator TuR Dresden 750 kV, 30 kJ R_{d1}/R_{d2} - resistive divider Haefely, 800 kV, serial No. 554333 measuring system Haefely Trench, type HiAS 743, serial No. 175247 measuring system for atmospheric conditions Comet, serial No. 10910247 tape measure 7,5 m, Assist, PM-242

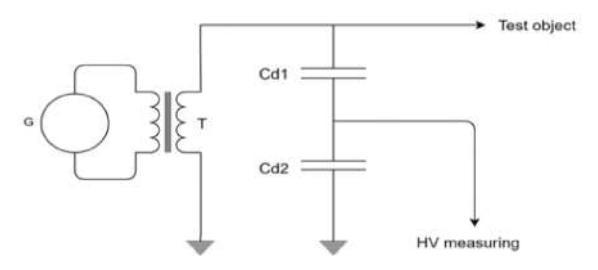
G - synchronous generator BEZ Bratislava 6 kV, 1300 kVA, T - test transformer TuR Dresden, 500kV/3 000 kVA, serial No. 870786 Cd1/Cd2 – divider MCF 600, serial No. 863705 universal voltmeter Haefely DMI 551, serial No. 188856 digital stop-watch Fastime, PM-251 measuring system for atmospheric conditions COMET, serial No. 14900363 digital thermometer Fluke 54II, serial No. 41070290WS + probe 80PK-27 tape measure 7,5 m, Assist, PM-242

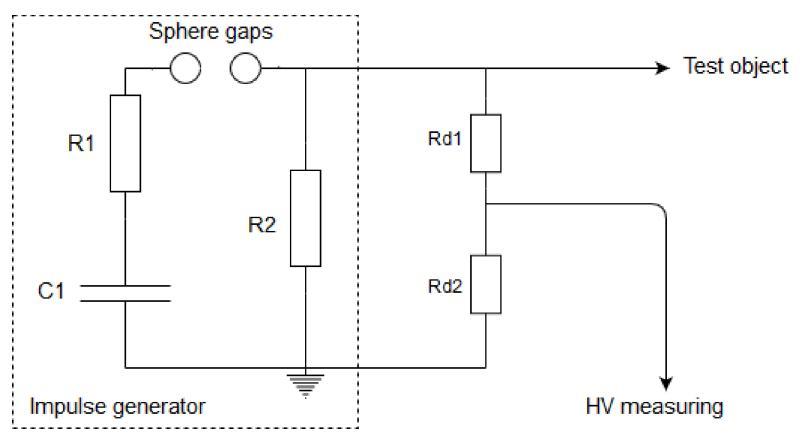
impulse generator TuR Dresden 750 kV, 30 kJ R_{d1}/R_{d2} - resistive divider Haefely, 800 kV, serial No. 554333 measuring system Haefely Trench, type HiAS 743, serial No. 175247 measuring system for atmospheric conditions Comet, serial No. 10910247 tape measure 7,5 m, Assist, PM-242

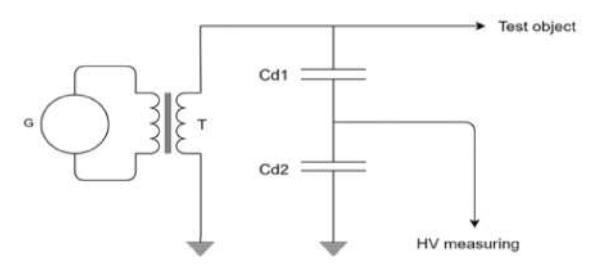
G - synchronous generator BEZ Bratislava 6 kV, 1300 kVA, T - test transformer Fischer Köln, 250 kV, serial No. P38879 Cd1/Cd1 – LK-250, serial no. 001-12 universal voltmeter MU 17, serial No. 929218 digital stop-watch Kalenji, PM-259 measuring system for atmospheric conditions COMET, serial No. 10910247 digital thermometer Fluke 54II, serial No. 41070290WS + probe 80PK-27 tape measure 7,5 m, Assist, PM-242

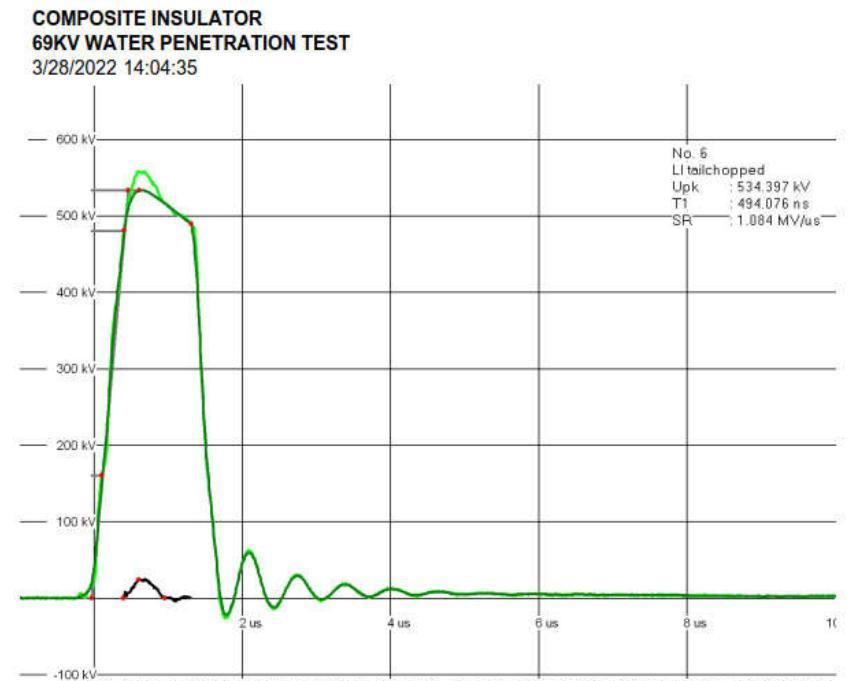
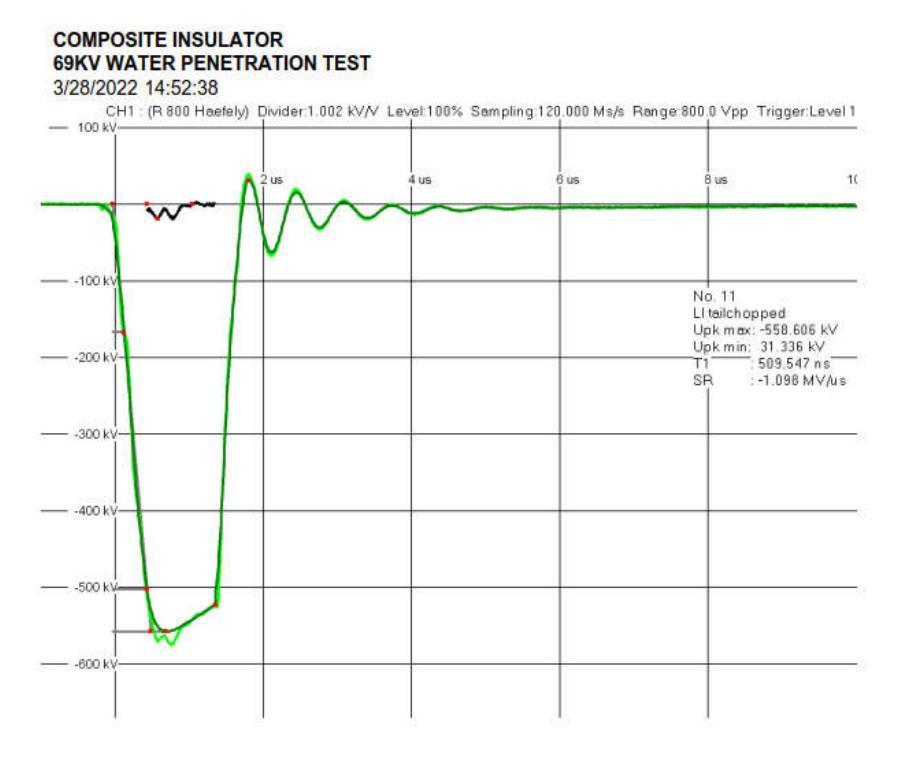
Graph 1 Representative wave shape of steep front impulse (water penetration test)

No. 6 Ll tailchopped Upk : 534.397 kV T1 : 494.076 ns SR : 1.084 MV/us

No. 11 LI tailchopped Upk max: -558.606 kV Upk min: 31.336 kV T1 : 509.547 ns SR : -1.098 MV/us

The wave shape of the test impulse is given in Graph 1.

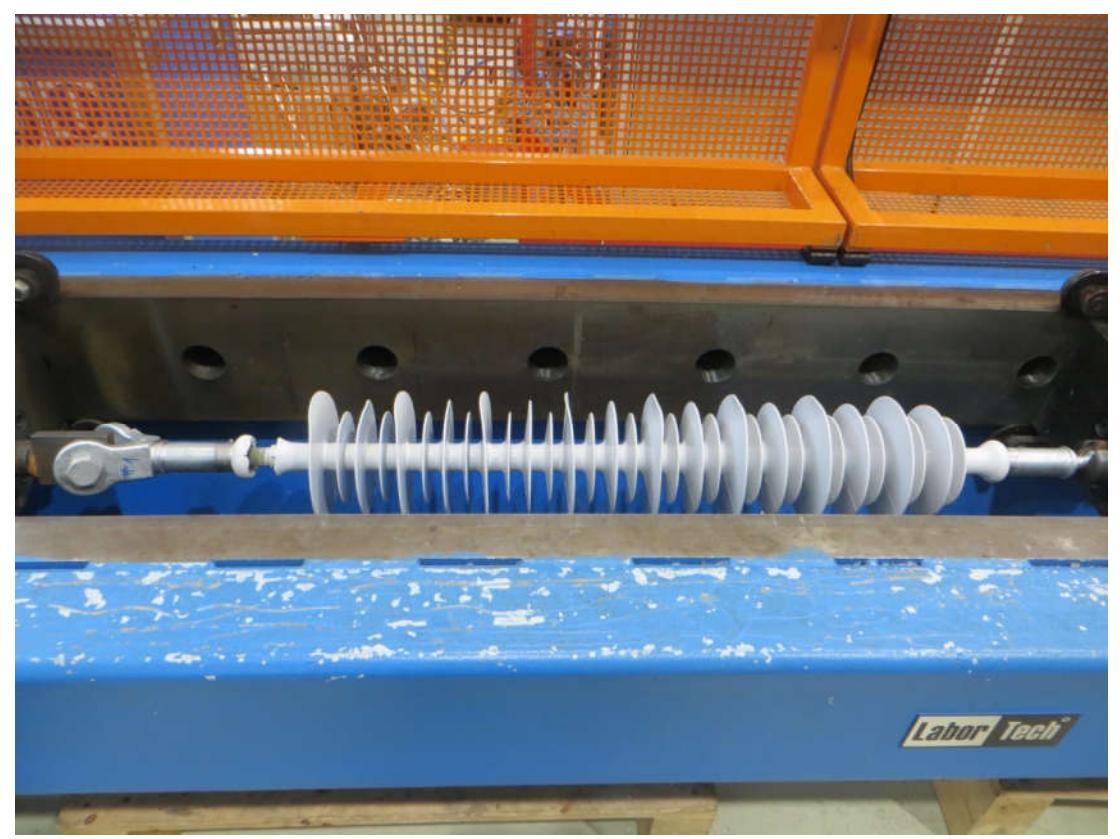
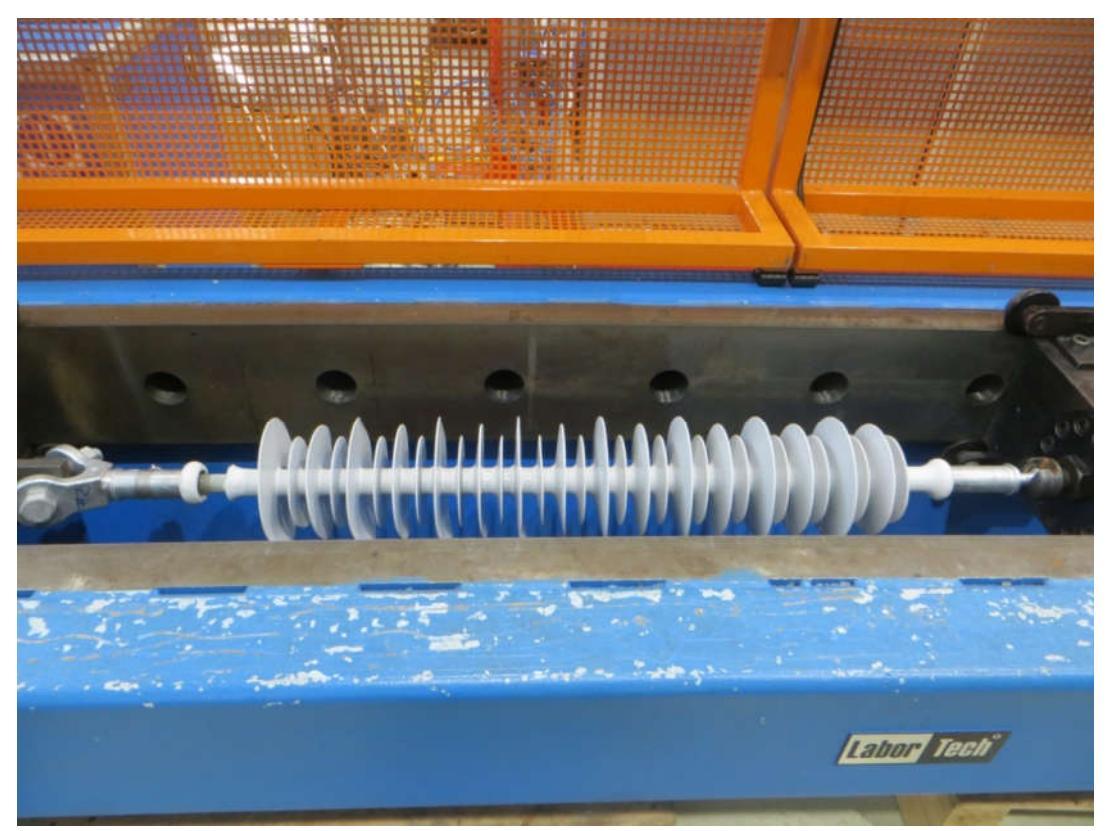
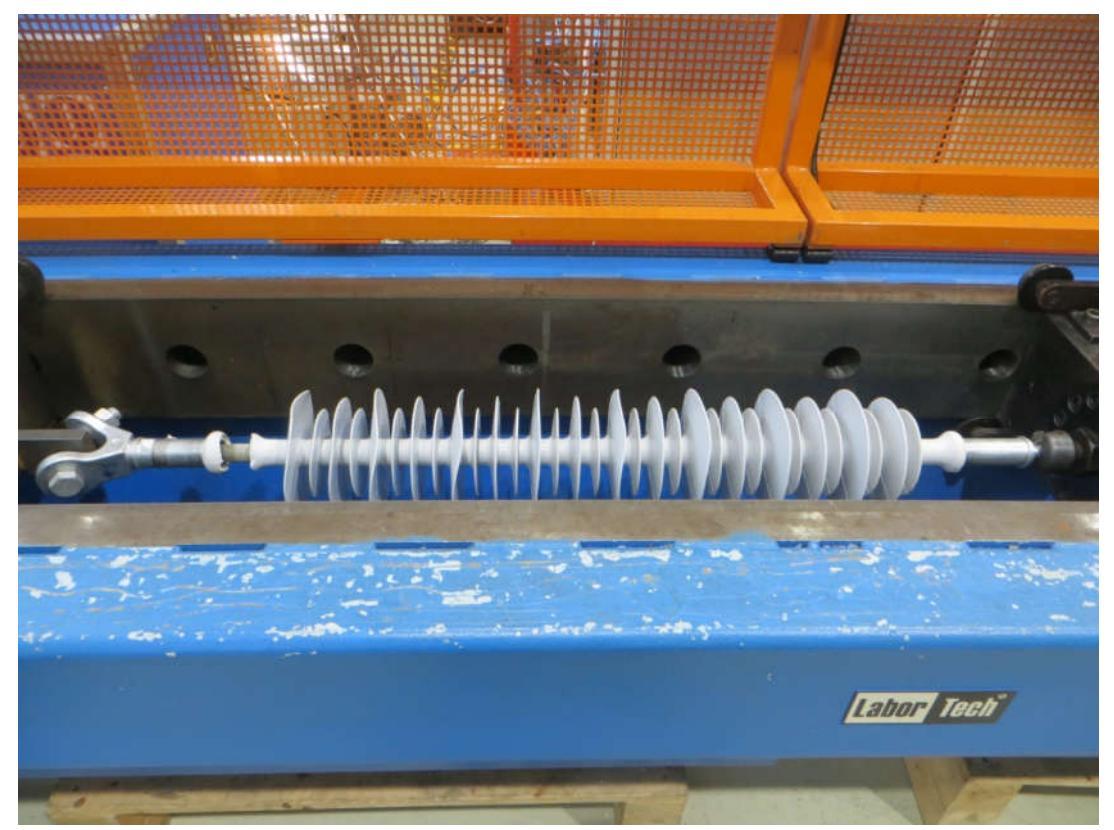
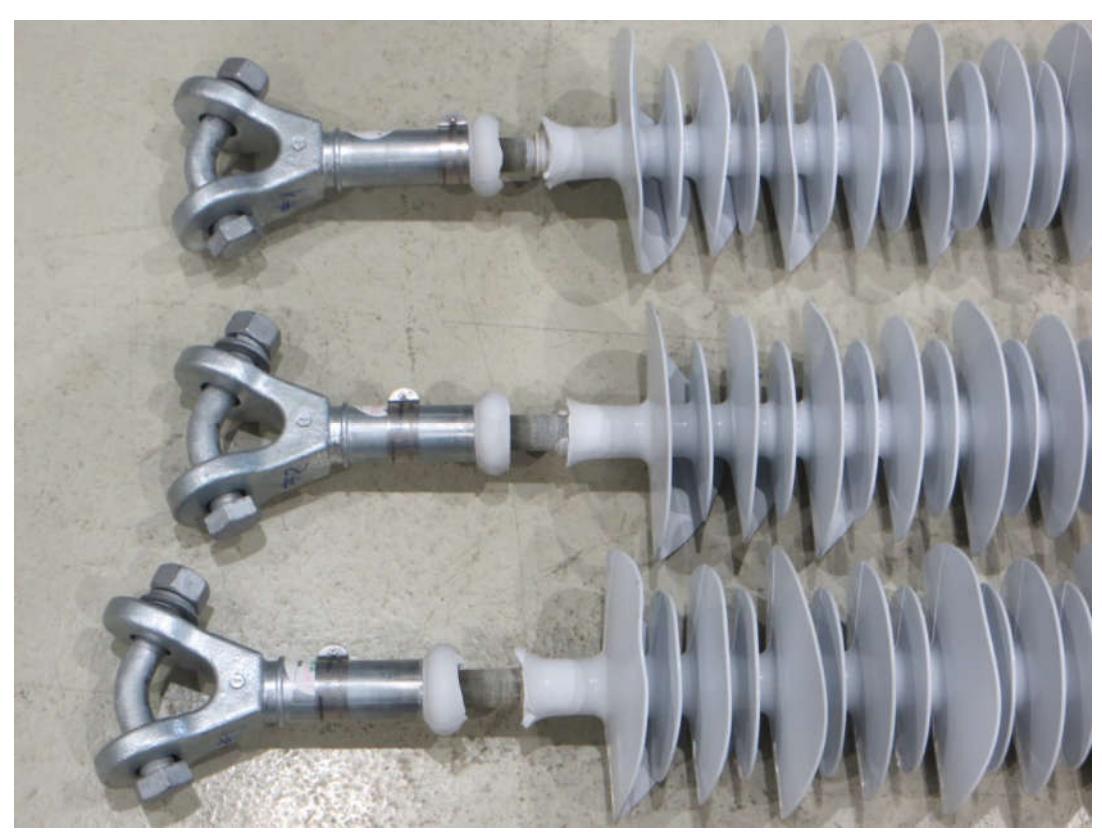
Figure 17 Test sample No. 1, after the mechanical failing load test, tensile load test

Figure 18 Test sample No. 1, after the mechanical failing load test, tensile load test

Figure 19 Test sample No. 1, after the mechanical failing load test, tensile load test

Figure 20 Test samples No. 1, 2 and 3 after the mechanical failing load test, tensile load test

The samples after mechanical failing load test are shown in Figure 17, 18, 19 and 20.

Test sample No.	100 % SML	Composite insulator failing load (kN)	Type of failure
1	133 kN/60 s - OK	235,0	Pull out of the core from the end fitting
2	133 kN/60 s - OK	209,5	Pull out of the core from the end fitting
3	133 kN/60 s - OK	234,0	Pull out of the core from the end fitting

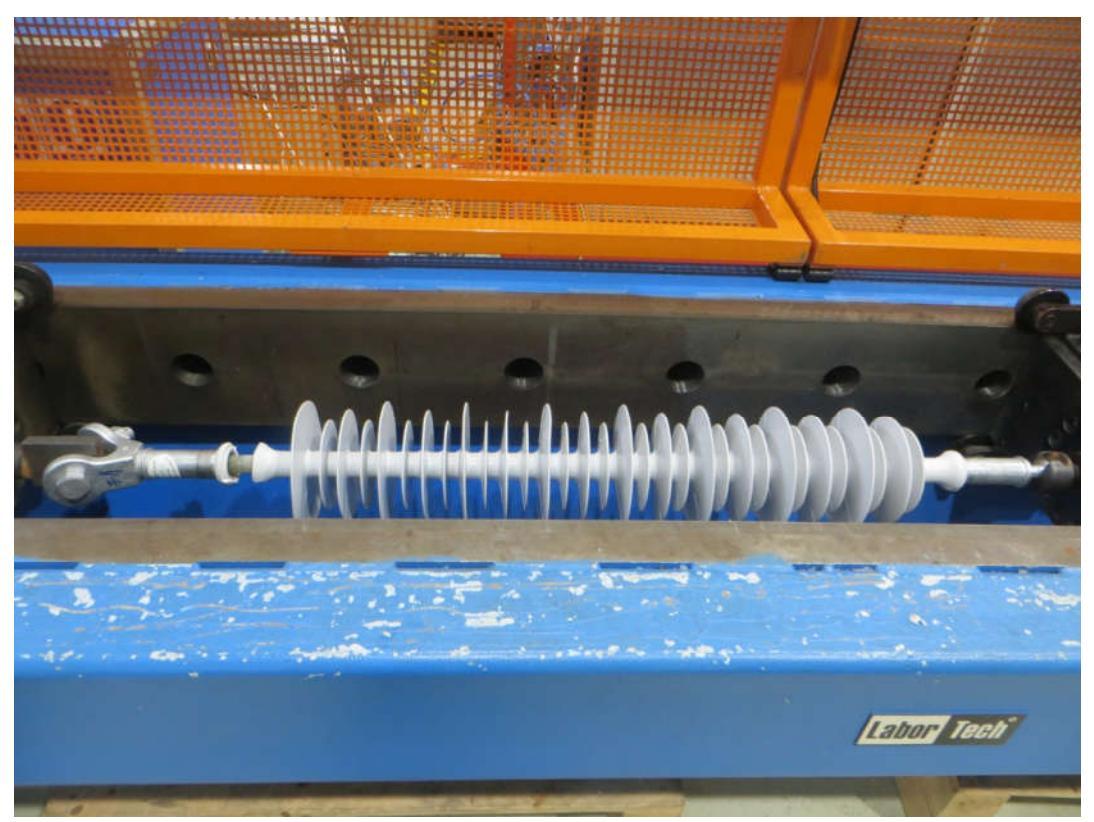
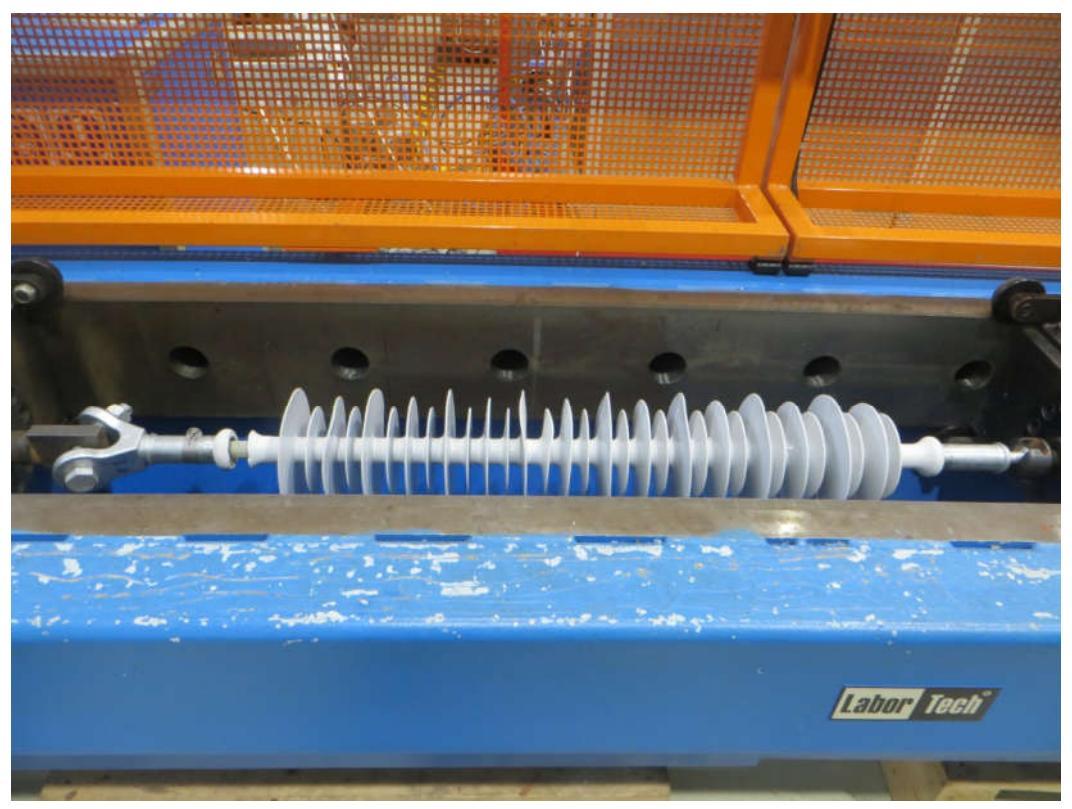
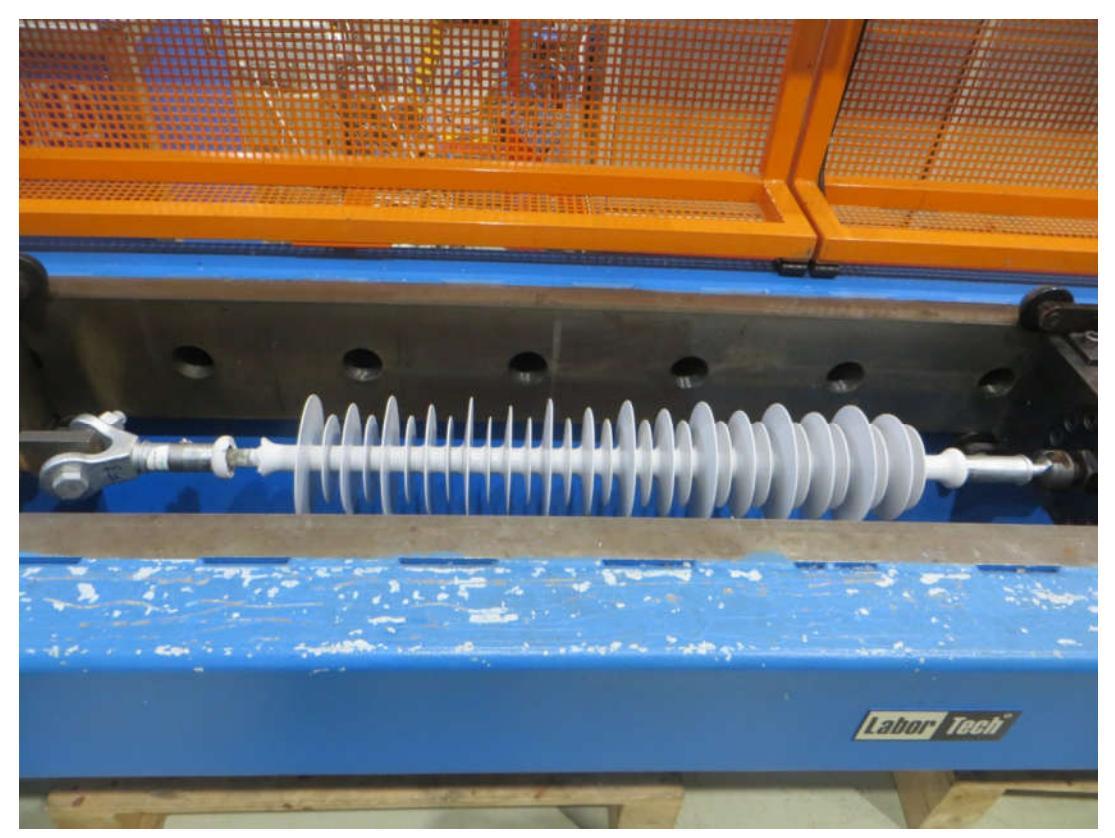
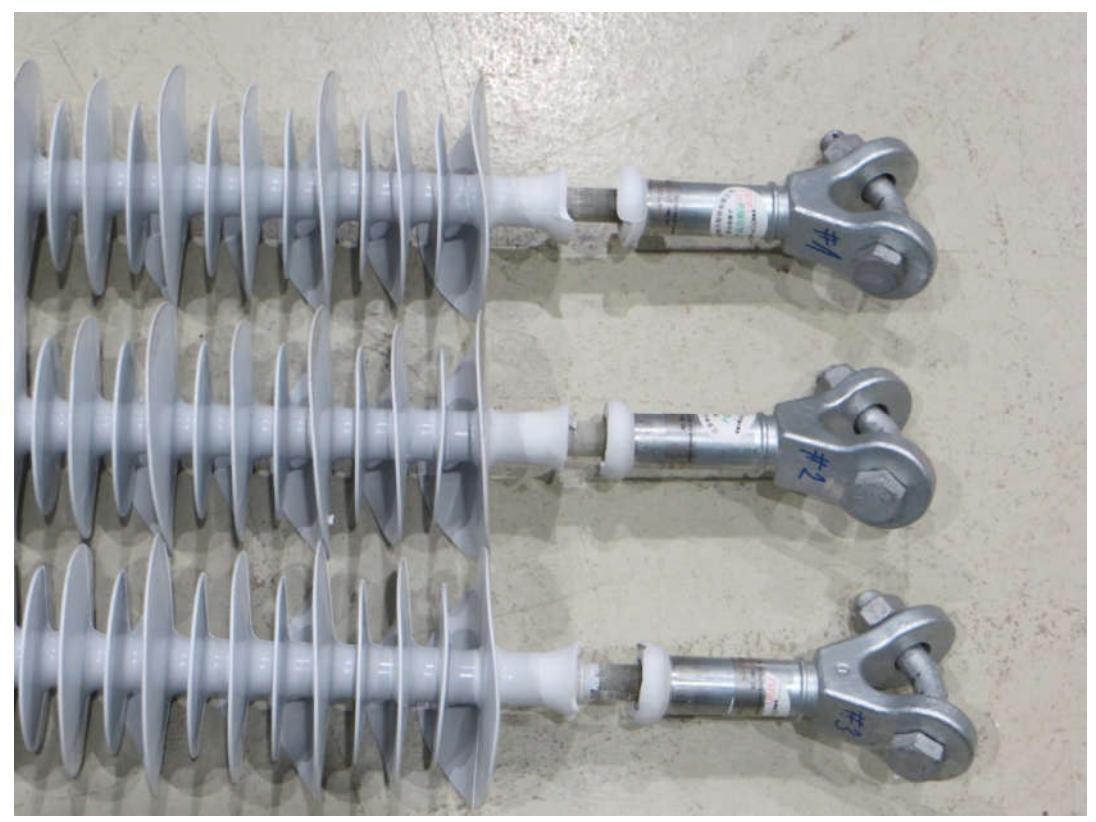
Figure 25 Test sample No. 1, after the mechanical failing load test, assembled core load-time test

Test sample No. 2, after the mechanical failing load test, assembled core load-time test

Figure 27 Test sample No. 3, after the mechanical failing load test, assembled core load-time test

Figure 28 Test samples No. 1, 2 and 3, after the mechanical failing load test assembled core load-time test

The samples after mechanical failing load test are shown in Figure 25, 26, 27 and 28.

Test sample No.	Type of failure	Composite insulator failing load (kN)
1	Pull out of the core from the end fitting	211,7
2	Pull out of the core from the end fitting	205,7
3	Pull out of the core from the end fitting	196,3
	Average of the failing load	204,6
	60 % of average of the failing load	122,8

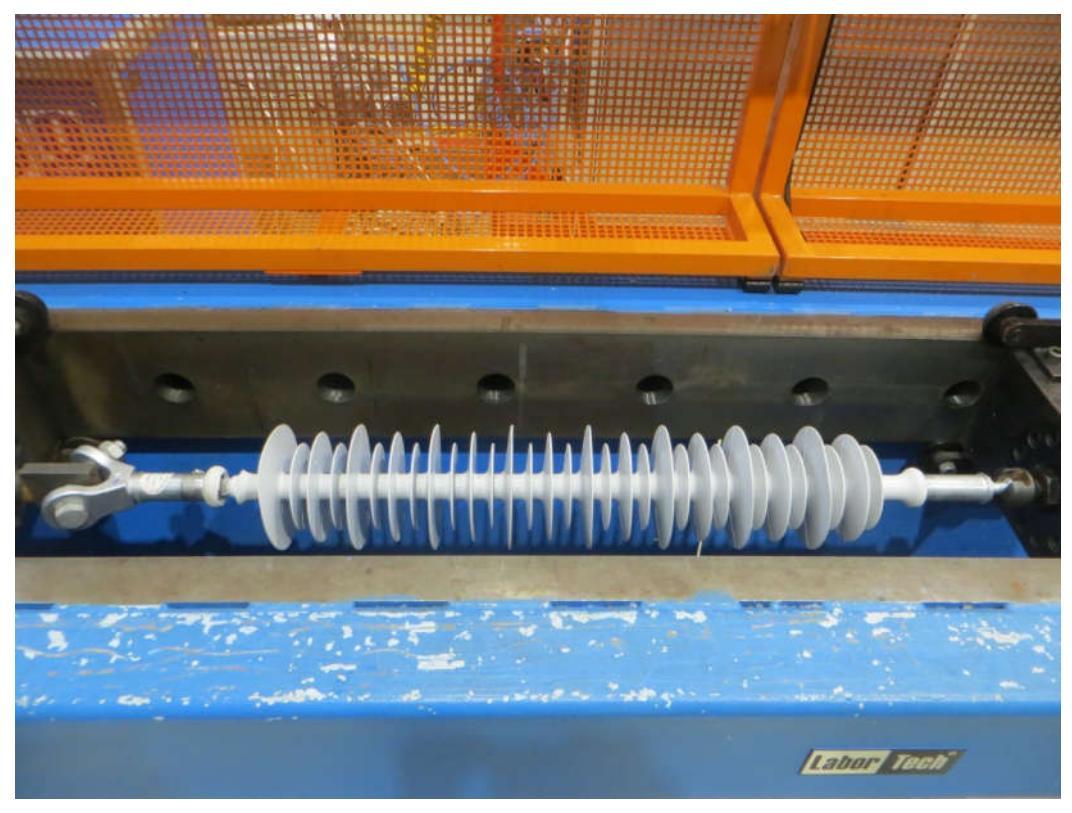
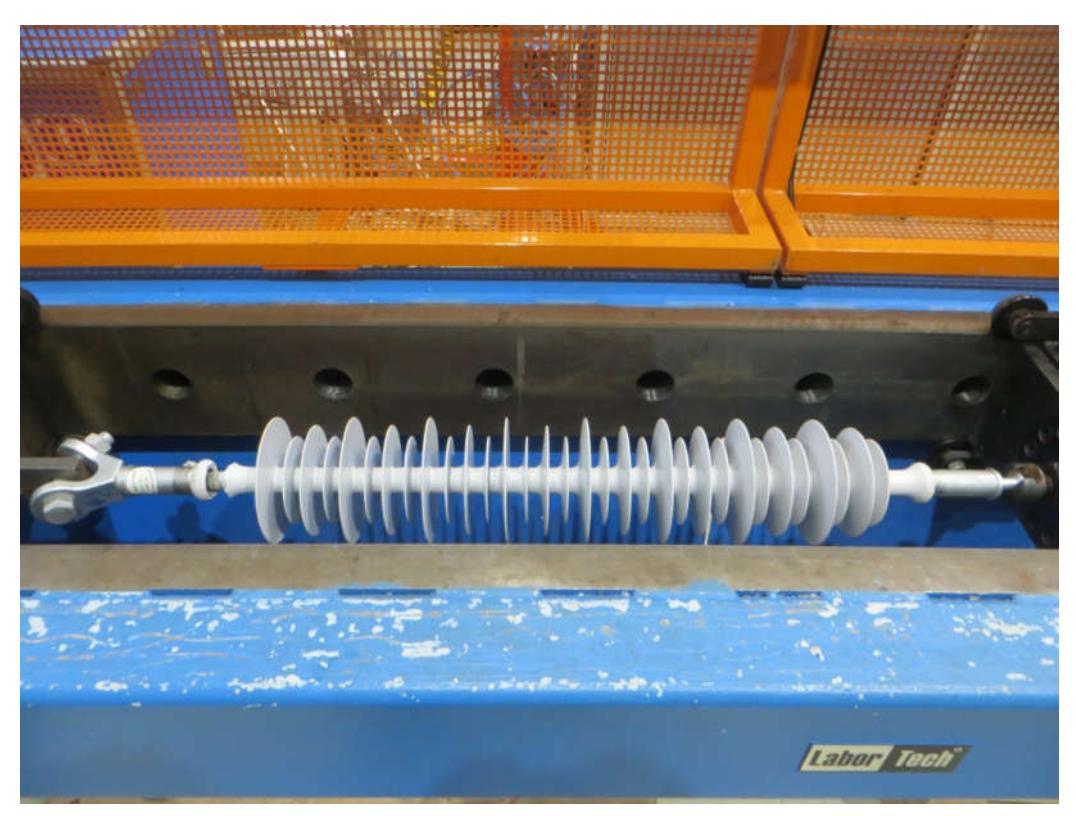
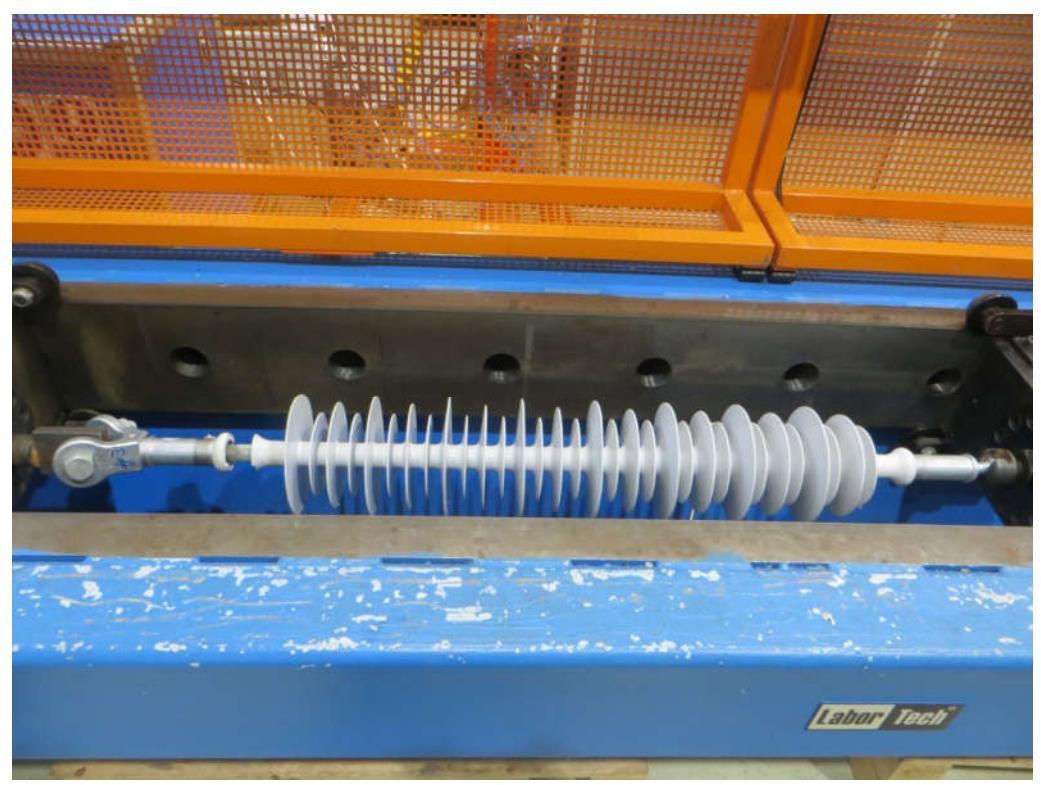
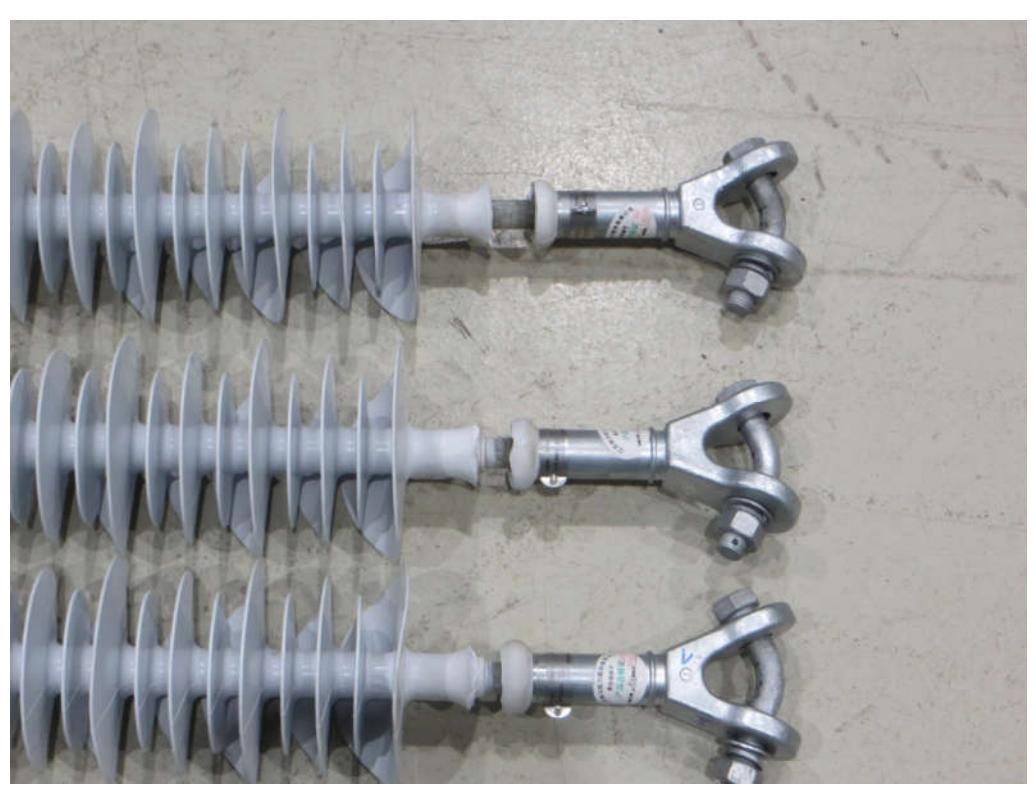
Figure 33 Test sample No. 1 after the mechanical failing load test, mechanical load-time test

Figure 34 Test sample No. 2 after the mechanical failing load test, mechanical load-time test

Figure 35 Test sample No. 3 after the mechanical failing load test, mechanical load-time test

Figure 36 Test sample No. 1, 2 and 3 after the mechanical failing load test, mechanical load-time test

Three remaining insulators No. 1, 2 and 3 were then again subjected to the tensile load applied between the couplings. The tensile load was increased rapidly but smoothly from zero approximately to 99,8 kN (75 % of SML) and then gradually increased in a time between 30 s to 90 s to 133 kN (100 % of SML). The load was sustained for the 60 s. Then the load was increased up to the failure of the insulator. Record of applied tensile load during testing are shown in Graphs 18, 19 and 20. The insulators after the failing load tests are shown in Figures 33, 34, 35 and 36.

Insulator No.	Failing load (kN)	Type of failure
1	183,5	Pull out of end fitting
2	214,7	Pull out of end fitting
3	220,9	Pull out of end fitting

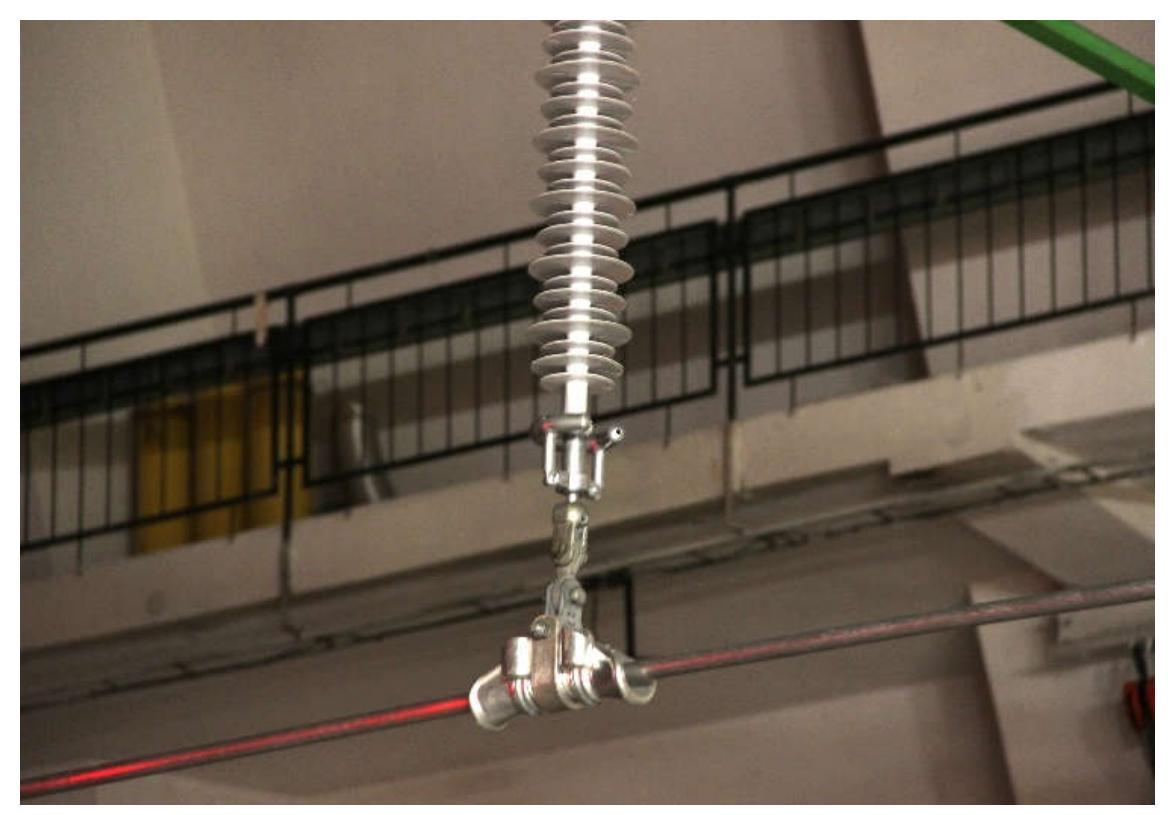
Figure 4 Test object at the test voltage of 50 kV – no positive corona

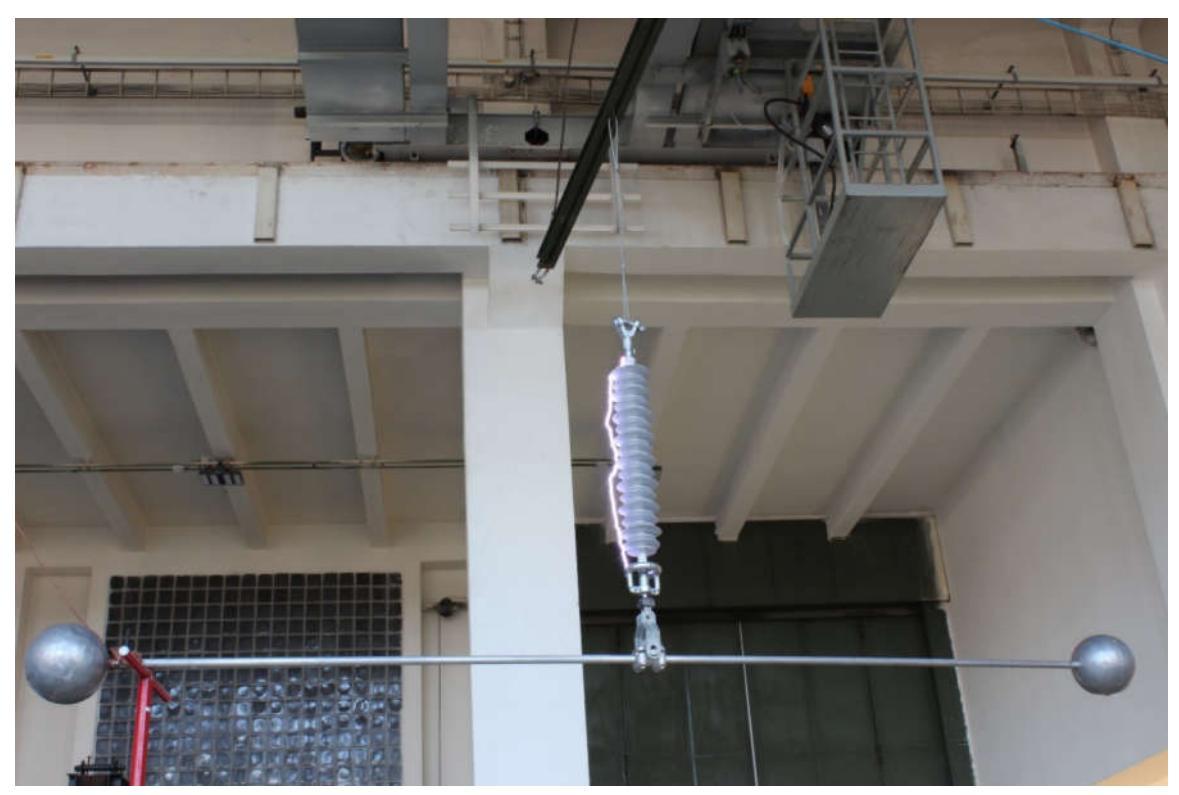
Figure 6 Test arrangement and flashover under the critical impulse flashover test

Test sample No.	1	l	2	2	3	
Impulse polarity	+	-	+	-	+	-
Atm. conditions:						
air pressure (kPa)	100,1	100,1	100,0	100,0	100,1	100,1
air temperature (°C)	16,8	16,8	16,6	16,6	16,9	16,9
relative humidity (%)	38,5	38,5	35,2	35,2	33,2	33,2
Correction factors:						
air density correction factor k ₁	0,999	0,999	0,999	0,999	0,999	0,999
humidity correction factor k ₂	0,958	0,966	0,952	0,963	0,952	0,962
atmospheric correction factor Kt	0,957	0,965	0,951	0,962	0,951	0,961
Critical impulse flashover voltage (kV)	635	667	627	668	633	667
Polarity		+	I		-	1
Average critical impulse flashover value of the three insulators (kV)	632 667					
Measured arcing distance: 980 mm						
Drawing specified critical impulse flashover voltage: 628 kV

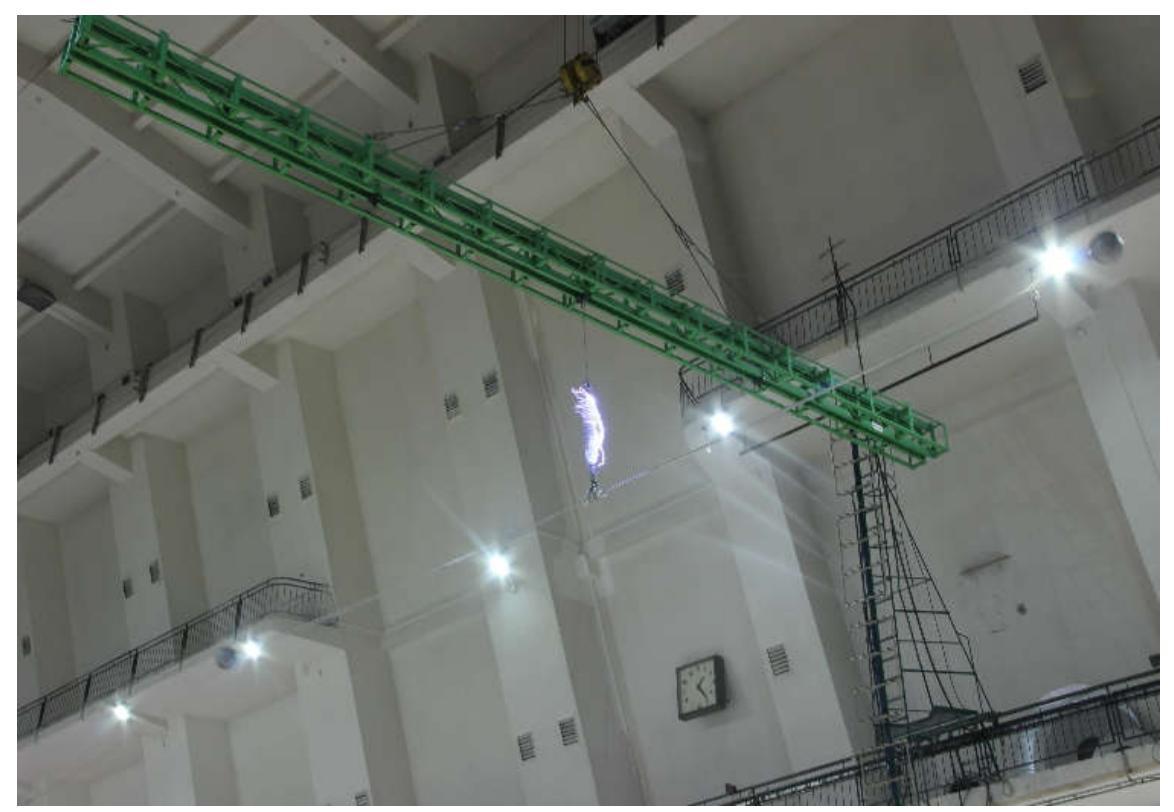
Figure 7 Test arrangement and flashover under the wet power frequency voltage flashover test

Test sample No.	1	2	3	
Atm. conditions:				
air pressure (kPa)	98,9	98,9	98,9	
air temperature (°C)	15,5	15,5	15,5	
relative humidity (%)	51,2	51,2	51,2	
Rain parameters:				
vertical (mm/min)	1,6	1,6	1,6	
horizontal (mm/min)	1,6	1,6	1,6	
Conductivity (µS/cm)	99	99	99	
Correction factors:				
air density correction factor k ₁	0,992	0,992	0,992	
humidity correction factor k ₂	1,000	1,000	1,000	
atmospheric correction factor K _t	0,992	0,992	0,992	
Flashover voltage	320 kV	327 kV	332 kV	
The average wet flashover voltage of the three insulators326 kV				
Measured arcing distance: 980 mm				
Drawing specified wet power frequency flashover voltage: 320 kV

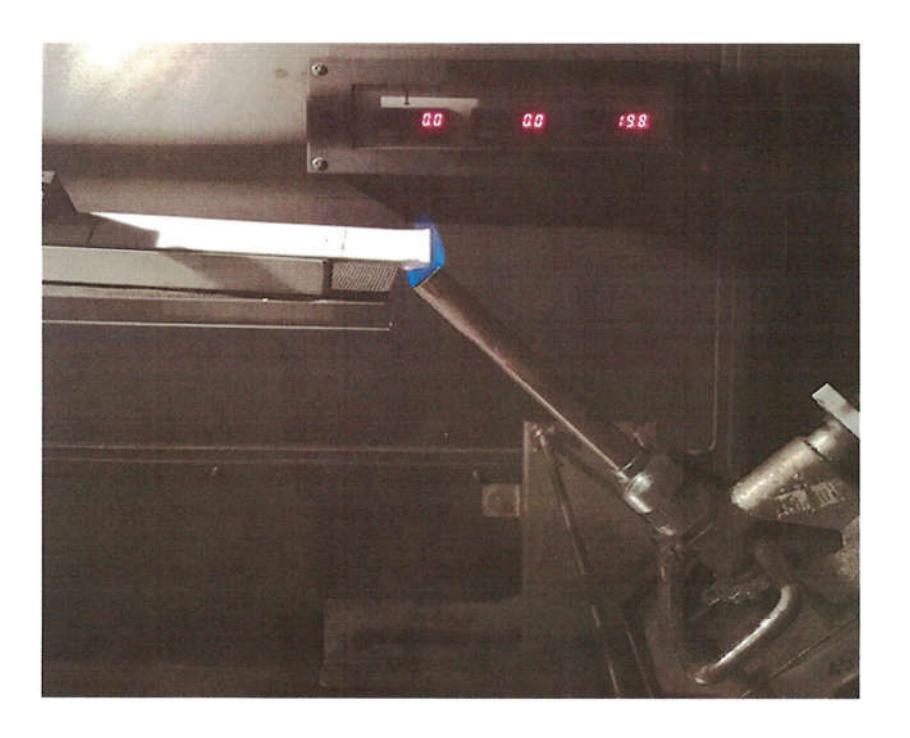
Photo of the position of the test specimen during the test:

00/		1	
	Test re	port No	b. 59/20	022/EN			
Test standard:	ČSN EN 6069	95-11-10 ed	. 2: 2014				
Test equipment:	Chamber At	amber Atlas HVUL2					
Ignition course:	Burner with	an inner dia	ameter 9.5 m	m			
ignition source.	The gas used	d: Methane	2.5				
	Blue flame h	eight 20 m	m, the expos	ure time 30s	5		
Test conditions:	No forced ve	entilation w	as used durir	ng the test			
	Temperatur	e:	22,0 - 23,0°	C	Humidity:	48,0 - 49,0%	
Description of the sample (sample type, the color, the location in the product, the number of samples tested):	Test specim	est specimens of grey color 125x13x3mm, 3 pieces					
Conditioning of samples:	48 hours at	23±2°C and	50±5% relati	ive humidity			
Conditioning of cotton indicator:	24 hours in	desiccator 2	23±2°C				
Deviations from the standard:	no						
Test progress:	After removing the ignition flame, the test specimens do not burn. The flame did not exceed the 25 mm mark. A support fixture was used during the test due to the bending of the test specimens.

Test specimen No.1	burning stop	oped before	25 mm				
Test specimen No.2	burning stop	oped before	25 mm				
Test specimen No.3	burning stop	oped before	25 mm				
No. of test specimen	Damaged length L (mm)	Burning time t (s)	Linear burn rate (mm/min)	Linear burn va (mm	rate average Ilue /min)	Sample standard deviation (mm/min)	
1	0	0	0				
2	0	0	0		0	0	
3	0	0	0				
Statement of conformity to specification	Measured results (burning rate, damaged length) on tested three samples meet all requirements for classification HB according to article 8.4 ČSN EN 60695-11-10 ed.2 This statement of conformity to specifications is given in the sense of the shared risk decision rule; without including measurement uncertainty.						
Tested and evaluated by:	Ing. Lukáš N	avrátil		Date:	13.1.2022
